Ici sont regroupées toutes les notes techniques émises par Moto Guzzi depuis 2004 jusqu'à aujourd'hui. Ou au moins toutes celles que j'ai pu obtenir.

Here is all Technical and Servicing Notes from Moto Guzzi, from 2004 since today. All of what I have picked up...

MODEL	ABOUT...	SERVICE NOTE	DATE	TECHNICAL NOTE	DATE
All models	Electrical diagnosis improvement	---	---	008-2008	30/09/08
All models	Neutral sensor	---	---	002-2010	19/07/10
All models	Cleaning throttle body	---	---	005-2010	29/10/10
All models	Compatibility with E10	---	---	004-2011	13/09/11
All models	Diagnosis instrument : PADS	---	---	005-2012	28/03/12
All models	Handling and Storage	---	---	003-2013	26/03/13
All models	Speedometer indication	---	---	007-2013	16/05/13
All models	Control of the position of the electrical wiring harness	---	---	014-2013	31/07/13
All models	Battery initialisation	---	---	007-2014	17/07/14
All models	Vehicle servicing time	010-2012	09/2012	---	---
All models	Vehicle servicing time	002-2013	03/2013	---	---
All models	Vehicle servicing time <i>Only french version available for the moment</i>	xxx-2013	12/2013	---	---
All models	Warranty : modified components	004-2013	003-9967	---	---

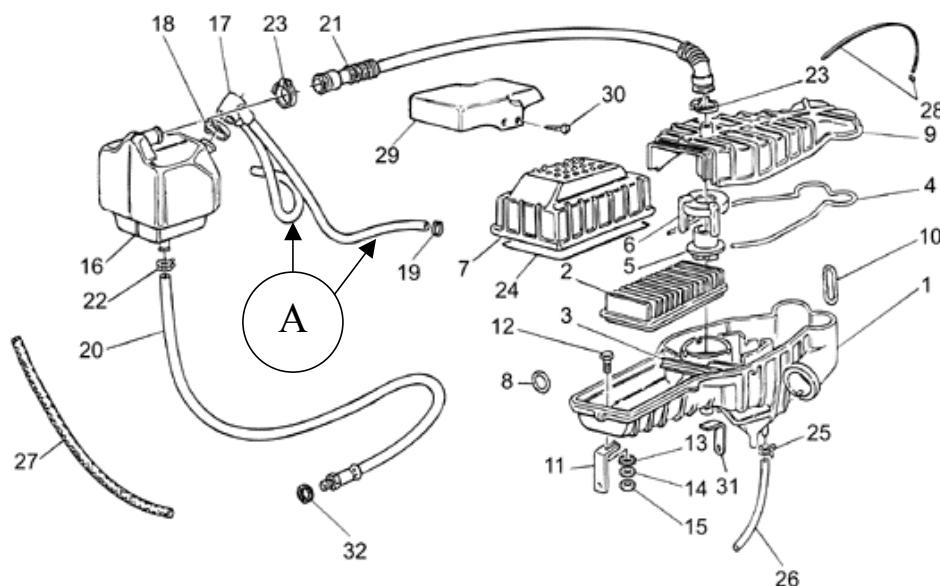
To the dealer principal,
the presence of excess oil on the filter casing is caused by

Check that the two breather pipes (A) carrying oil vapour from the rocker covers to the overflow are not crimped or blocked by poor rigidity; if so, replace them with more rigid

reinforced hose.

Replace the sleeve(C) and the spacers (B) with the corresponding Brevia 750 parts (for machines produced before 2003).

Use code 19027500 for the sleeve(C) and 32032310 for the spacer (B).

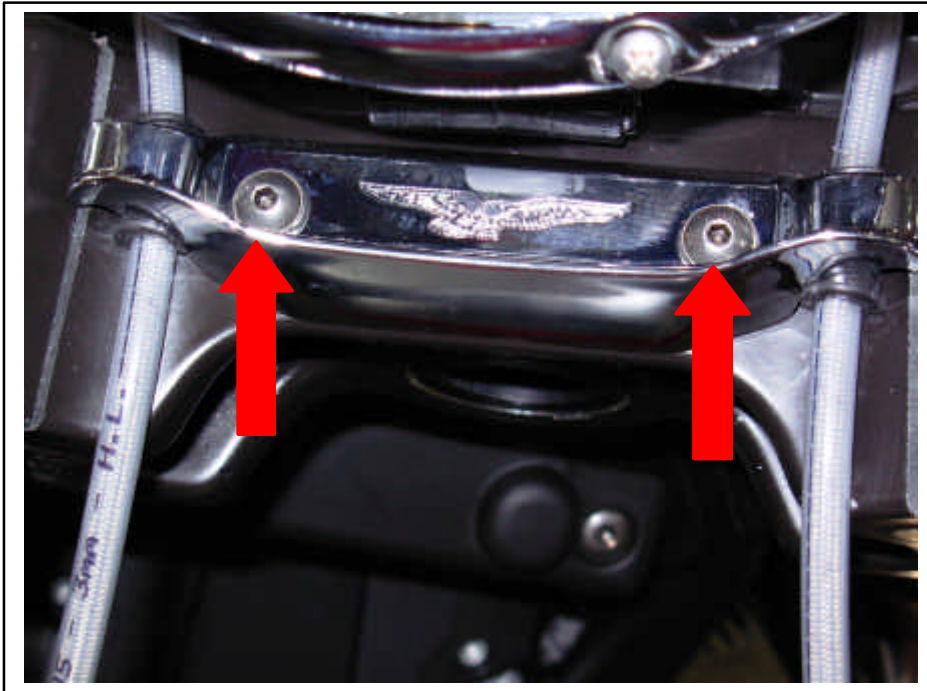
We received a few claims from the network concerning Griso V1100, about the chance that the front brake line interferes with the mudguard resulting in mudguard damage.

- 1) Loosen the two M5 retaining screws from brake line plate

- 2) Insert the two front brake line supports (part no. 977552 to be checked) into line plate

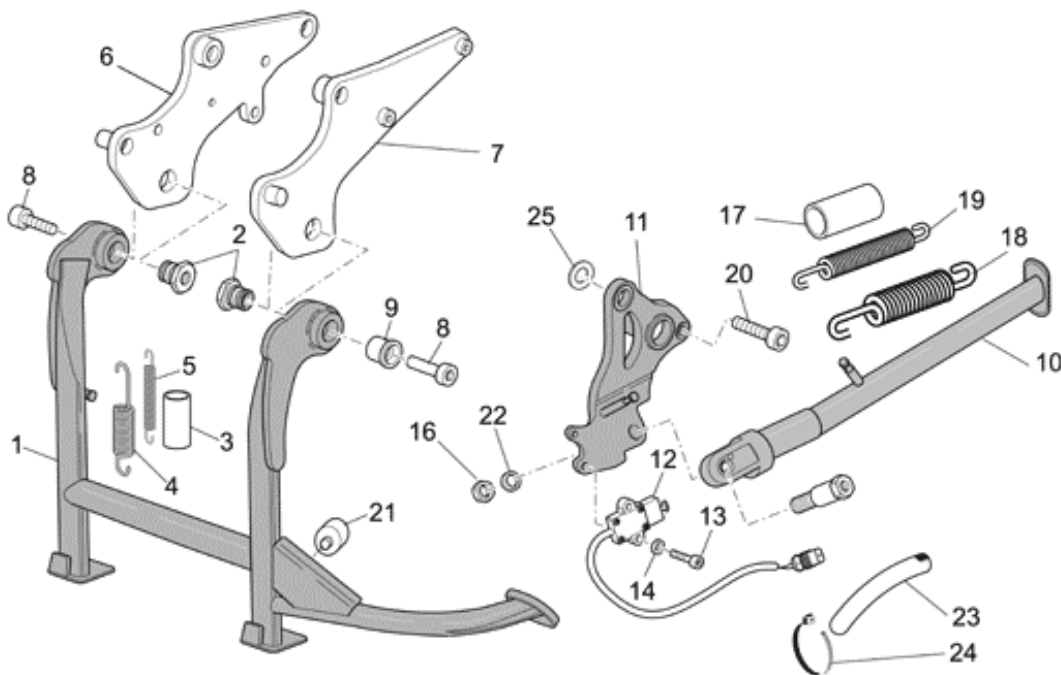
Dear Dealer,
We have been recently informed by the Official Moto Guzzi Sales Network about the loosening of the two fastening screws on the side stand plate, marked with reference "20" in the following exploded view.

This problem has already been remedied on the manufacturing line by adding two washers, part No. 30217900, between the "side stand plate" and the above mentioned screws, and by monitoring the tightening torque, which shall be of 80 Nm.
Here is the table with the frame number of the first vehicles where the problem has been solved.

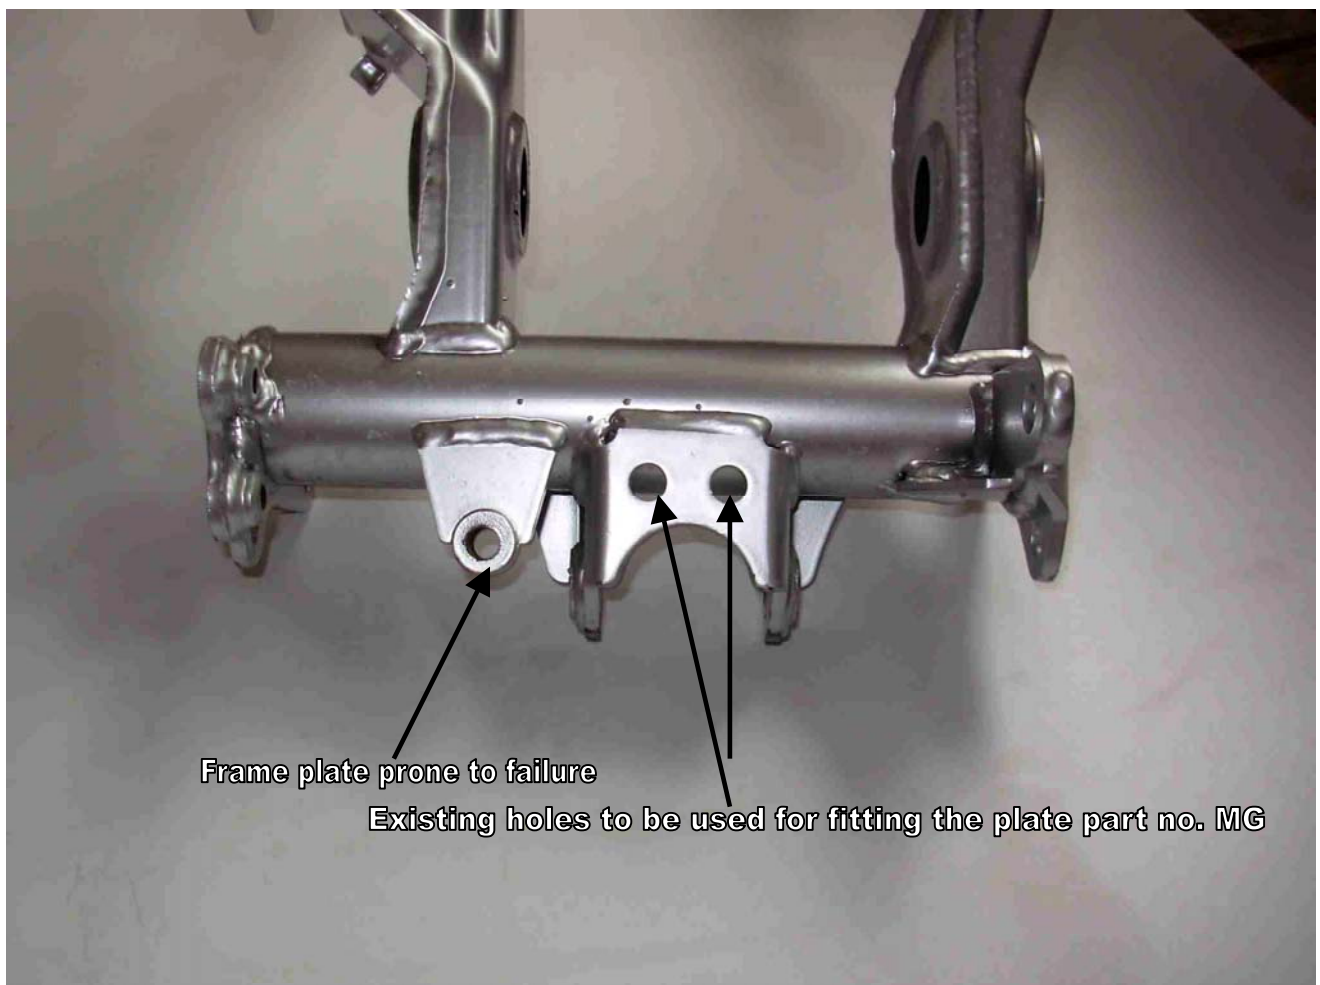
SUBJECT: Compensator support failure

In some bikes of this model the exhaust pipe compensator support might fail (highlighted with an arrow in the picture below).

This failure could not be restored since the original support is welded onto the frame.

To fix this problem, Moto Guzzi makes available spare part no.MG 978146 (see picture) that will supersede the failed support. Once this new part is fitted, the problem is finally fixed.

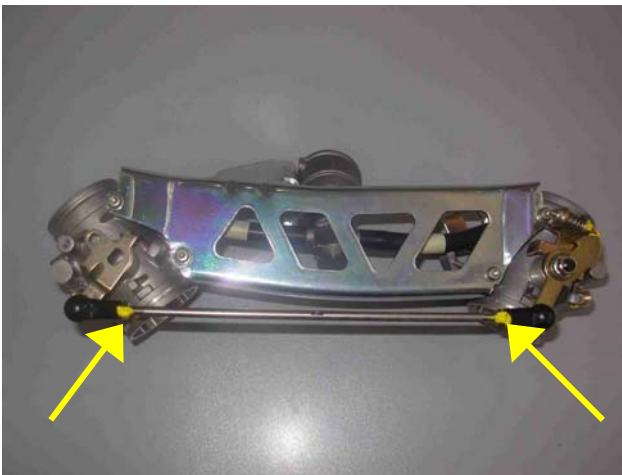
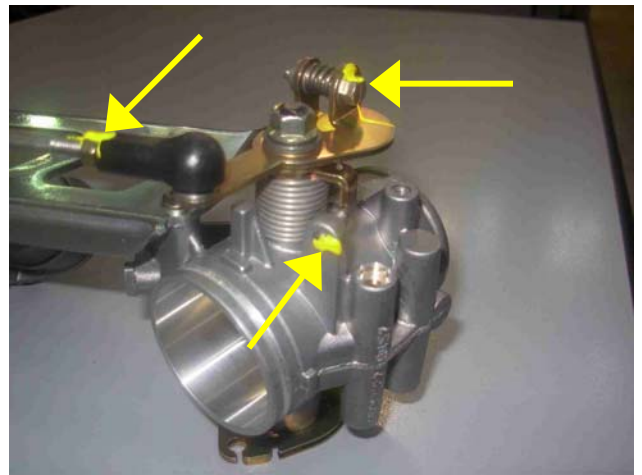
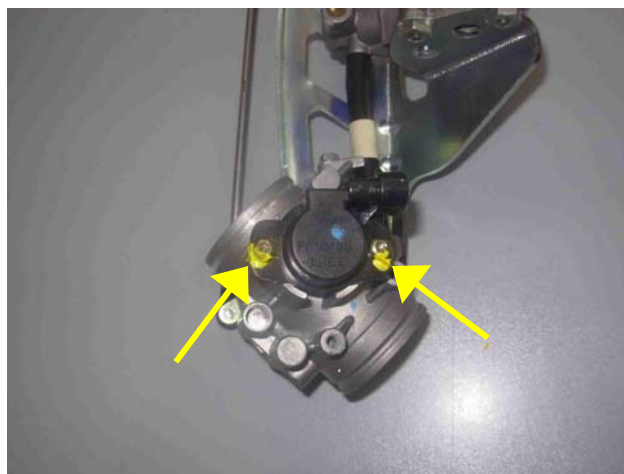
we hereby would like to inform you that, from today onwards, the warranty claims relating to the replacement of throttle body on the a.m. models will no longer be valid in case an alteration of adjuster screws (sealed with yellow paint - see attached picture) is found.

This is the reason why, if the screws used to maintain this balance are tampered with, it is no longer possible to restore throttle body correct setting, and throttle bodies have thus to be compulsorily replaced.

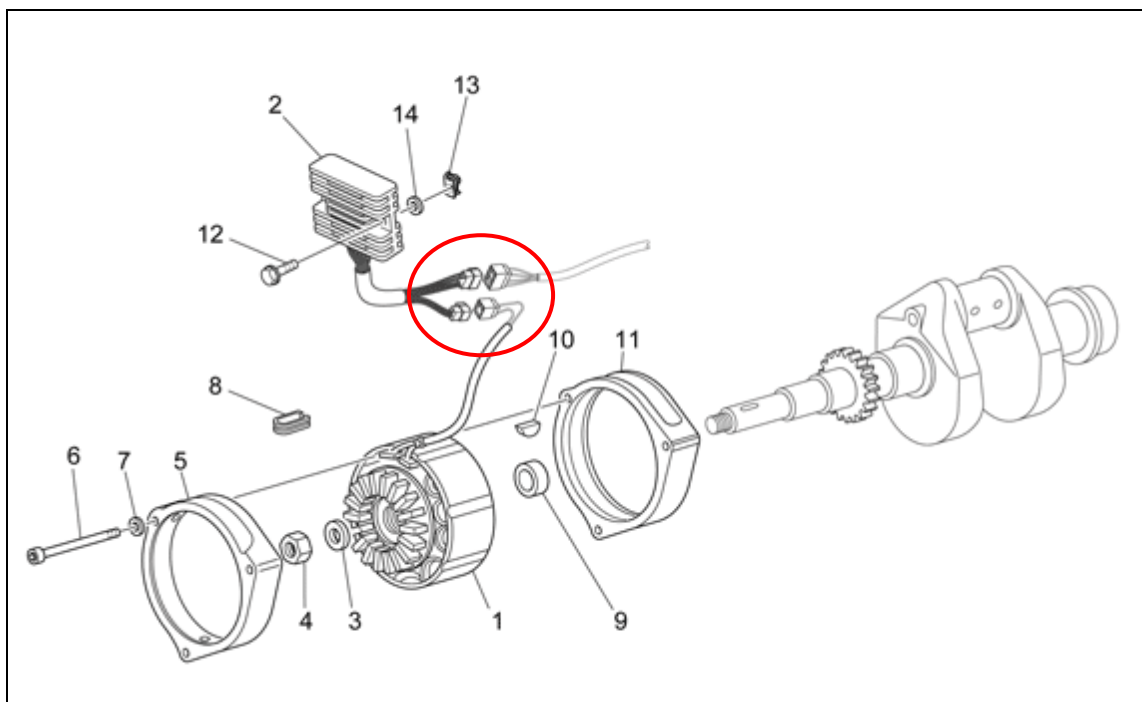
This may result in damage to both the alternator and the voltage regulator, with possible repercussions on the vehicle battery and wiring harness.

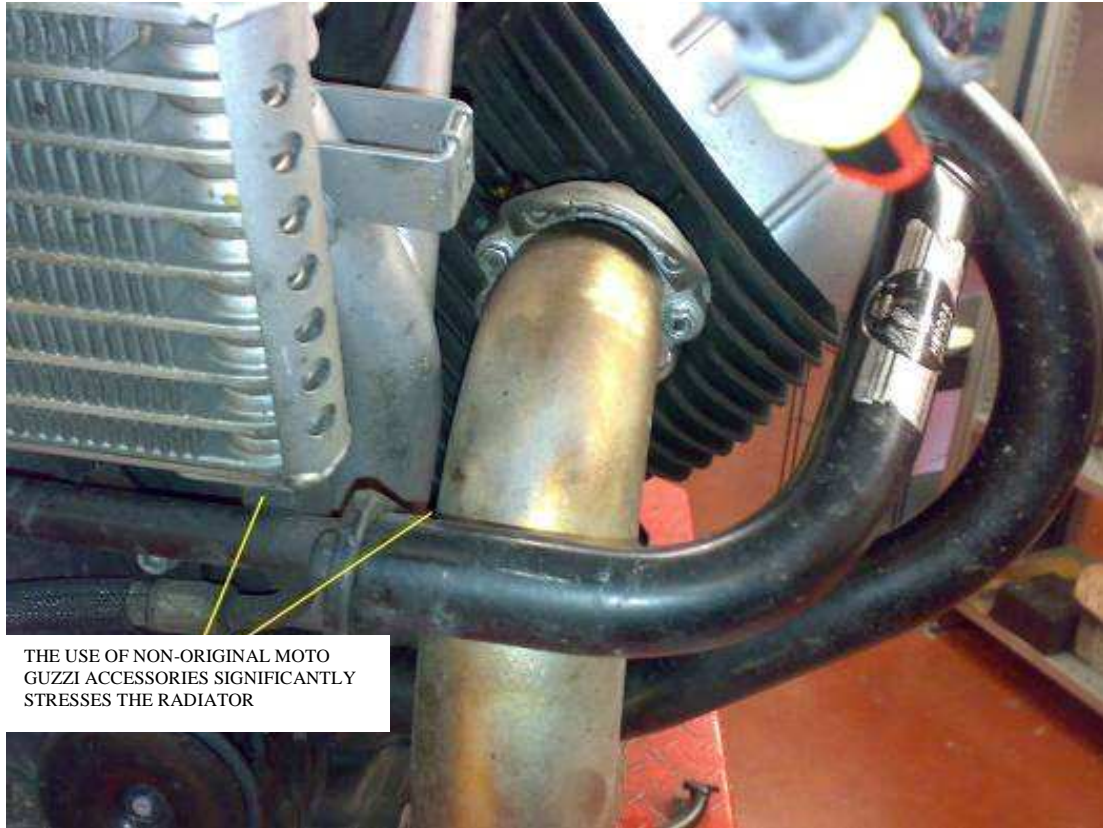
The following photos illustrate the problem more clearly. The engine guard installed here stresses the radiator and oil pipes. This is also transmitted to the screw fastening the frame to the engine, as the screw is not designed to sustain the additional strain.

THE USE OF NON-ORIGINAL MOTO GUZZI ACCESSORIES SIGNIFICANTLY STRESSES THE RADIATOR

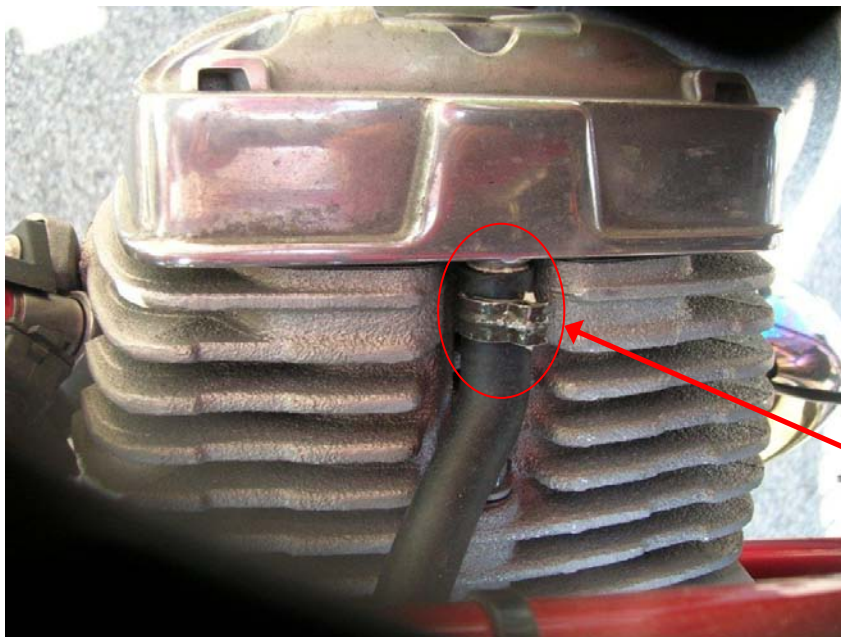
on the models and versions in question, it is necessary to check the type of clamp fixing the blow-by pipes of the left and right cylinder. Where the clamp is of the type cod. AP8102239 remove the clamp, verify the integrity of the end of the pipe (if damaged/cut, trim the pipe or otherwise replace it if not possible), replace with the clamp cod. Ap8201358

Remove COD.
AP8102239

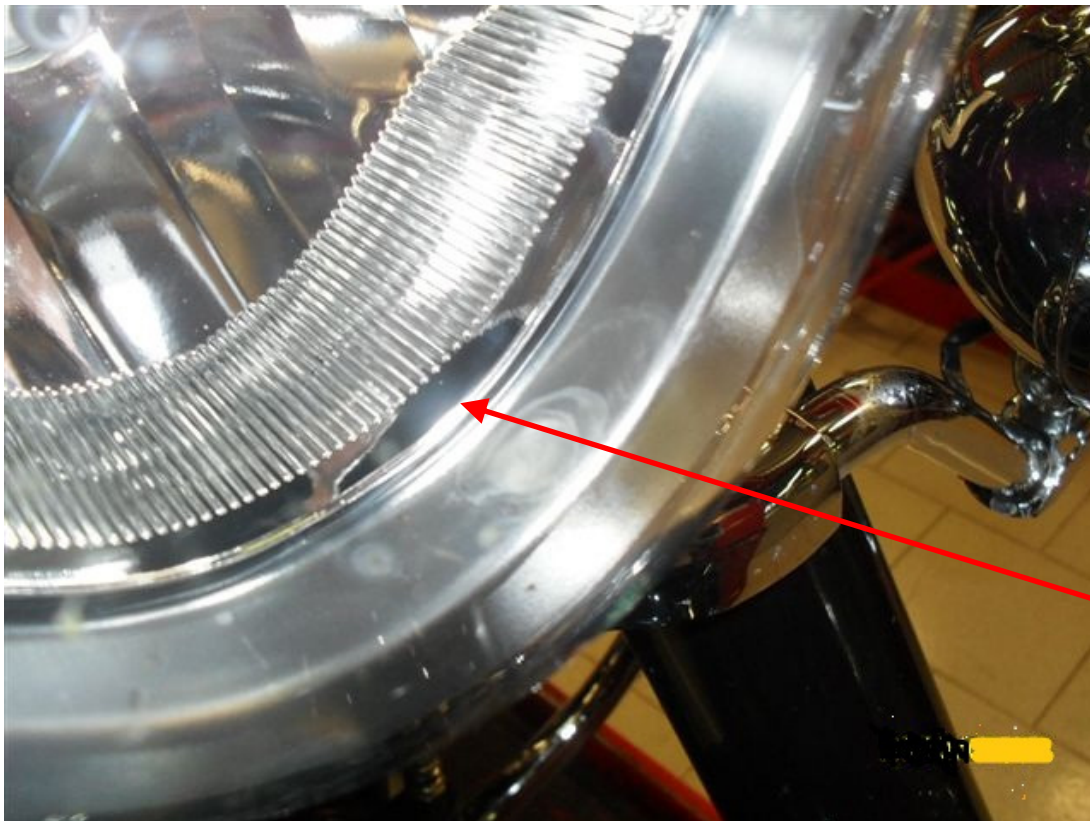
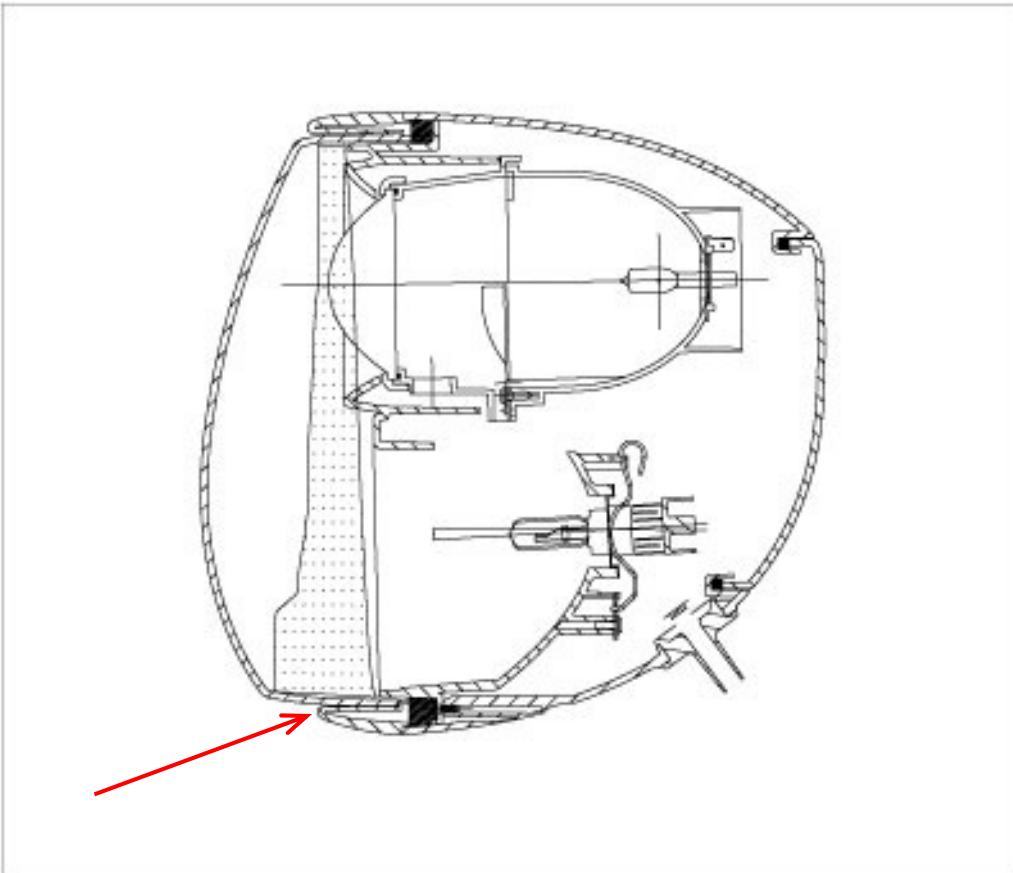
in response to a number of warranty claims for alleged **infiltration of water/dirt into the headlamp**, please note that the construction of the headlamp itself makes water infiltration impossible. Cases such as the example shown in the photo below are in fact attributable to water pooling between the lens and the headlamp housing, and not actually within the headlamp unit. This may be rectified by simply drying with compressed air or absorbent paper.

Note: note that generic warranty claims relative to water infiltration into the headlamp made without performing the aforementioned check will be rejected.

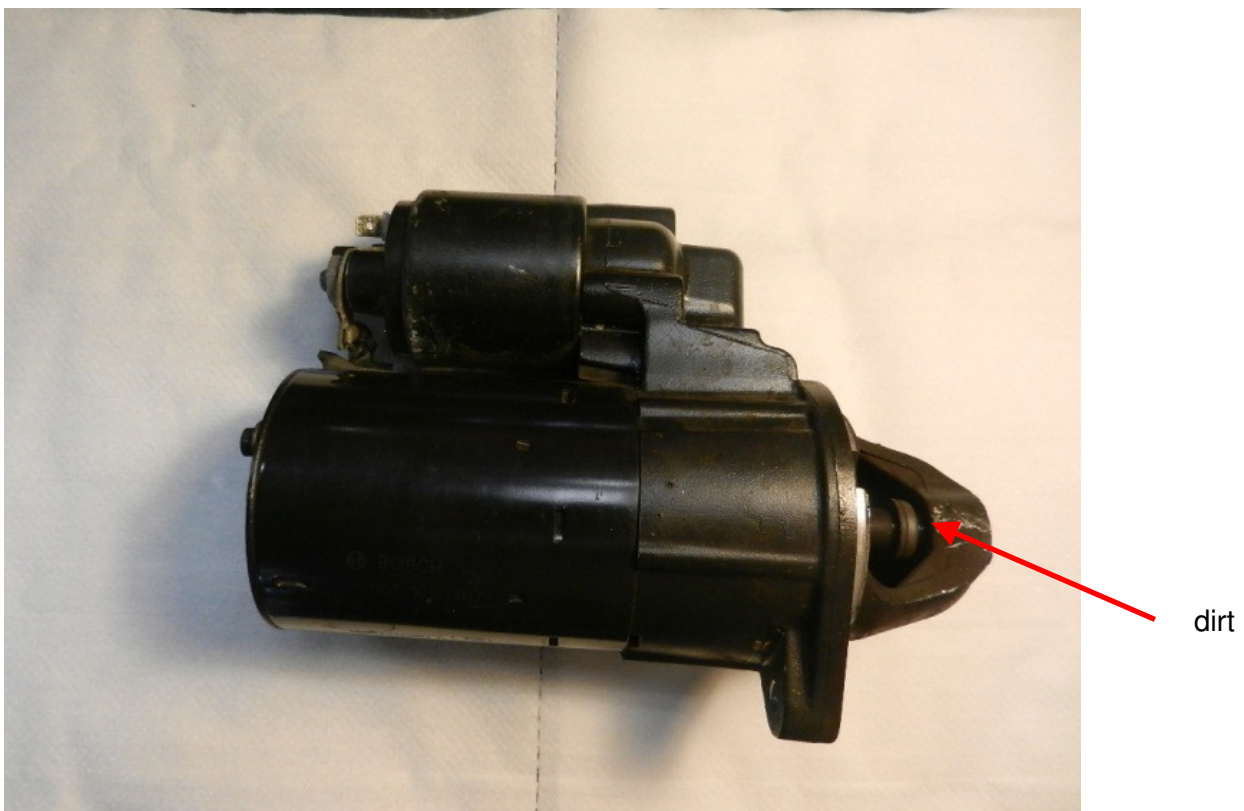
- Starter motor very dirty in flywheel engagement area

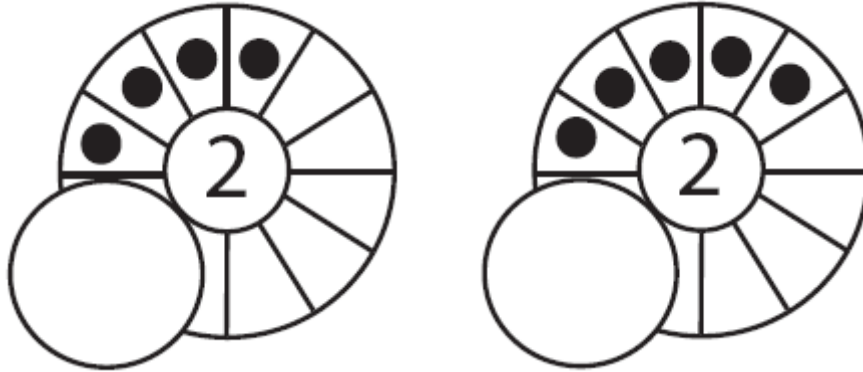
Plates needing replacement are only the ones with number 2 at the centre and having four or five dot marks on the “sections” :

All the required torque settings are indicated in the workshop manual and shall be strictly complied with.

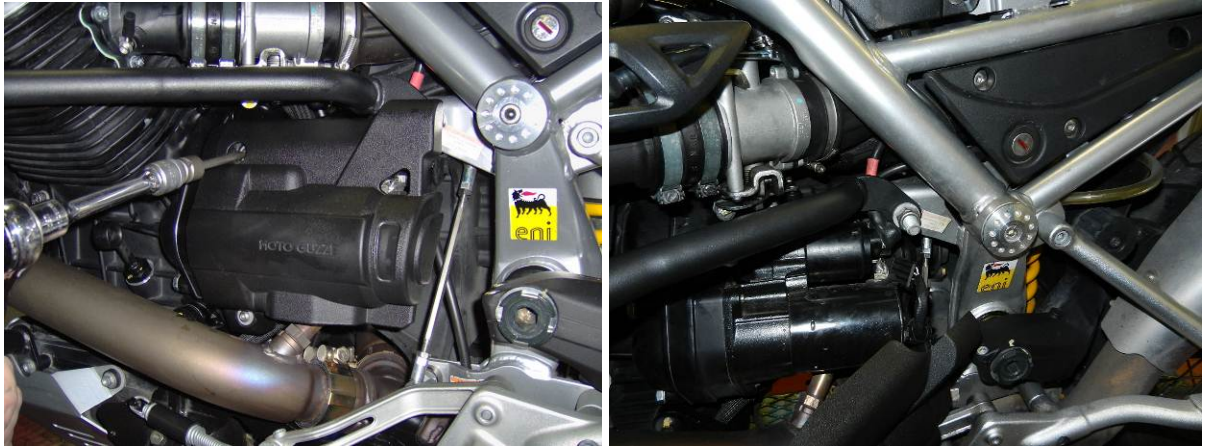
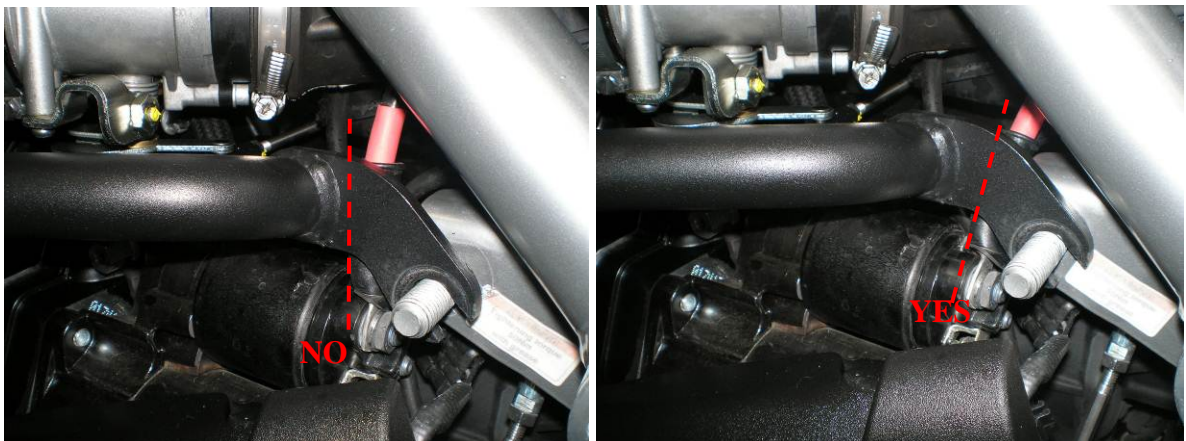
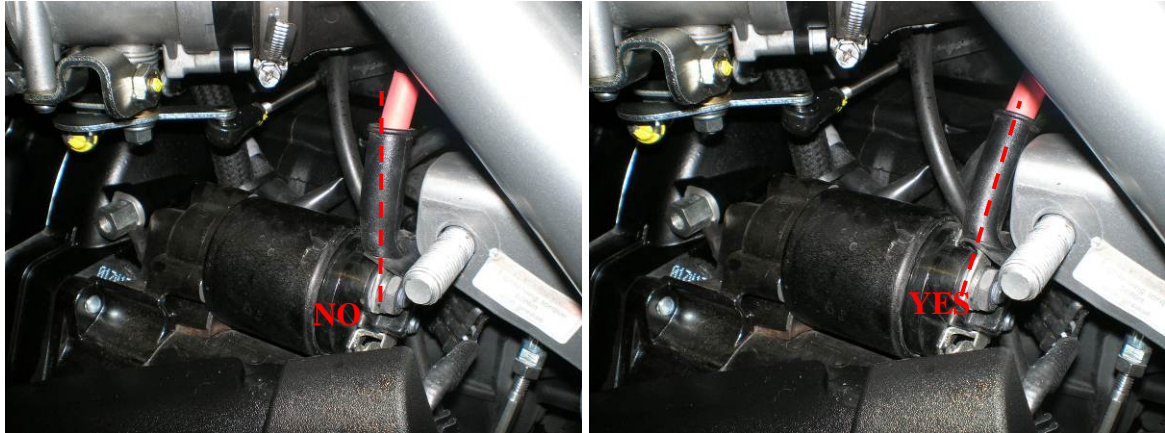
- Check if the positive cable harness of the starter motor are dangerously compressed by the engine bars
- If they are in a dangerous position (labelled **NO** in the photos) then remove the nut securing the engine bars, loosen the nut on the positive cable harness clamp of the motor and then lock it in the correct position

- Tighten the cable harness clamp nut, being careful to reposition the protection of the clamp, tighten the nut fixing the engine bars, reposition the starter motor protection, and lastly restore the connection of the starter battery.
