Moto Guzzi technical training

February – March 2010

- Sheet No. 1: Differences between Stelvio MY'08 and MY'09
- Sheet No. 2: Engine oil leakage on gearbox side
- Sheet No. 3: Stiff, noisy clutch
- Sheet No. 4: LH calliper mounting bracket failure

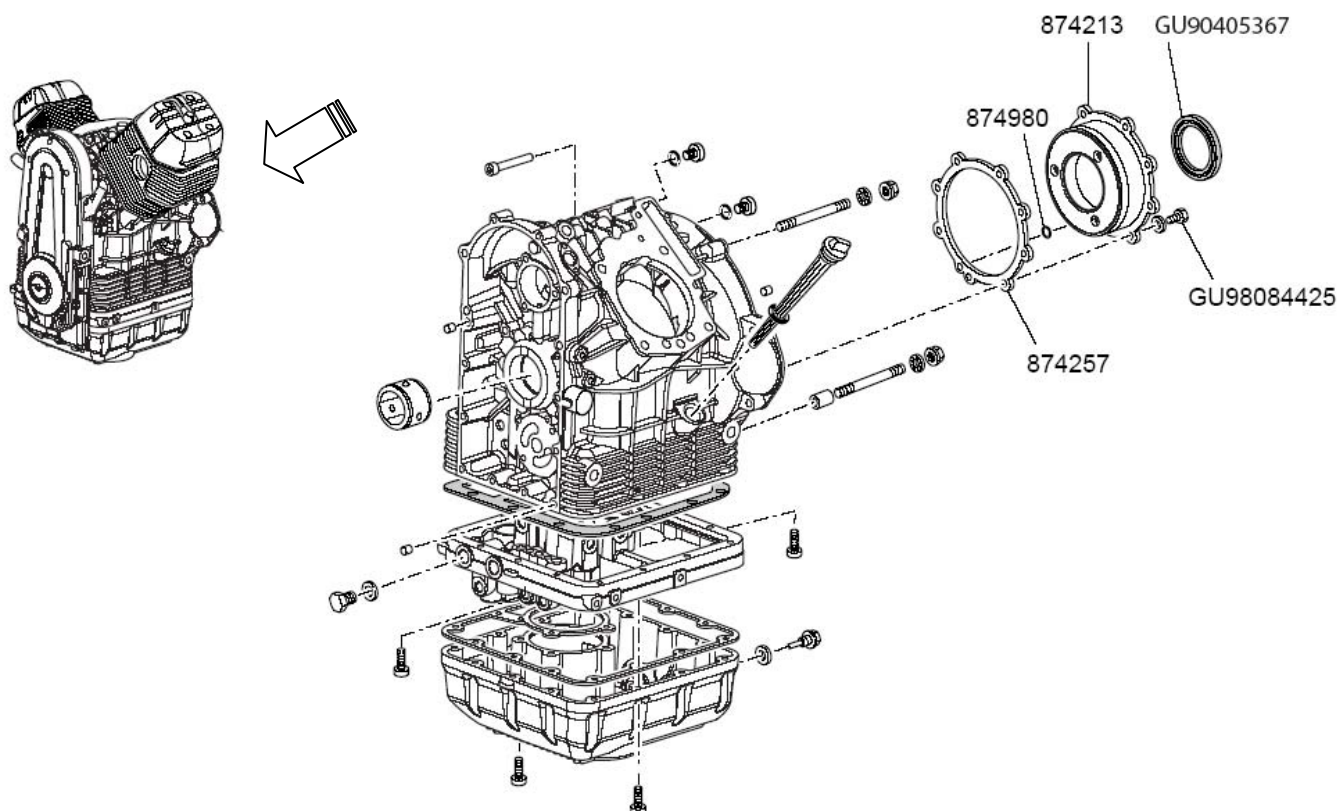
SUBJECT: Engine oil leakage on gearbox side

SYMPTOMS: damage identified during visual inspection.

- 1) Possible defect of oil seal p/n GU90405367, gasket p/n 874257 or O-ring p/n 874980.
- 2) Faulty oil passage bush on crankshaft mounting flange
- 3) Nonconformity of holes for crankcase/flange mating screws
- 4) Possible incorrect flange assembly

- 1) Remove the flange p/n 874213, following the procedure given in the workshop manual, and replace the damaged component.
- 2) Remove the flange p/n 874213, following the procedure given in the workshop manual and check that the oil passage bush is installed correctly as shown in the figure:

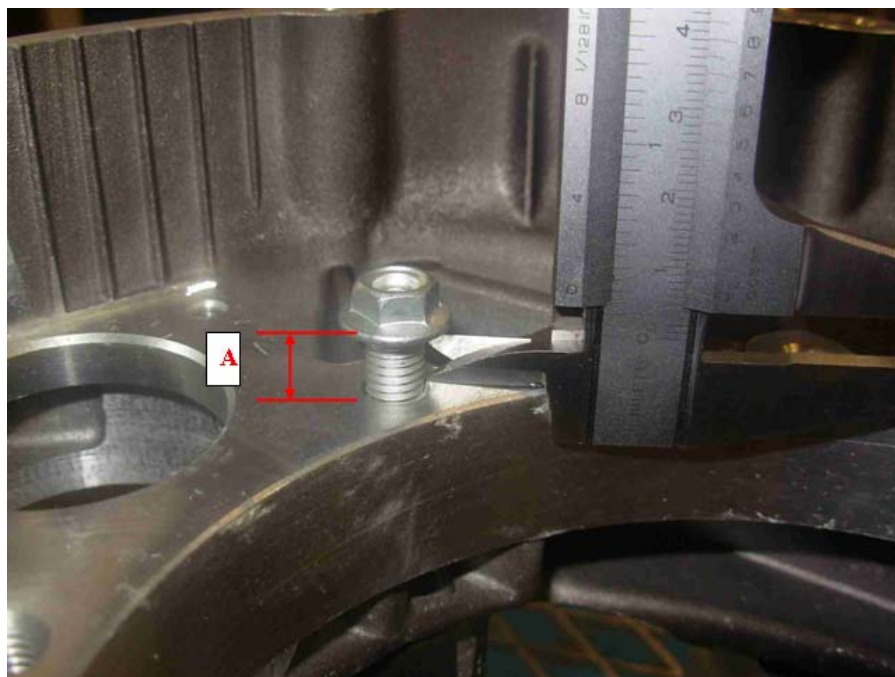
If the dimension A is less than 8 mm, the screw hole in the crankcase is conformant. If the dimension is equal to or greater than 8 mm, the hole is non-conformant; replace the standard GU98084425 fastener screws with the shorter GU98084422 screws

- 3) Screw a flange fastener screw into one of the crankcase holes without tightening to torque, and measure the gap between the crankcase and the interior of the screw head, as shown in the following figure

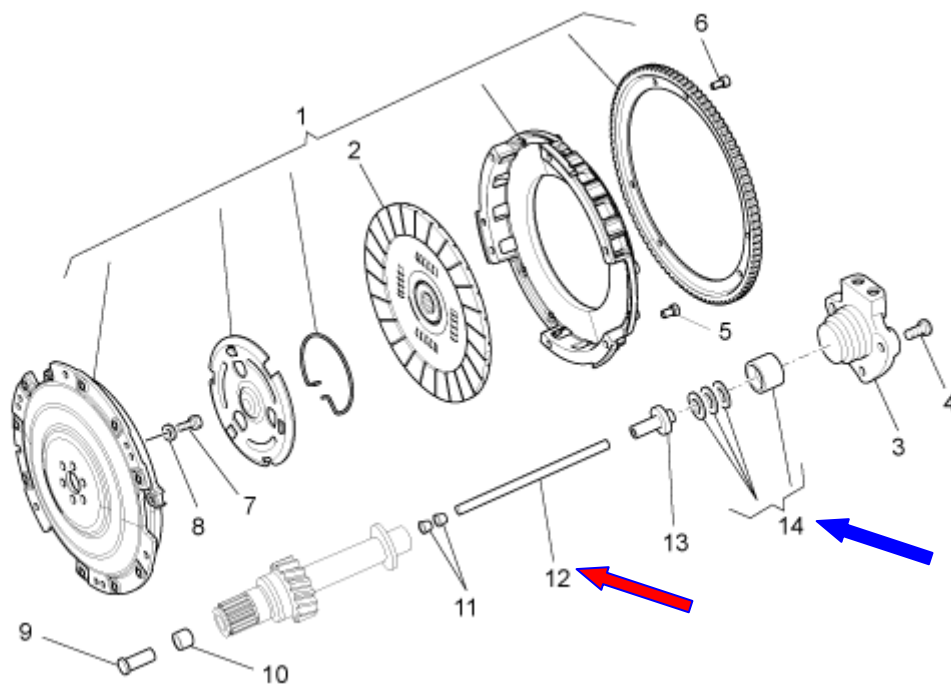
CAUSES: Incipient bearing seizure, with resulting deterioration

- 1) Replace the thrust bearing kit (detail 14 in the image, indicated by the blue arrow). Order p/n 976696 complete with spring cup, the two complete roller bearings and the intermediate metal washer. Before assembling the components described above, lubricate with Agip GREASE SM2. NB: before delivering the vehicle to the client, also grease the clutch lever pin on the left hand side of the handlebar

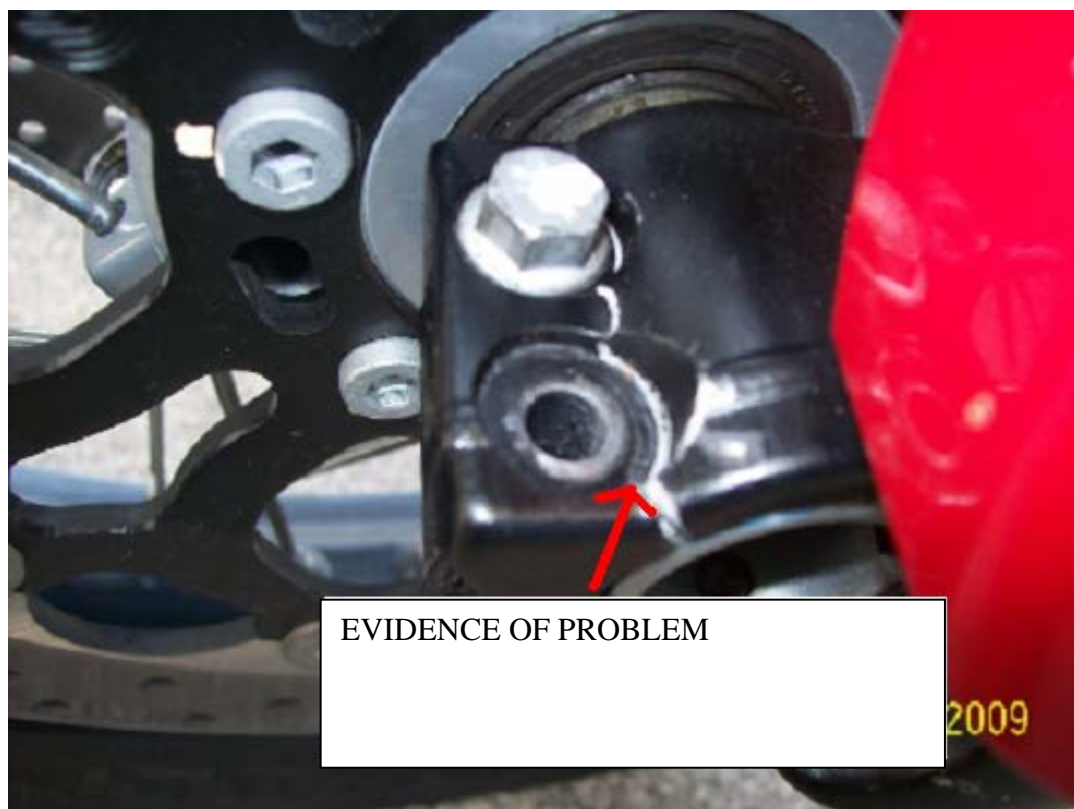
SUBJECT: LH calliper mounting bracket failure

SYMPTOMS: damage identified during visual inspection or when changing front tyre.

CAUSES: excessive tightening torque applied to screw p/n 981021

SOLUTIONS: replace LH stanchion with fractured calliper mounting bracket with a new stanchion with the same p/n (981029), using the relative Allen screws with p/n AP8150220 (which must also be applied to the LH calliper mounting bracket).

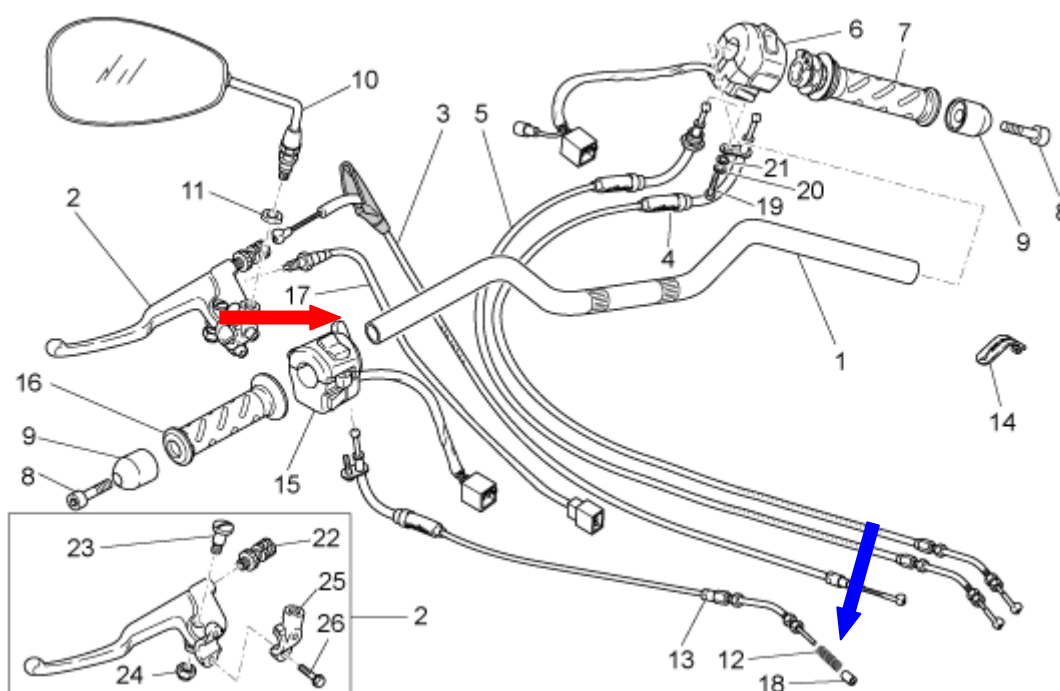
SYMPTOMS: The vehicle may have difficulty starting, especially when cold, even though the manual choke lever, located on the LH switchgear set and indicated by the red arrow, has been operated correctly.

Alternatively, the lever may not remain in the correct position when operated and, as a result, fail to maintain the cold starting position.

The cause is attributable to an incorrect rigidity of the spring p/n GU94321074, identified in the image by the blue arrow.

- 1) Replace the spring p/n GU94321074 with the new spring, p/n 883752, which will shortly be available and orderable as a normal spare part.

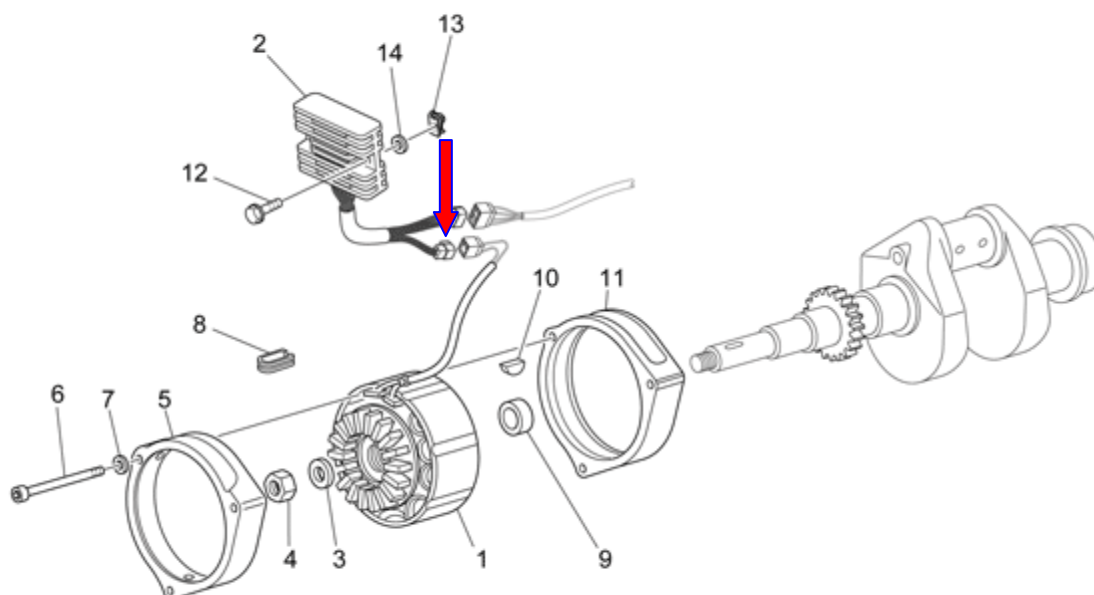
SYMPTOMS: on certain vehicles, the connection between the alternator and the voltage regulator may burn out in the zone indicated by the red arrow.

This may result in damage to both the alternator and the voltage regulator, with possible repercussions on the vehicle battery and wiring harness.

CAUSES: poor connection, particularly in the case of major vibration, resulting in the connector overheating

1. During the pre-delivery process, bind the connection between the alternator and the voltage regulator with a regular cable tie to keep it securely fastened
2. When the vehicle is in the workshop for normal maintenance, check the area in question. If any signs of incipient burning are noted, we recommend bypassing the original connection between the alternator and the voltage regulator with a terminal block connector, cutting the wiring ahead of and after the connection itself.

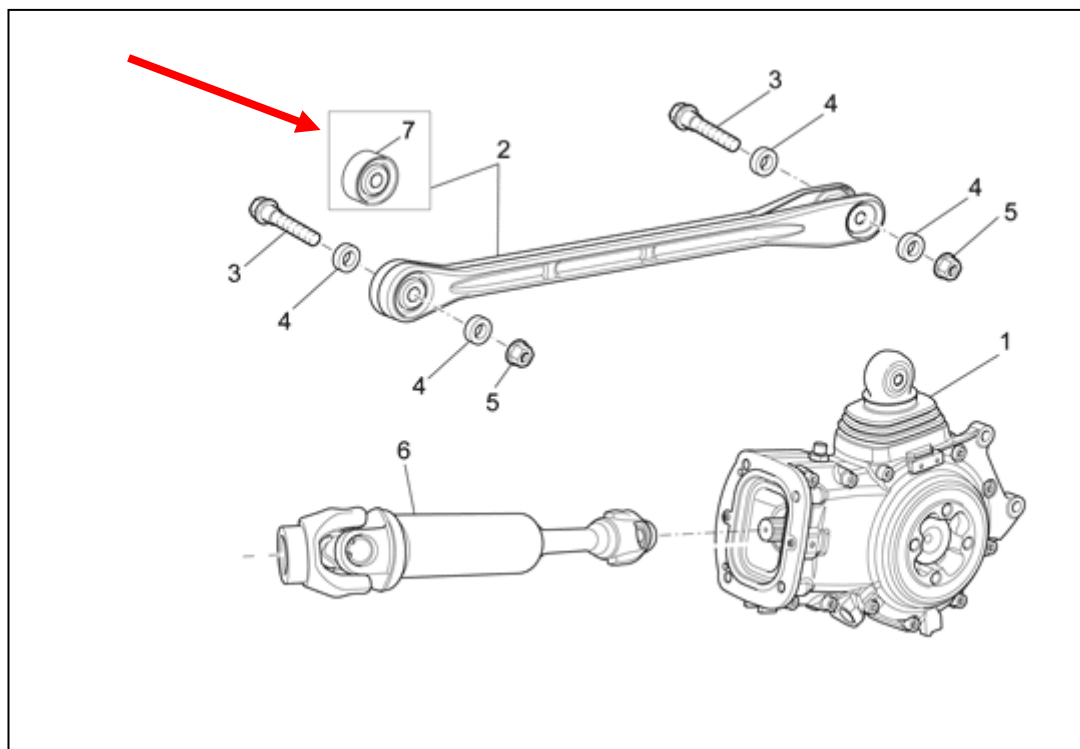
SYMPTOMS: Metallic noise coming from gearbox area on right hand side of motorcycle under acceleration and/or deceleration

CAUSE: Excessive clearance in frame side bearing on reaction rod. on certain vehicles, a noise may be heard from the gearbox area under acceleration and lift-off. This noise may be caused by the excessive rigidity of the ball joint on the gearbox side end of the reaction rod. The rigid joint cannot absorb the longitudinal flexing to which the reaction rod is subjected, generated by the inversion in the direction of acceleration (such as when lifting off immediately after accelerating or accelerating hard immediately after decelerating).

SOLUTIONS: Remove the reaction rod following the procedure described in the workshop manual, then extract the frame side bearing and replace with the silent block p/n 883045.

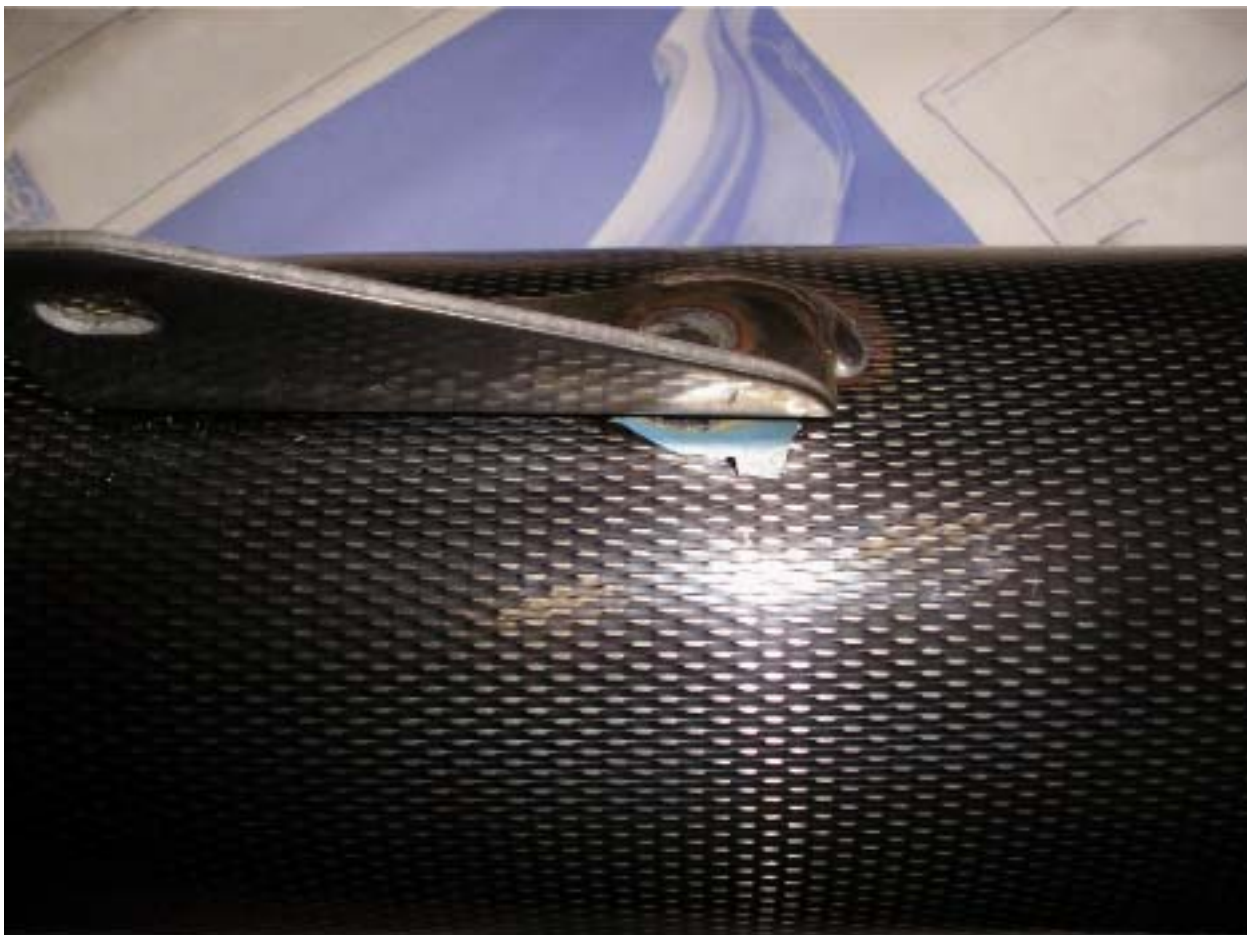
SYMPTOMS: Noisy exhaust, corrosion and subsequent detachment of frame mounting bracket.

CAUSES: non conformant welding

SOLUTIONS: replacement of faulty exhaust with the new exhaust p/n 9778371, also ordering the silencer mounting clamp p/n 883439, two TBEI M6X16 screws, p/n GU98210616, and two M6 self-locking flanged nuts, p/n AP8152299, as indicated by the note in the spare parts catalogue (table 29). Photo by Tiso.

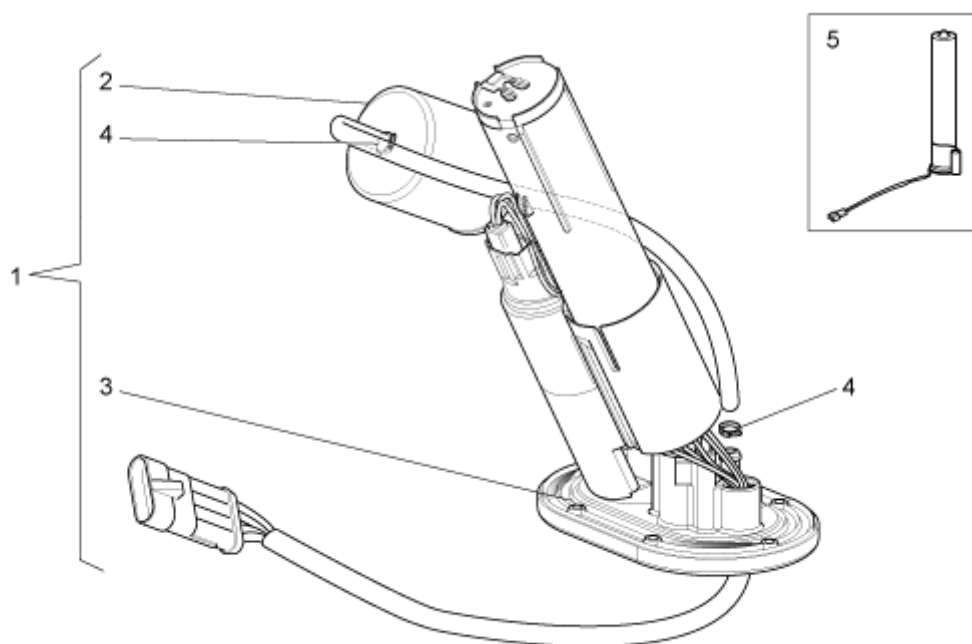
SYMPTOMS: Incorrect fuel level indication on instrument panel

CAUSE: Jammed fuel pump float

Replace the float only, p/n AP8127817, not the complete fuel pump, p/n GU05107230.

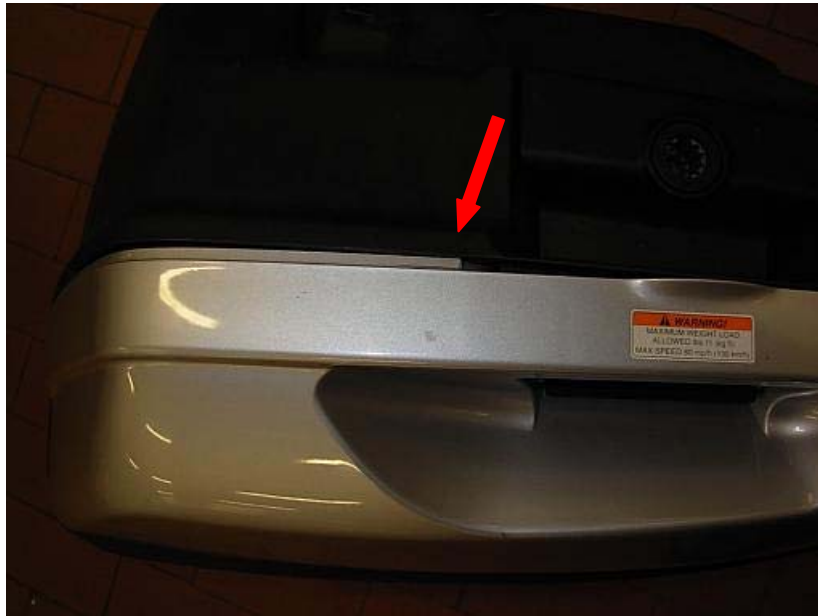
Figure 1

SYMPTOMS: on certain vehicles, the panniers (left or right) may fail to close properly after a very few kilometres of use.

Specifically, the hinged shell fails to close correctly against the fixed part of the pannier: in some cases, there is a visible gap in the upper area where the two shells should seal against one another. This gap may reach significant dimensions (to assess the size of the gap, remove the seals and close the two shells together): and it is through this gap that water infiltrates in rainy conditions or when washing the bike.

CAUSES: Warping of one of the two pannier shells resulting in poor closure, as shown in figure 1.

- 1) Replace the seal, using the new component with p/n 883246 (detail 20 in the image, indicated by the blue arrow). The new seal differs in thickness and stiffness (all contact surfaces must be lubricated with petroleum jelly). Immediately after replacement, the hinged shell may not seal easily against the fixed part of the pannier and the pannier itself may be difficult to close. Open and close the pannier repeatedly until the new seal settles correctly between the two shells.
- 2) As mentioned earlier, if a significant gap between the shells is revealed when test closing the shells without seals, it may be possible that even replacing the seal may not be sufficient to solve the problem (see figure 2). In this case, the replacement of the entire pannier is necessary, after sending photographic documentation to the respective department for evaluation of the case.

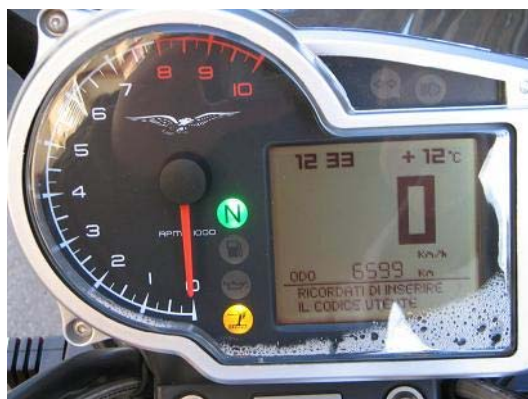
In this case, the most important aspect is to determine whether or not instrument panel replacement is necessary. It is necessary to differentiate between cases in which water is effectively infiltrating into the instrument panel and cases where there is merely light condensation inside the instrument panel (see image below)

In the latter case, condensation generally forms near the instrument panel perimeter surround and usually disappears within a few minutes of riding the vehicle. It is important that the instrument panel is always legible (both the analogue and digital areas) and that the condensation disappears within the first 5 – 7 minutes of riding the motorcycle. In this case, the instrument panel does not need to be replaced as it is still conformant with project specifications and, therefore, with the quality standards required.

SOLUTIONS: Replace the component under warranty

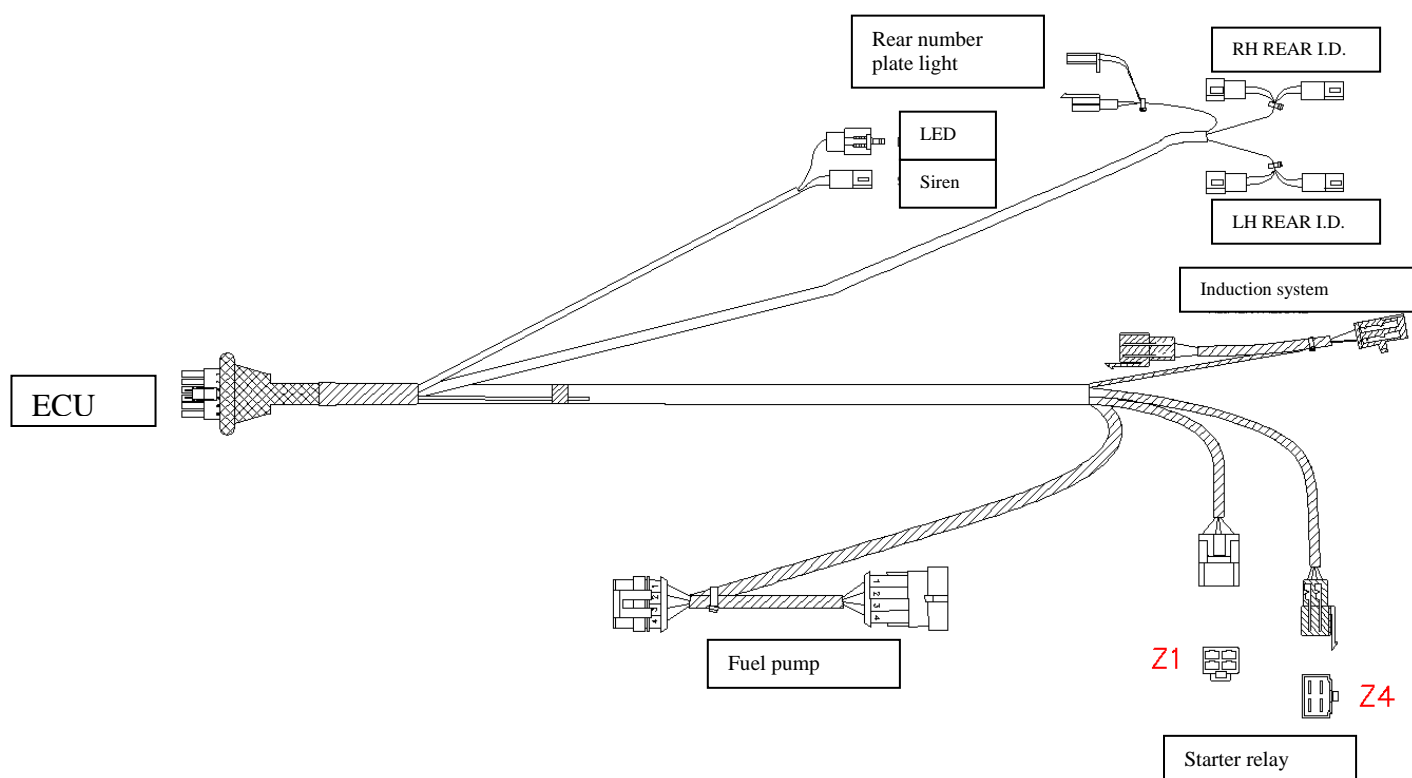
SYMPTOMS: Starting failure with warm engine

CAUSE: Probable electromagnetic disturbance in antitheft system/vehicle wiring harness

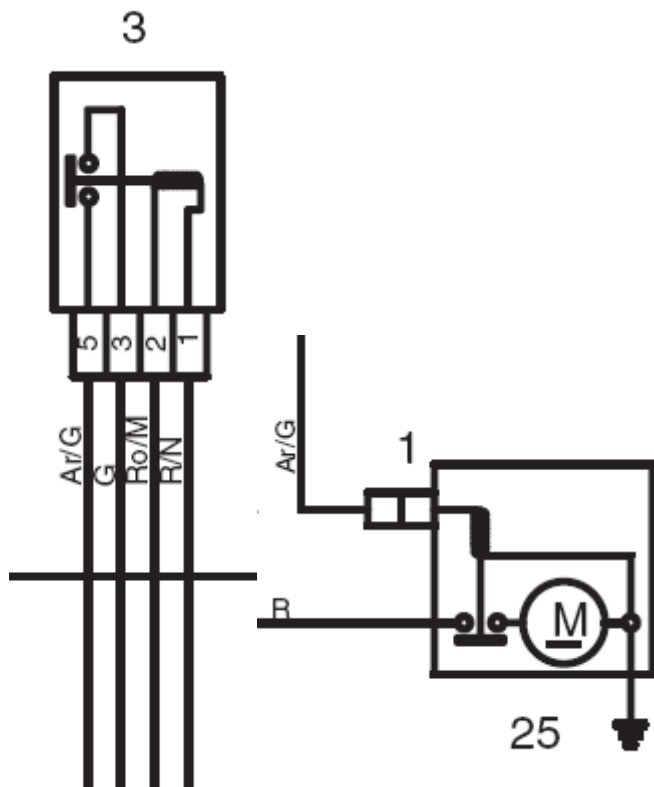
SYMPTOMS: starting failure with warm engine.

Insufficient cross section of the +12V wire energising the starter relay

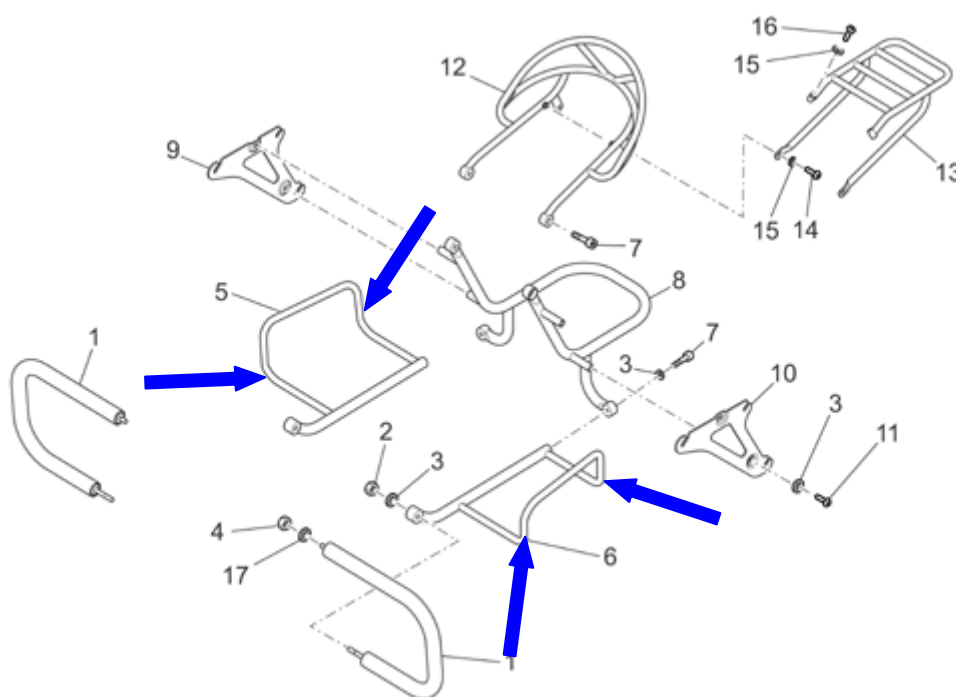
SYMPTOMS: on certain vehicles, the pannier may come into contact with the bag mounting (details 5 and 6 in the following image). As it frets against the mounting, the paintwork on the pannier is damaged. The area in which contact between the mounting and the pannier normally occurs is localised around the curved section of the mounting itself (see blue arrows in figure below)
