Ici sont regroupées toutes les notes techniques émises par Moto Guzzi depuis 2004 jusqu'à aujourd'hui. Ou au moins toutes celles que j'ai pu obtenir.

Here is all Technical and Servicing Notes from Moto Guzzi, from 2004 since today. All of what I have picked up...

MODEL	ABOUT...	SERVICE NOTE	DATE	TECHNICAL NOTE	DATE
All models	Electrical diagnosis improvement	---	---	008-2008	30/09/08
All models	Neutral sensor	---	---	002-2010	19/07/10
All models	Cleaning throttle body	---	---	005-2010	29/10/10
All models	Compatibility with E10	---	---	004-2011	13/09/11
All models	Diagnosis instrument : PADS	---	---	005-2012	28/03/12
All models	Handling and Storage	---	---	003-2013	26/03/13
All models	Speedometer indication	---	---	007-2013	16/05/13
All models	Control of the position of the electrical wiring harness	---	---	014-2013	31/07/13
All models	Battery initialisation	---	---	007-2014	17/07/14
All models	Vehicle servicing time	010-2012	09/2012	---	---
All models	Vehicle servicing time	002-2013	03/2013	---	---
All models	Vehicle servicing time <i>Only french version available for the moment</i>	xxx-2013	12/2013	---	---
All models	Warranty : modified components	004-2013	003-9967	---	---

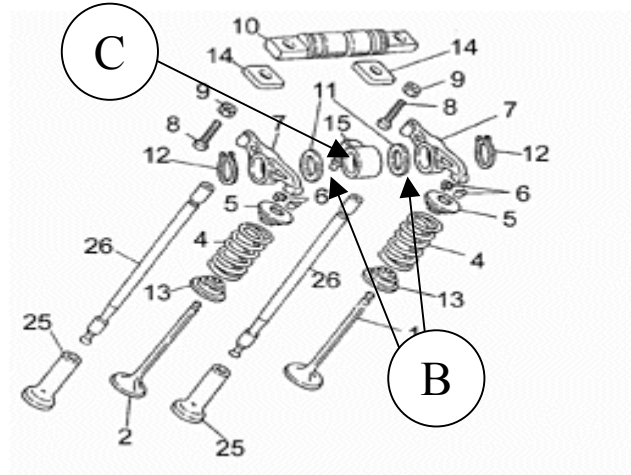
To the dealer principal,
the presence of excess oil on the filter casing is caused by

Replace the sleeve(C) and the spacers (B) with the corresponding Brevia 750 parts (for machines produced before 2003).

Use code 19027500 for the sleeve(C) and 32032310 for the spacer (B).

If the problem persists, replace the piston rings with Brevia 750 rings.

Use code 32060710 to replace the first piston ring, or code 32060610 for the complete piston ring set.

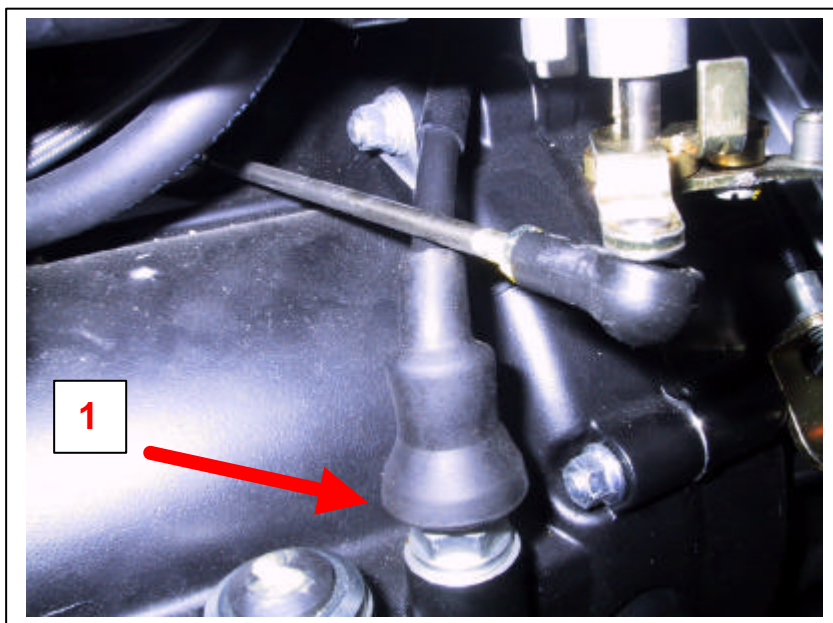
Picture 1

We have ascertained that on the above vehicles, that are equipped with the return cable for the throttle cable (part no. 01603380), the tachometer cable might break due to the angle with which it is fixed to the engine (1). (Picture 1)

In case the cable needs replacing, spare new cables are available part no. 01760481 (supersedes part no. 01760480) and part no. 01760492 (supersedes part no. 01760491), that are fitted to the engine at a wider angle (20°).

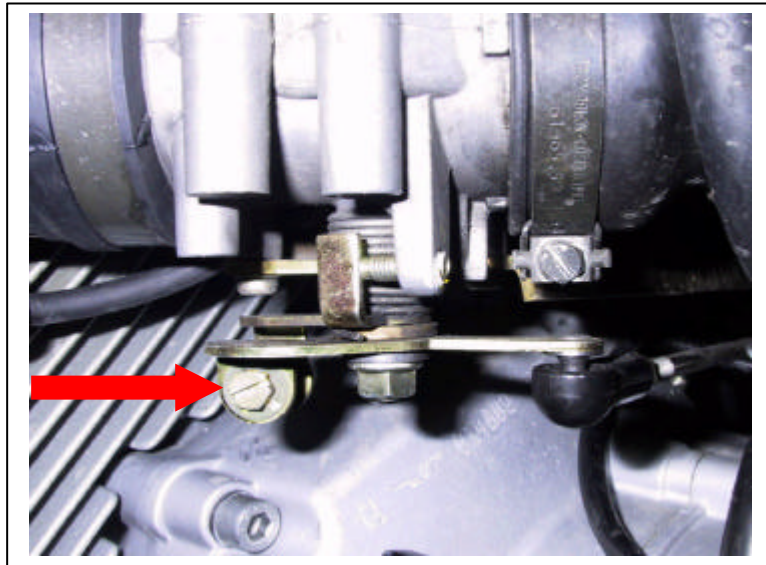
Errata: The **chassis workshop manual** recommends to loosen lock nuts on throttle body push-rod to correct the cylinder balance. THIS PROCEDURE IS INCORRECT: TO BALANCE CYLINDERS WORK THE THROTTLE BODY LINKAGE ADJUSTER.

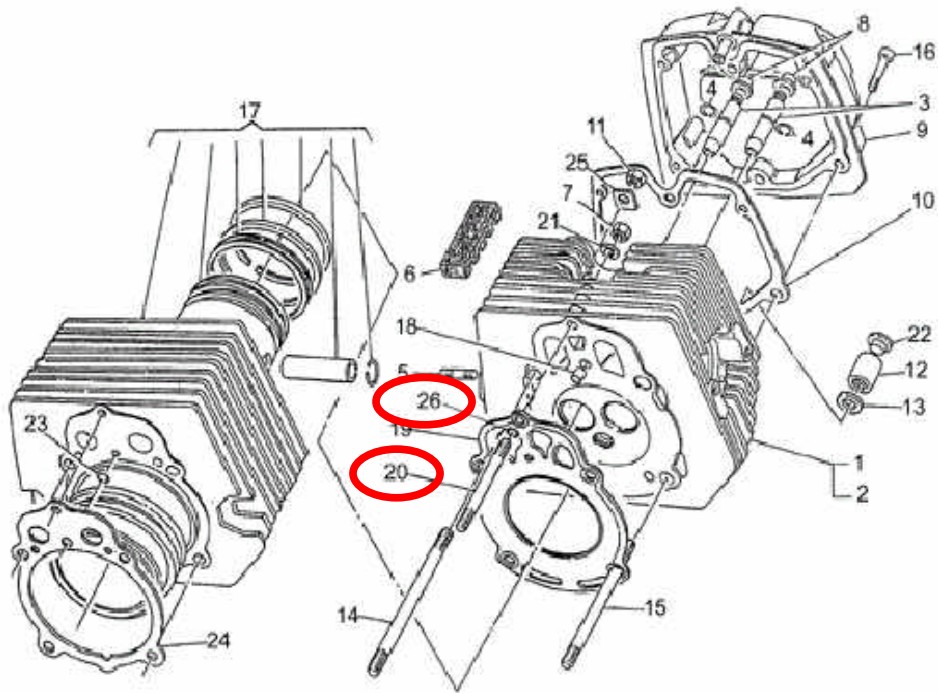
We received a few claims from the network concerning leaking cylinder base on the above-indicated models.

After due analysis, we found that this oil leakage can be fixed by adding the O-ring part no. 90706076 on stud bolt part no. 96508145.

To fix this fault, apart from changing the gaskets/seals, you need to proceed in this way:

- Remove the stud bolt M8 x 143 part no. 96508145 (part 20).
- Clean stud bolt and its seat.
- Refit stud bolt using Loctite 243 and tighten to specified torque.
- Fit O-ring part no. 90706076 (part 26) onto stud bolt.
- Refit all parts using new gaskets/seals; do not use sealing compound.

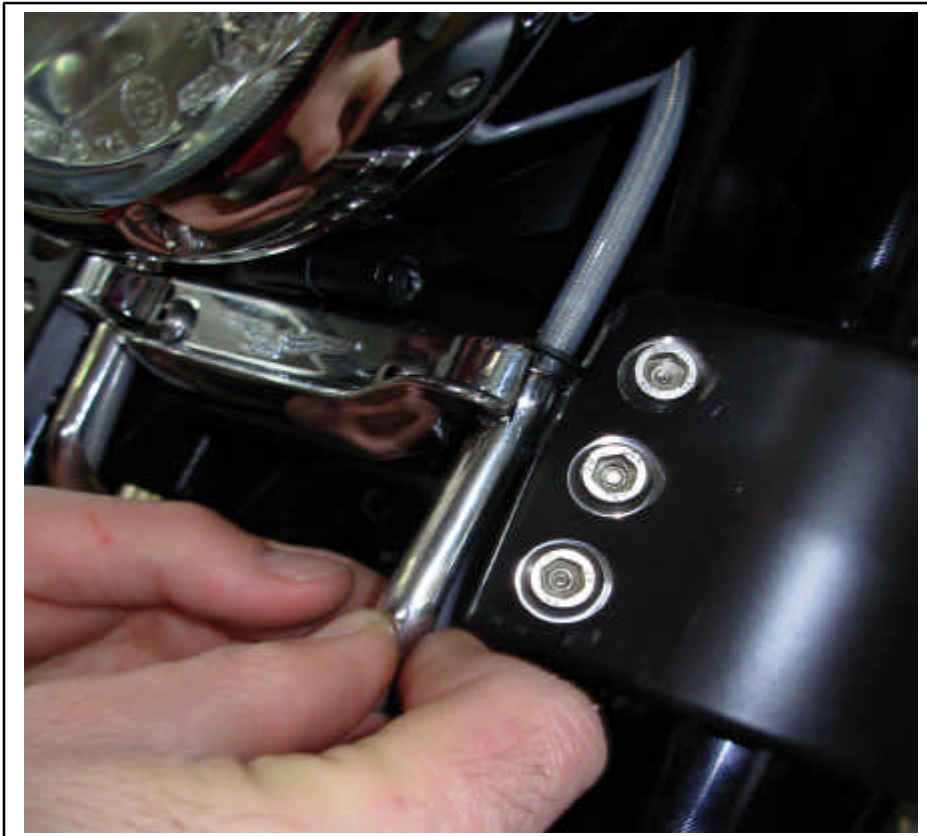
We received a few claims from the network concerning Griso V1100, about the chance that the front brake line interferes with the mudguard resulting in mudguard damage.

- 2) Insert the two front brake line supports (part no. 977552 to be checked) into line plate

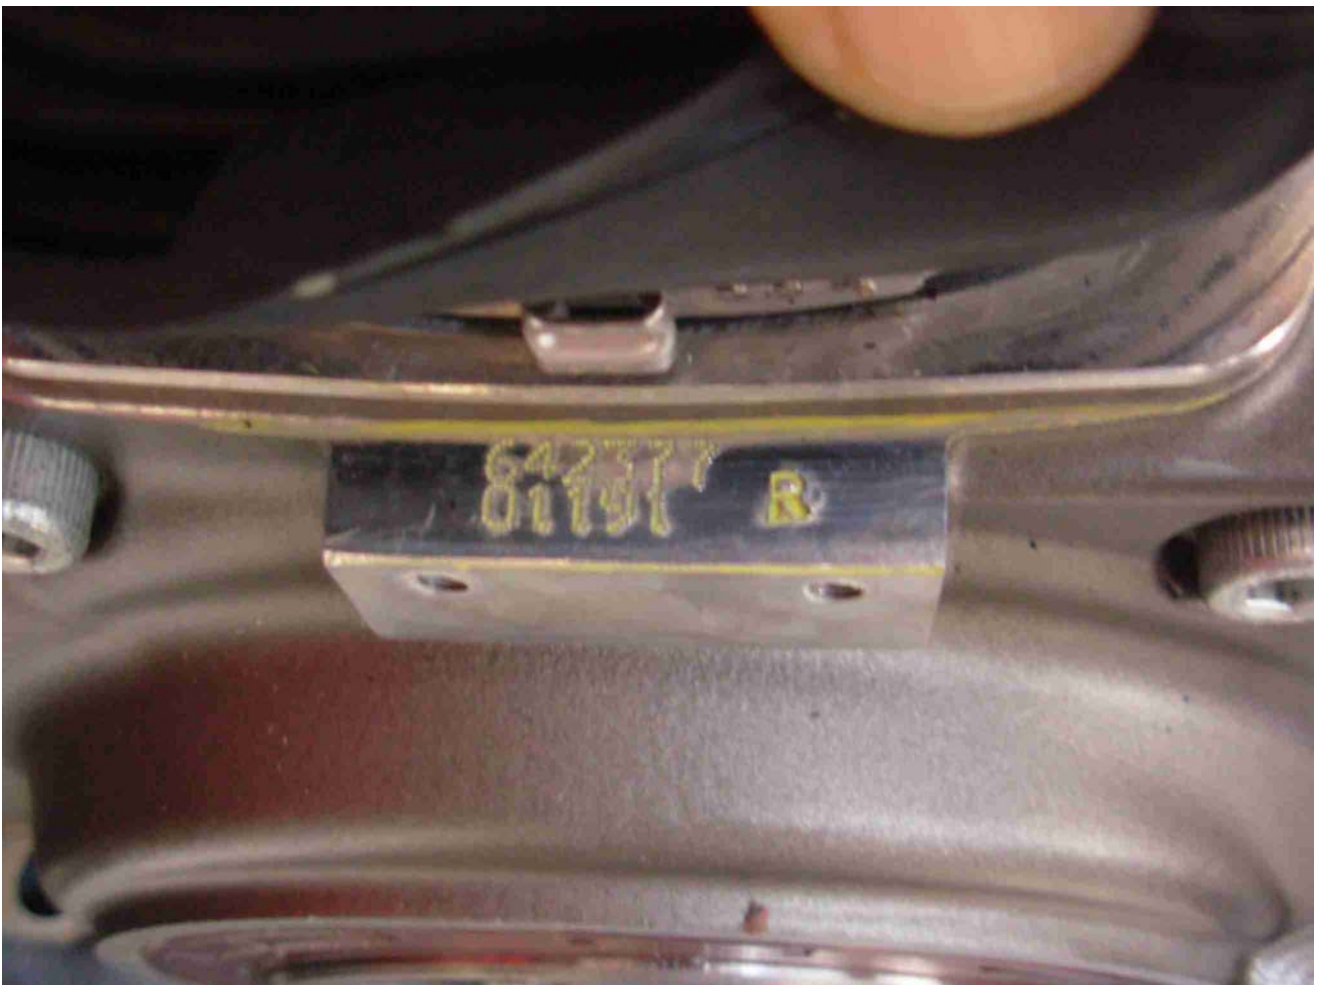
We herewith would like to inform you that on the a.m. bikes models currently manufactured you could find a number as shown in the attached picture.

These universal joints, even if having a number lower than that specified in the recall campaign, are not part of it since, as shown in the picture, a **R** letter is stamped on them.

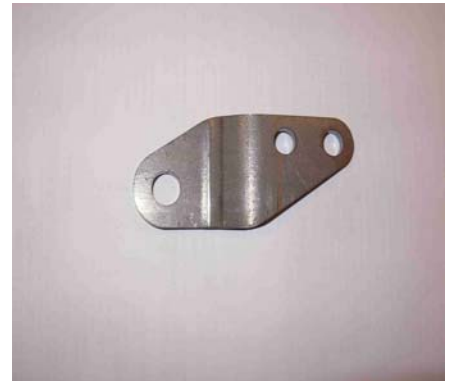
In some bikes of this model the exhaust pipe compensator support might fail (highlighted with an arrow in the picture below).

This failure could not be restored since the original support is welded onto the frame.

To fix this problem, Moto Guzzi makes available spare part no.MG 978146 (see picture) that will supersede the failed support. Once this new part is fitted, the problem is finally fixed.

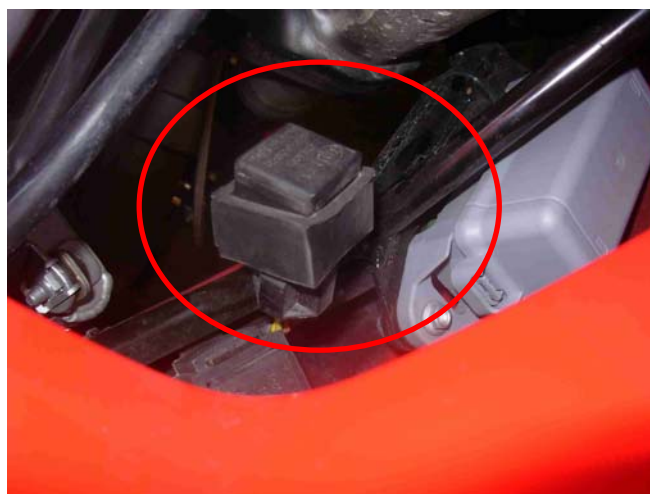
To avoid this failure you must remove the relay (**part no. AP8124869**), it being missing **does not compromise** in any way the vehicle functions.

The relay is installed at the front of the fairing, on the right side of the bike.

CAUTION: in this position there are 2 relays; you shall remove the one closer to the fuse carrier, the light grey one.

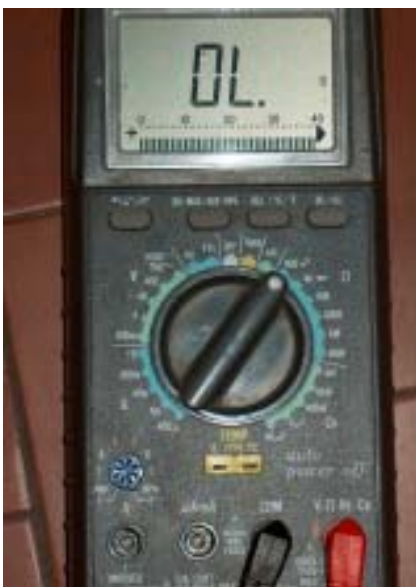
Fig 1 = Open Loop value (infinite /non measurable value) the stator is not grounded. This is not a fault

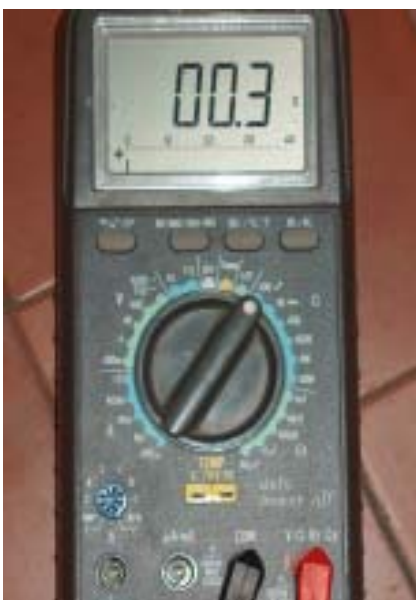
Fig 2 = resistance value, the stator is grounded, therefore, this is a fault

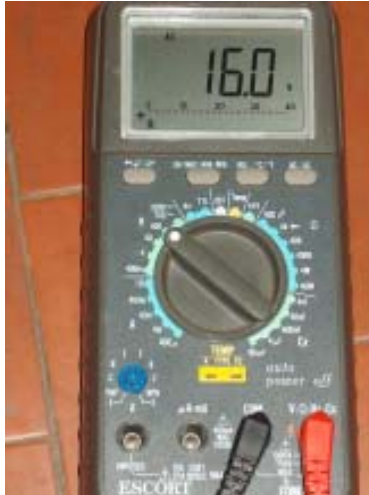
Picture 1

Place the multimeter in a volts scale and select alternating current AC (picture 1 and 2) with a maximum measure not **lower** than 200 volts, place the multimeter black lug on a stator output string and the multimeter red lug on another stator string and measure; then, compare the results obtained with the table of the vehicle (picture 1 = Stator to be replaced, picture 2 = Stator OK).

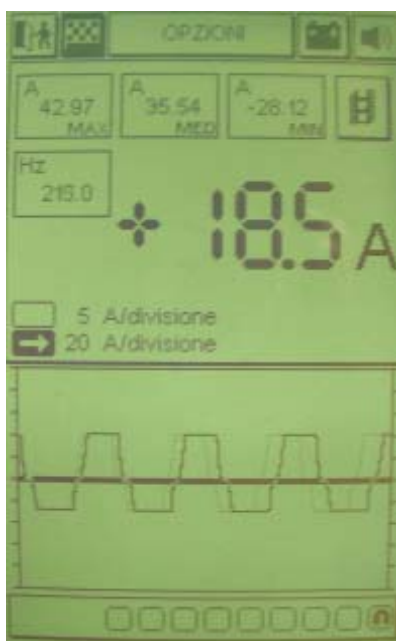
Fig 1

Compare the values of the current measured in the cables of the test cable. They must be in the same value range and differ maximum few Ampere decimals. The graphics underneath must have a regular course (Fig 1). More significative current rating variations and/or irregular graphics where irregular curves are evidenced (null current rating indications between the peaks and the grooves of the curve), signal a generator malfunction and, therefore, a negative test (Fig 2)

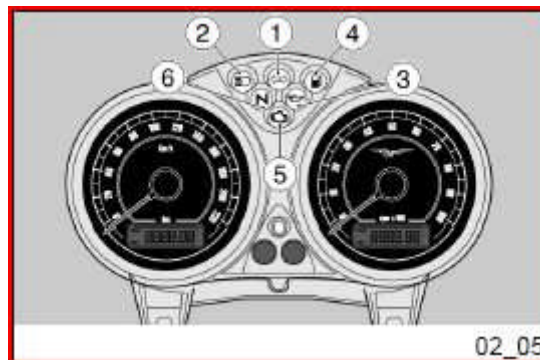
we have found some signs indicating that at pre-delivery stage there have been cases of irregular illumination of the (amber) warning light here specified and marked with the number 5 in the image below.

This irregular illumination of the warning light is caused by an electrical interference between the timing sensor cable and the vehicle coil cable, but this does not compromise adequate vehicle functioning in any manner.

You are reminded that no electrical component of the vehicle (ECU, timing sensor, coil or battery) needs to be replaced to solve this problem; if the problem continues even after repositioning the cable, please, contact Moto Guzzi Help Desk.

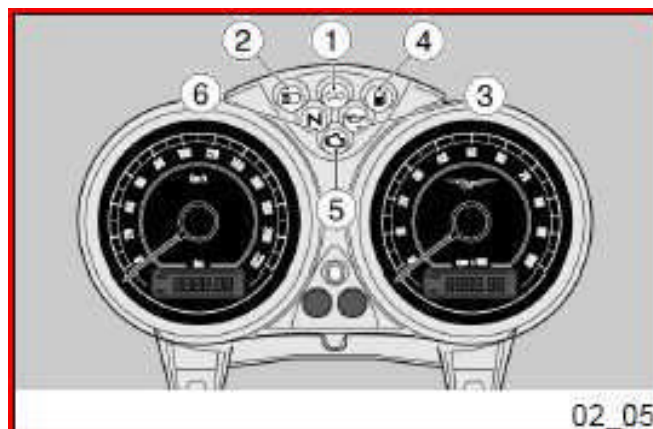
This new map solves the faulty illumination problem of the amber coloured warning light on the instrument panel (number 5 in the figure).

We therefore ask you to perform this operation during the predelivery phase on all vehicles still in your stock and on all motorcycles that go through your workshop for routine maintenance.

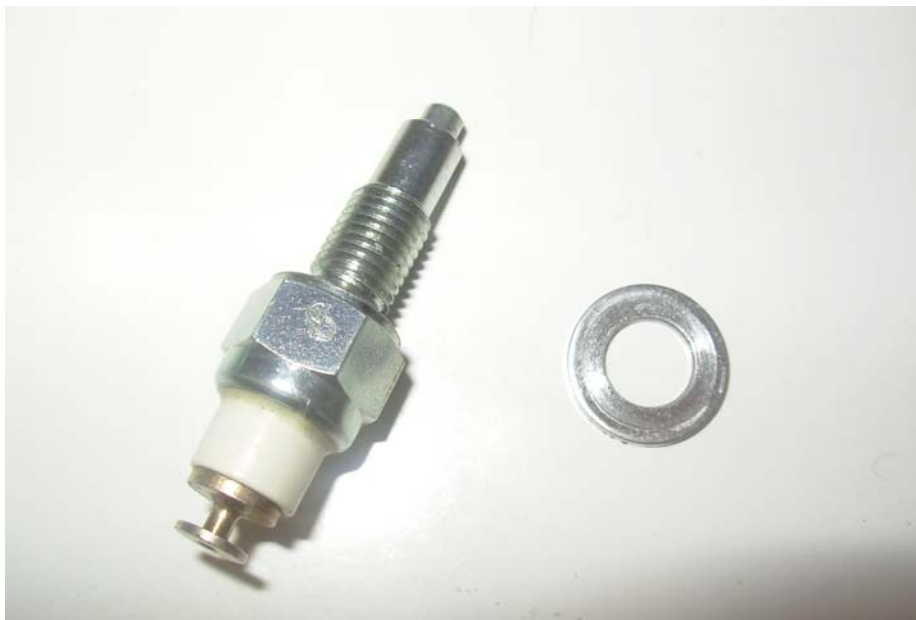
please note that each time the neutral sensor code GU19207220 is replaced the relative washer GU12154200 must also be replaced to ensure the correct functional tolerance is maintained.

It is also advisable to tighten sensor to the torque prescribed by the workshop manual:

- 10 Nm for all the engines 1100 – 1200
- 8 Nm for engines 750.

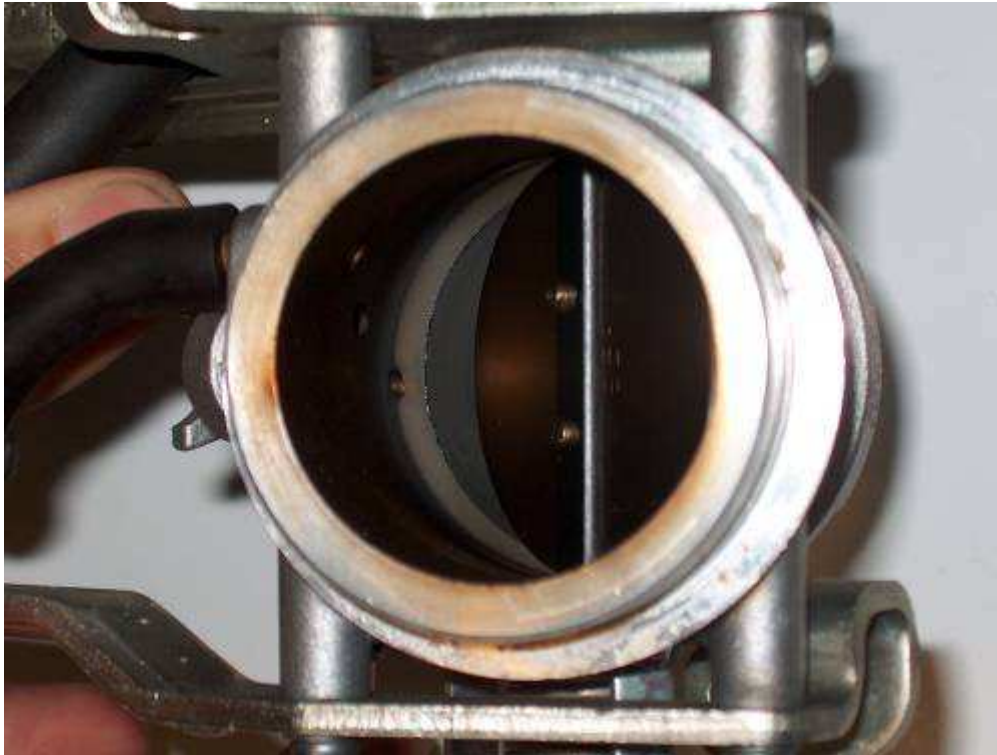
The following image shows significant deposits of unburnt fuel residue in the air duct: with the throttle closed, these deposits impede the injection system from delivering the correct air fuel mixture, compromising engine function at idle or at throttle lift-off and causing engine cut-out or irregular idling.

The throttle body must be cleaned with specific products for cleaning throttle bodies or carburetors.

Proceed as follows: with the throttle valve fully open, clean the duct with a normal cloth - do not use brushes or rotary brush attachments; never remove the throttle valves from the body.

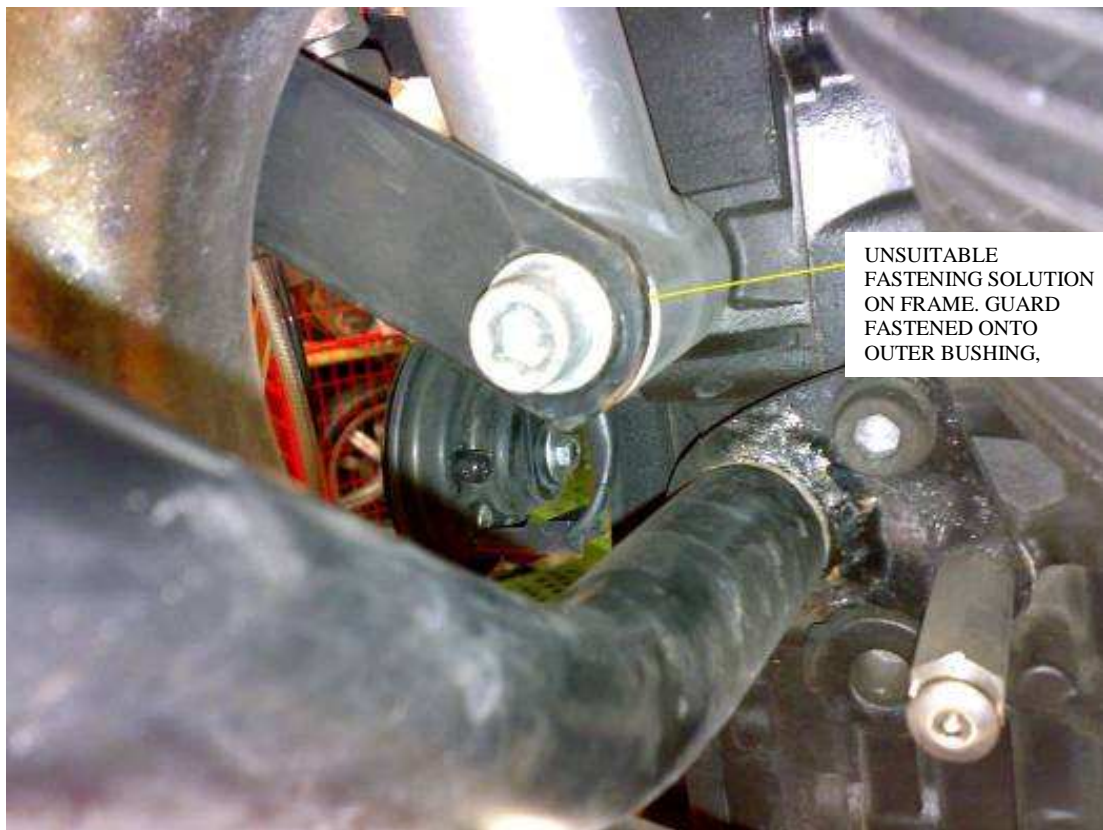
Clearly, this solution is **potentially dangerous** as it may lead to the failure of the mountings themselves.

THE USE OF NON-ORIGINAL MOTO GUZZI ACCESSORIES SIGNIFICANTLY STRESSES THE RADIATOR

UNSUITABLE FASTENING SOLUTION ON FRAME. GUARD FASTENED ONTO OUTER BUSHING,

Only install and recommend original Moto Guzzi accessories.

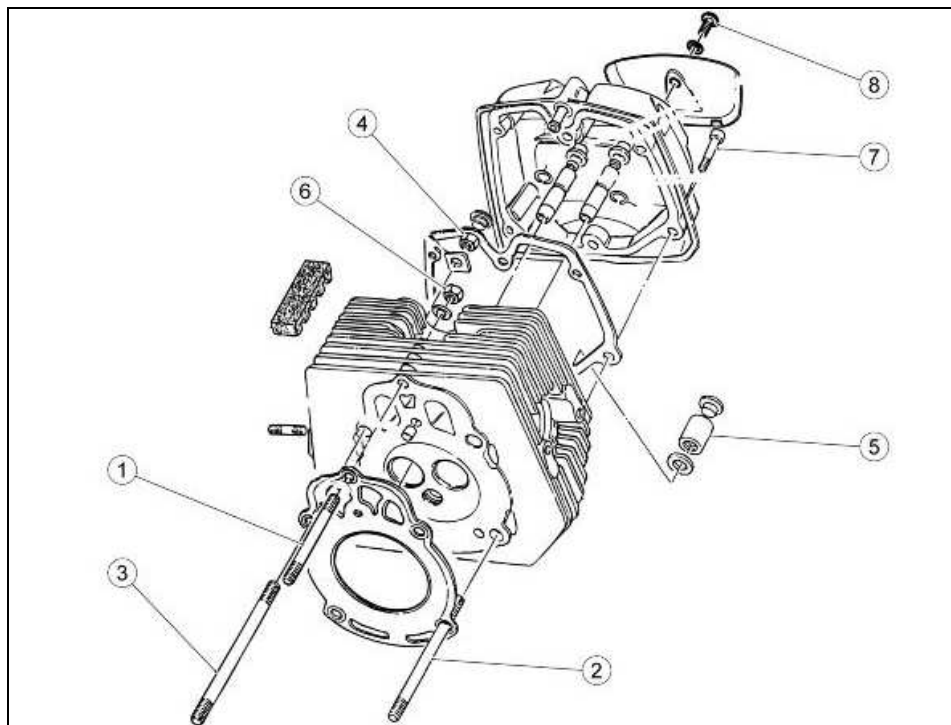
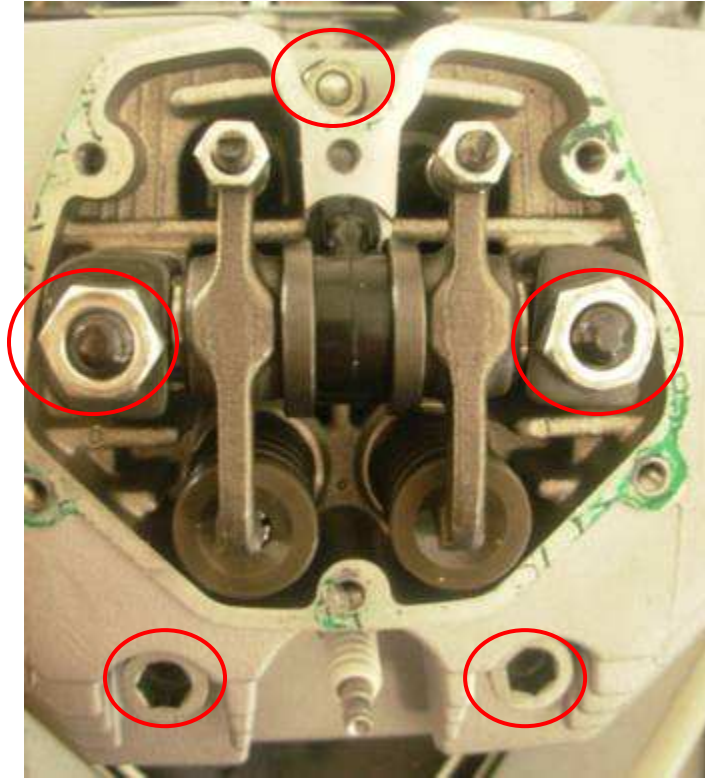
Dear Dealer,
we would like to remind you of the importance of checking that the cylinder head studs are tightened correctly at the first (1000 Km) service, is indeed indicated in the maintenance schedule.
Please note that the correct tightening torques are as follows (see exploded drawing):

The nuts which must be checked are indicated in the figure.

stud bolt (1) - M8 nut (6) = 28 Nm
stud bolts (2) and (3) - M10 nut (4) = 42 Nm
Long nut (5) = 25 Nm

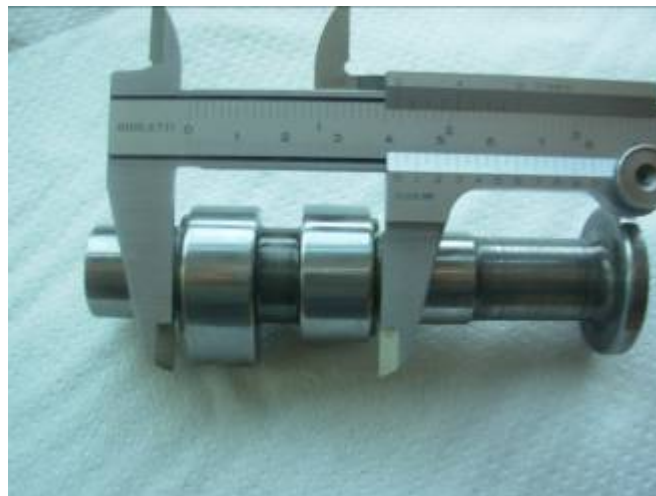
please note that replacement camshafts are now available which have been specifically modified to improve endfloat.

Before fitting the camshaft, you are kindly requested to check the dimension indicated in the following photo:

If the dimension measured is 40.35 mm, the camshaft may be installed with no additional shim.

If the dimension measured is 39.35 mm, a shim of the appropriate thickness must be added.

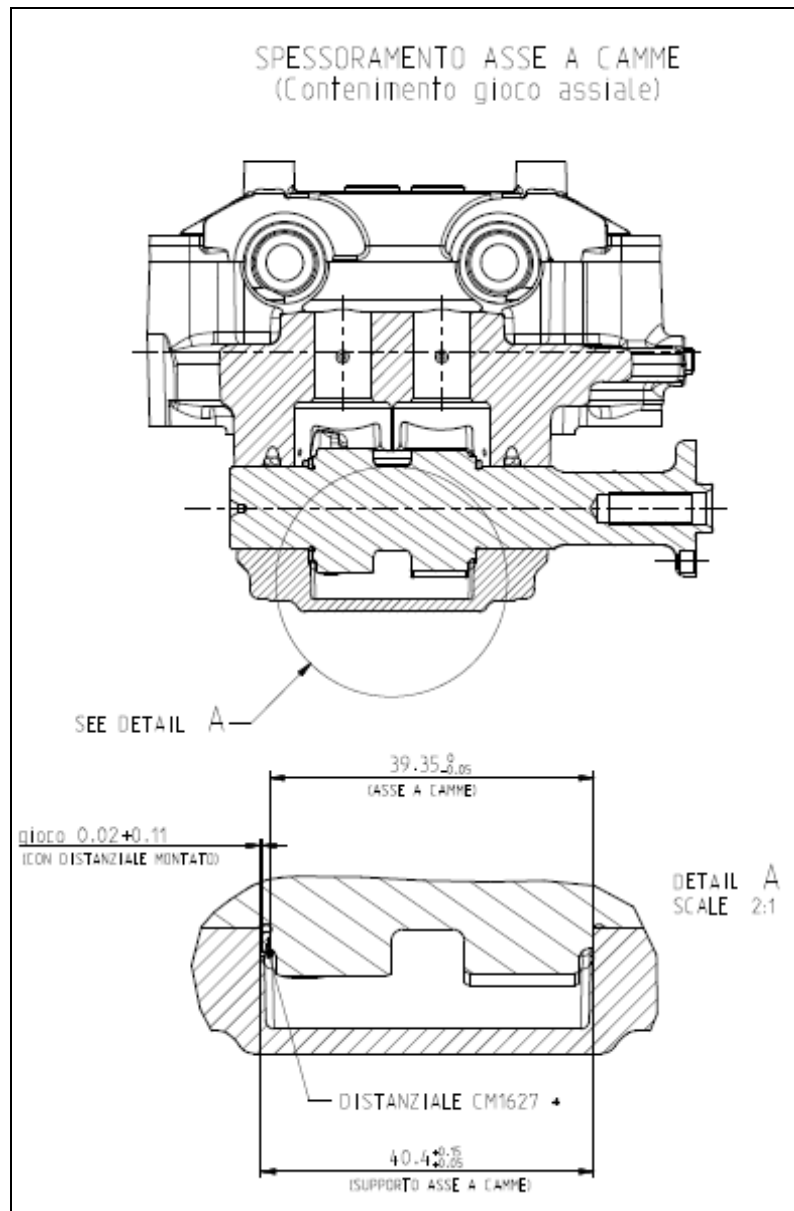
In the latter case, after installation of a shim between the camshaft and the relative seat, as shown in the following figure,

the final endfloat must be between: 0.02 and 0.11 mm.

Install the correct shim, using the following table as reference, to obtain the correct endfloat value described above:

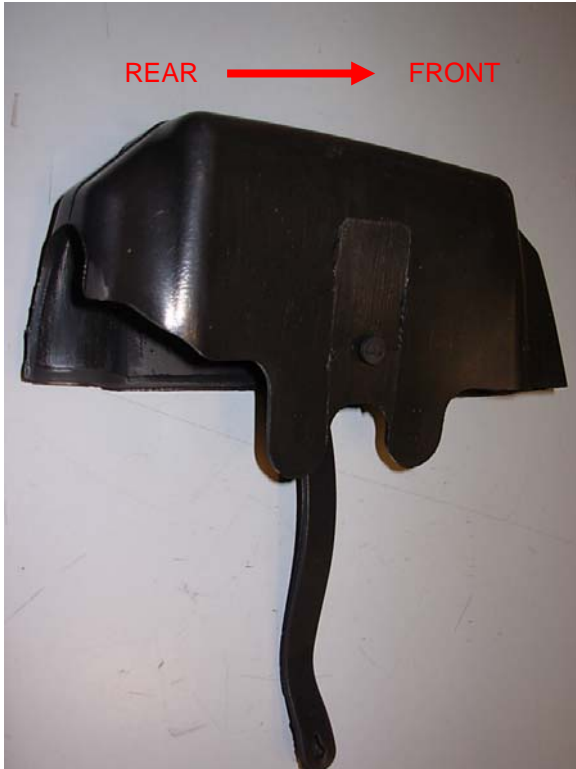
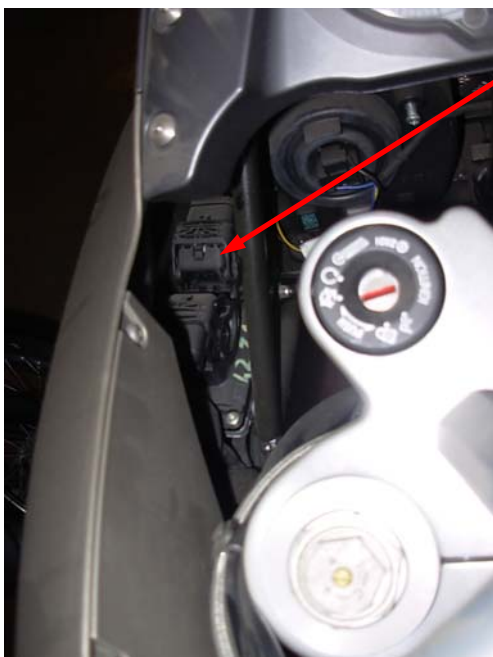
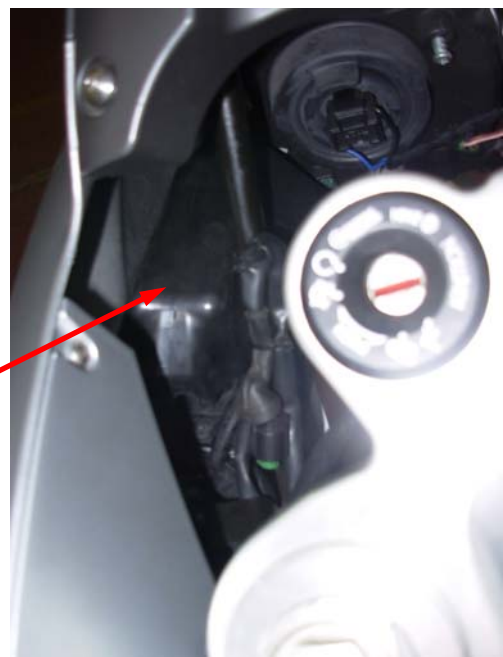
as part of our research aimed at improving the characteristics of use of our products, we recommend suggesting that the Customer include the **protection (code 883968)** to improve the insulation of the control unit.

- The protection is positioned as indicated in the figure:

- Fit the protection onto the control unit from above, pulling the strap downwards until it covers the control unit completely; attach the strap properly

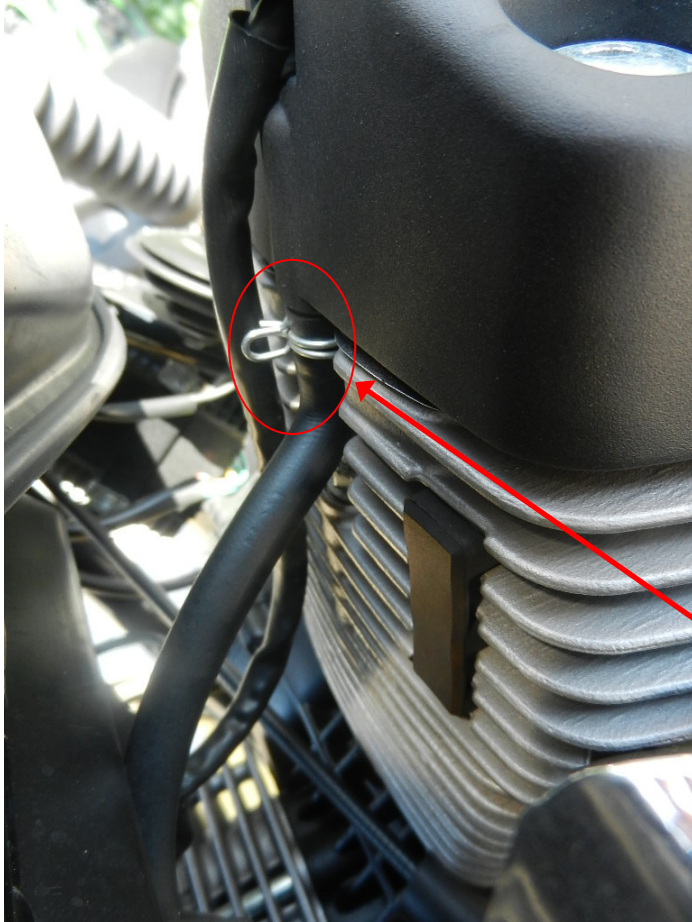
Insert COD. AP8201358

on the models and versions in question, it is necessary to check the type of clamp fixing the blow-by pipes of the left and right cylinder. Where the clamp is of the type cod. AP8102239 remove the clamp, verify the integrity of the end of the pipe (if damaged/cut, trim the pipe or otherwise replace it if not possible), replace with the clamp cod. Ap8201358

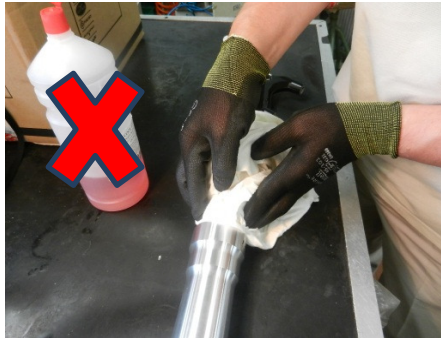
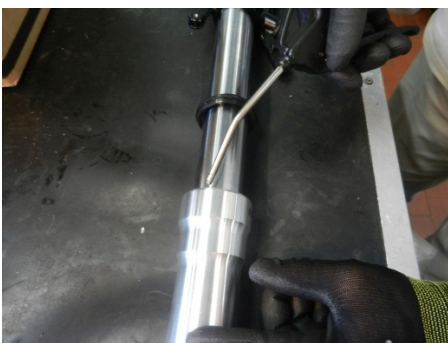
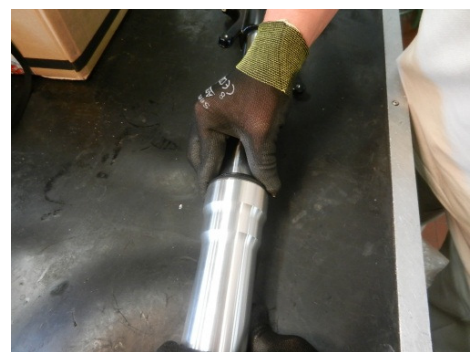
considering the repeated replacements under warranty of seals and/or fork stems within the first 2000km of riding the vehicle and identified as "oil leaking", we are hereby inviting you to perform the cleaning procedure illustrated below.

The purpose of this activity is to clean up any excess of fitting grease that could run down the stem within the first miles and be mistaken for an oil leak.

The stems replaced under warranty up to about 2000km, returned to the company, did not have any loosing or leaking of oil but excess grease. The cleaning process ensures the final elimination of the phenomenon.

Remove the dust gaiter being careful not to damage it and clean thoroughly with a cloth (do not use solvents)

2 Blow with air jet and clean with a cloth

3 Reinsert the dust gaiter and check its correct positioning

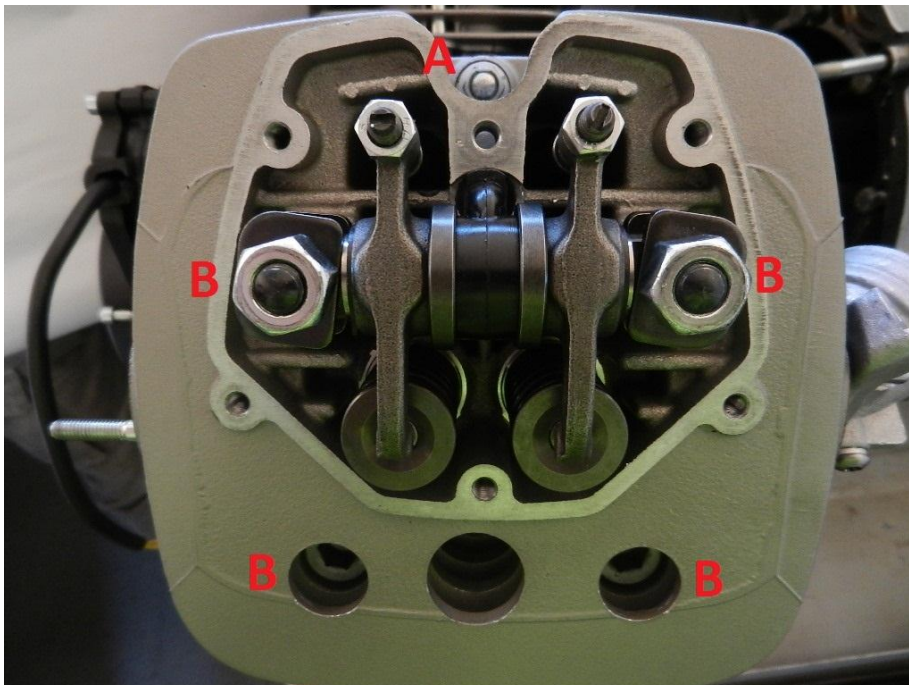
to ensure that the procedures relative to our products are performed correctly, it is fundamental that you follow the instructions given below relative to **checking the tightening torque of cylinder head screws** exactly as indicated.

- As indicated in the User manual in the “Scheduled Maintenance Table”, at the 1000 Km (600 mile) service, check and, if necessary, correct the tightening torque of these screws

A: 28 Nm (20.63 lbf ft)

B: 42 Nm (30.95 lbf ft)

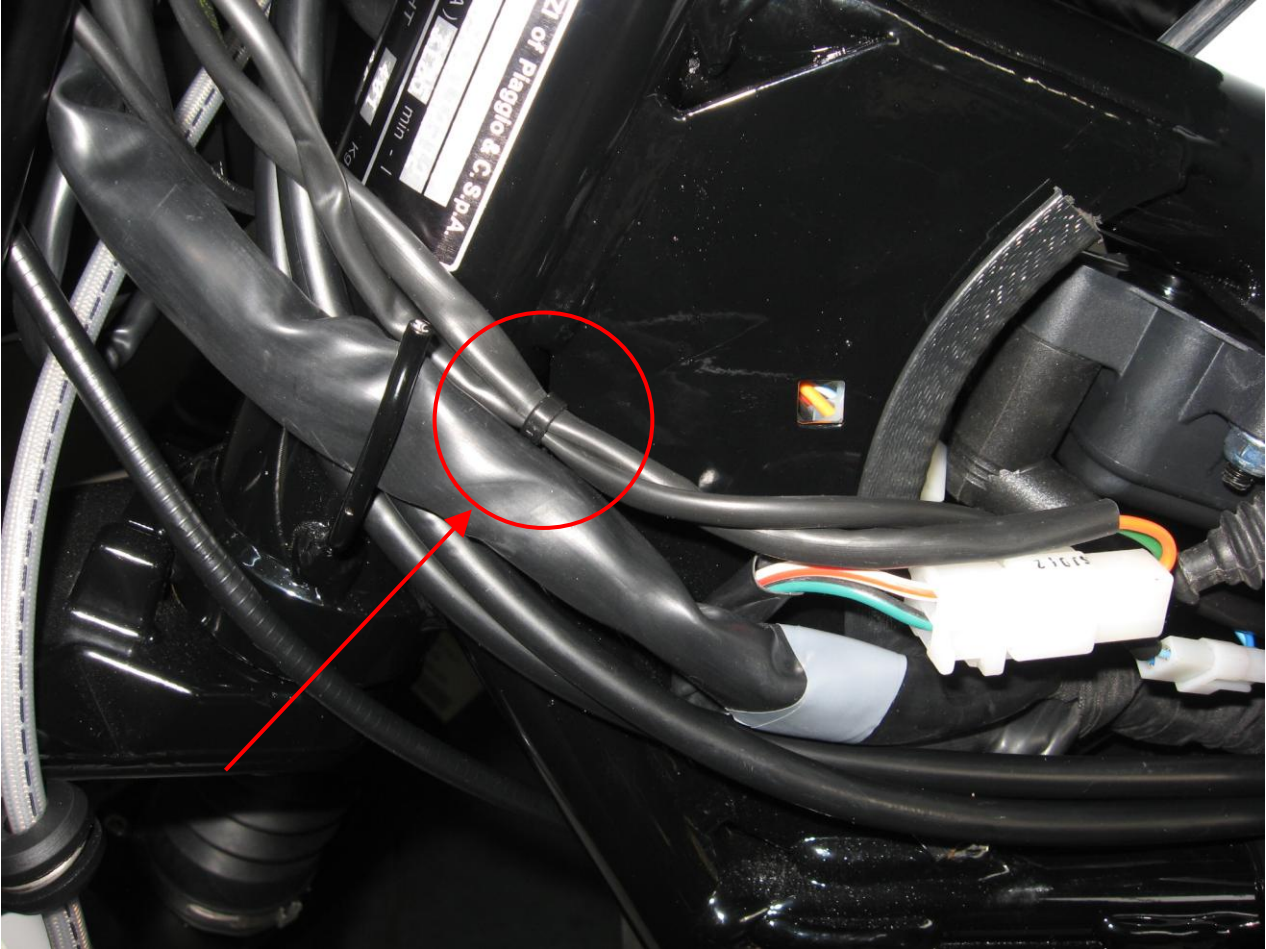
- Check with the handlebar turned all the way to the right that the section of key switch cable (indicated by the arrow in the photo) is free and not under tension

NOTE: The key switch cable must be joined to the front left turn indicator cable using a clamp as illustrated in the photo: the clamp joins the 2 cables (block and turn indicator) and should not under any circumstances be fixed to the frame as previously required.

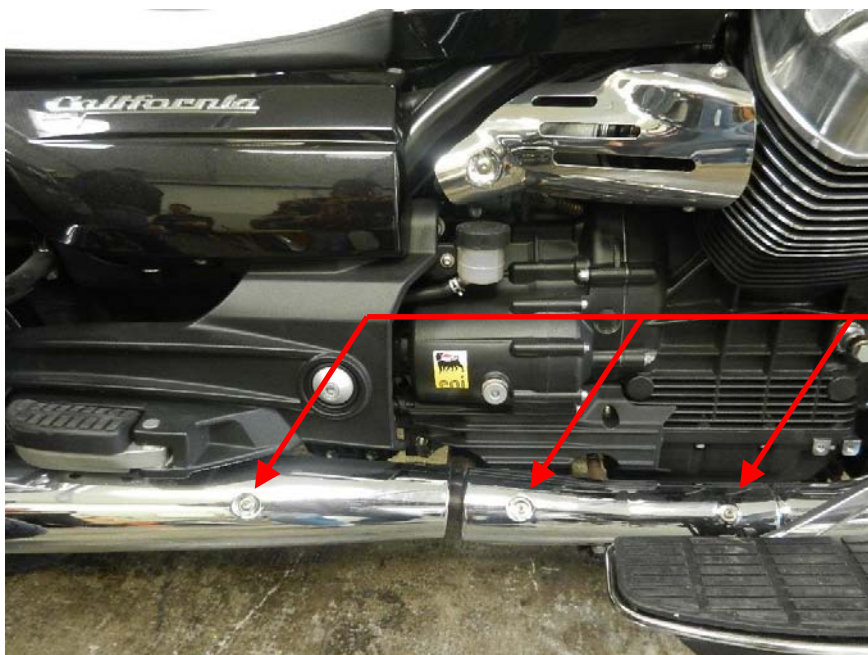
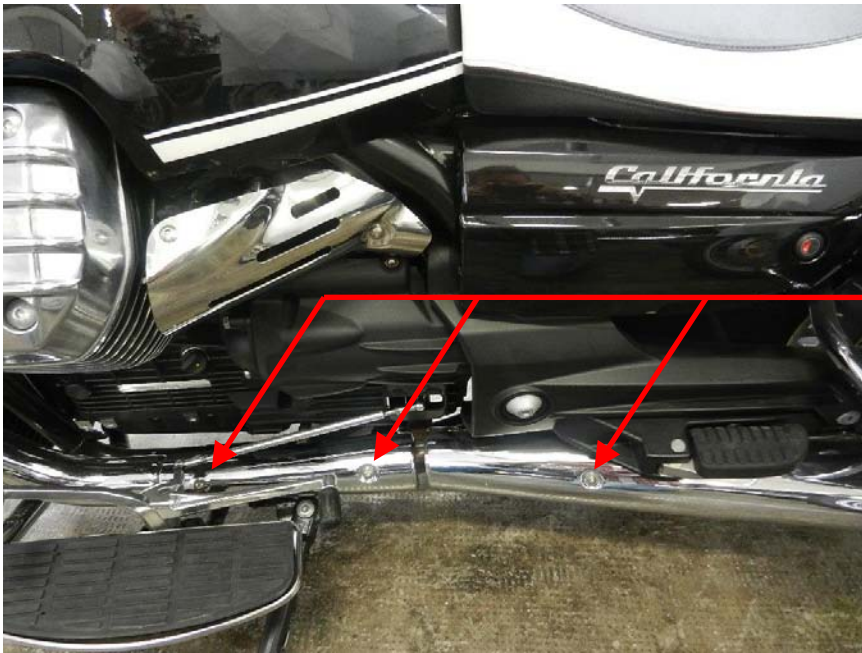
Securing screws on the manifold heat guard and silencer, right and left, type TBEI M6 X10 (code 884029), tighten to a torque of: **8 Nm**

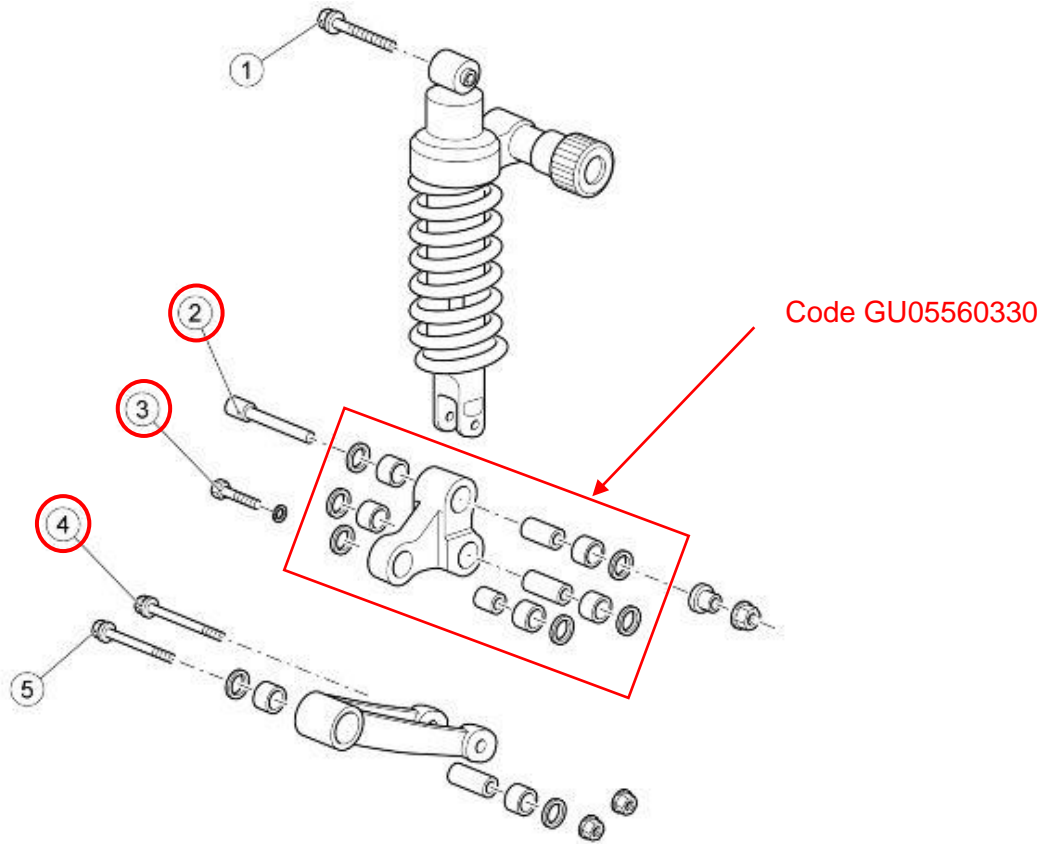
Failure of the components subject to replacement can generate possible problems to the chassis.

- Replace the rear suspension double connecting rod as shown in the workshop manual in the Chapter "Suspension - Shock absorber sect.", an extract of which is provided below.

pos.	Description	Type	Qty	Torque
2	TCEI screws for fixing double connecting rod/swingarm	M10x82	1	50 Nm (36.88 lb ft)
3	TE screw for fixing double connecting rod/shock absorber	M10x47	1	40 Nm (29.50 lb ft)
4	TE flang. screws for fixing single connecting rod/double connecting rod	M10x95	1	50 Nm (36.88 lb ft)

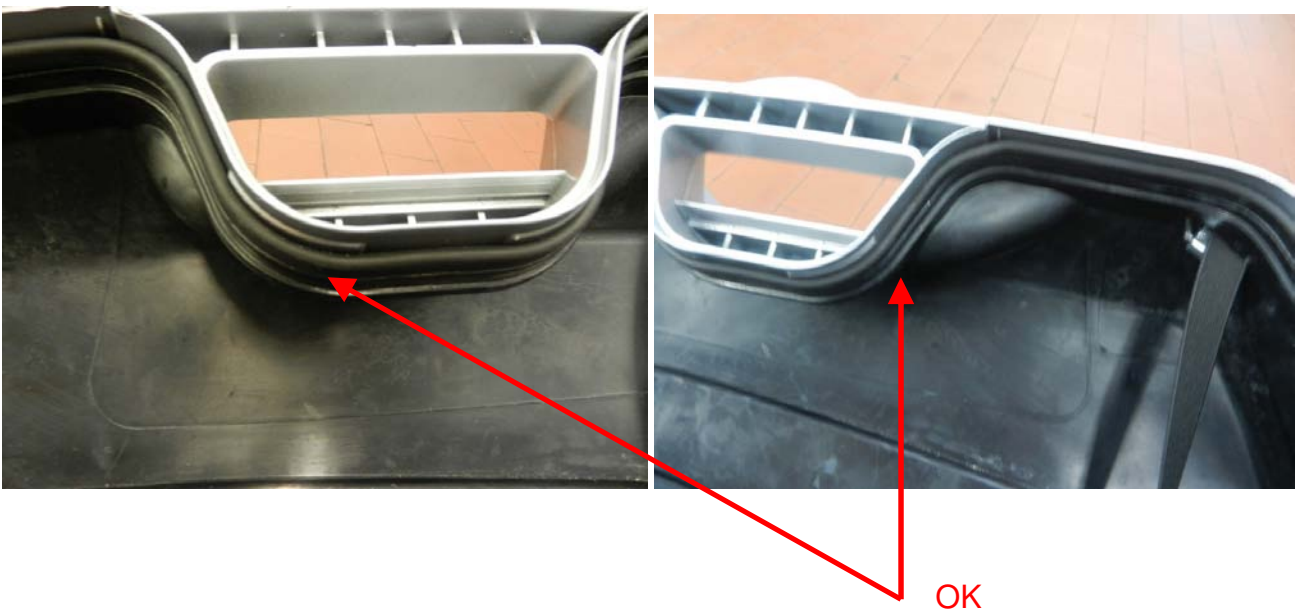
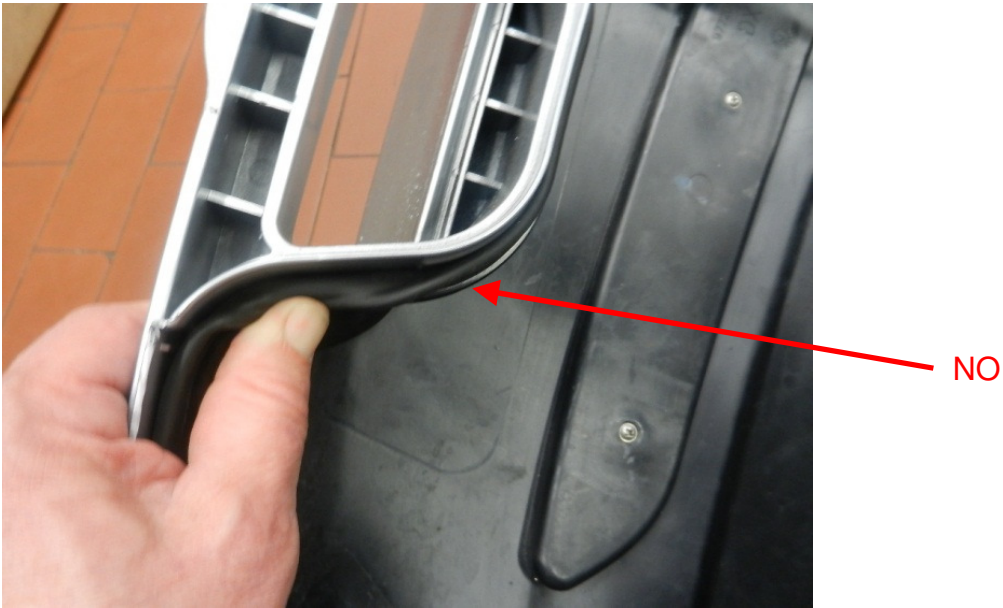
as part of our ongoing activities to improve our products, you are kindly requested to check reported instances of **water infiltration into the side panniers** with the following procedure:

- 1) check that the internal perimeter seals are fitted correctly:

Note: should it be necessary to replace the **seals**, these components are orderable from the spare parts catalogue with part number 883246

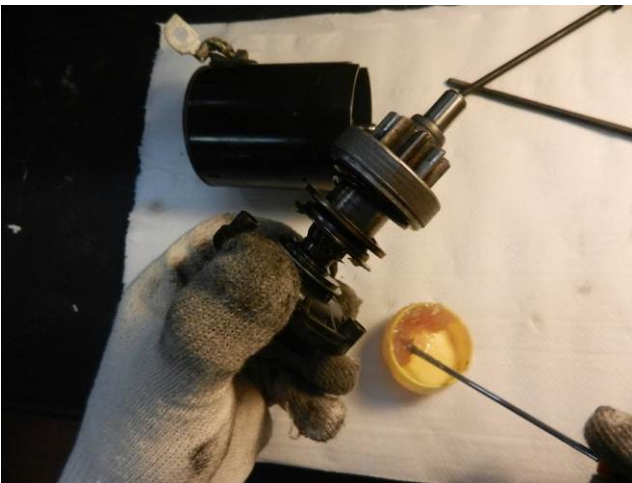
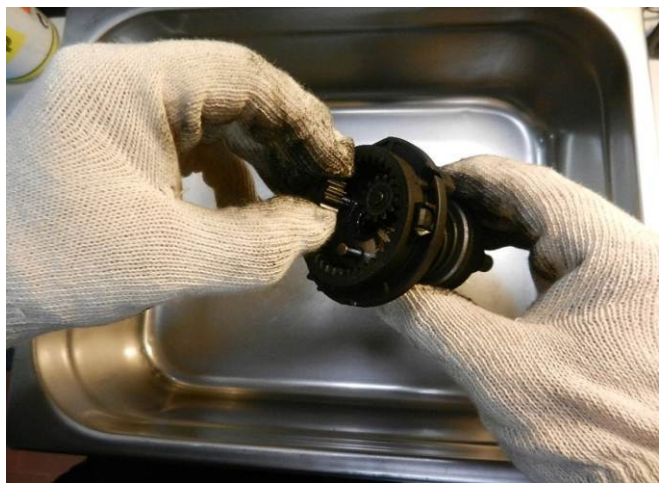
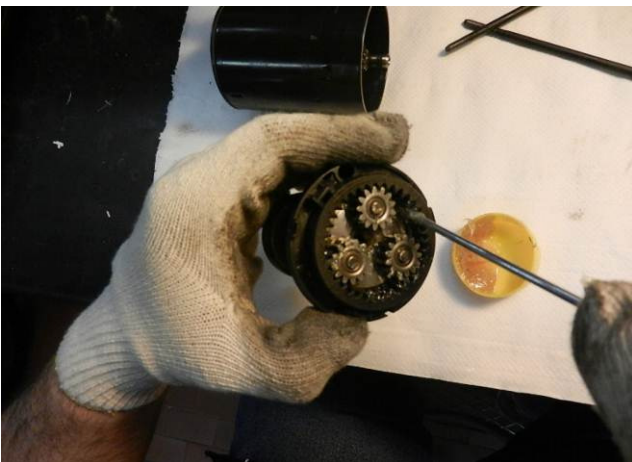
in response to a number of warranty claims relative to **noisy starter motor operation/starter motor functional problems**, please note that it is **not** necessary to replace the starter motor and that the problem may be rectified by performing the cleaning procedure described as follows.

- Clean the mechanisms with WD40-P140 degreaser for mechanical systems and lubricate with AGIP GREASE MU2

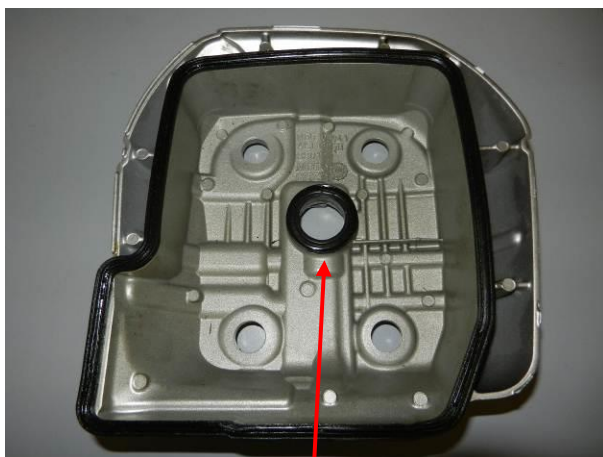
OK

To verify whether the vehicle can be modified with **kit A** remove the timing cover and check whether it is the floating type, which can be recognised by the presence of the circlip in the spark plug hole area:
