Ici sont regroupées toutes les notes techniques émises par Moto Guzzi depuis 2004 jusqu'à aujourd'hui. Ou au moins toutes celles que j'ai pu obtenir.

Here is all Technical and Servicing Notes from Moto Guzzi, from 2004 since today. All of what I have picked up...

MODEL	ABOUT...	SERVICE NOTE	DATE	TECHNICAL NOTE	DATE
All models	Electrical diagnosis improvement	---	---	008-2008	30/09/08
All models	Neutral sensor	---	---	002-2010	19/07/10
All models	Cleaning throttle body	---	---	005-2010	29/10/10
All models	Compatibility with E10	---	---	004-2011	13/09/11
All models	Diagnosis instrument : PADS	---	---	005-2012	28/03/12
All models	Handling and Storage	---	---	003-2013	26/03/13
All models	Speedometer indication	---	---	007-2013	16/05/13
All models	Control of the position of the electrical wiring harness	---	---	014-2013	31/07/13
All models	Battery initialisation	---	---	007-2014	17/07/14
All models	Vehicle servicing time	010-2012	09/2012	---	---
All models	Vehicle servicing time	002-2013	03/2013	---	---
All models	Vehicle servicing time <i>Only french version available for the moment</i>	xxx-2013	12/2013	---	---
All models	Warranty : modified components	004-2013	003-9967	---	---

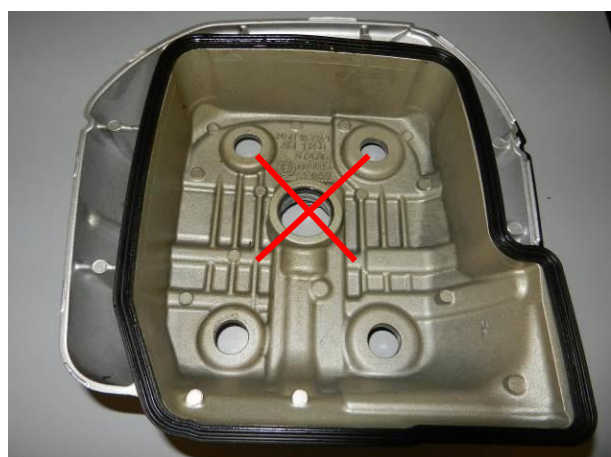
NO

To verify whether the vehicle can be modified with **kit A** remove the timing cover and check whether it is the floating type, which can be recognised by the presence of the circlip in the spark plug hole area:

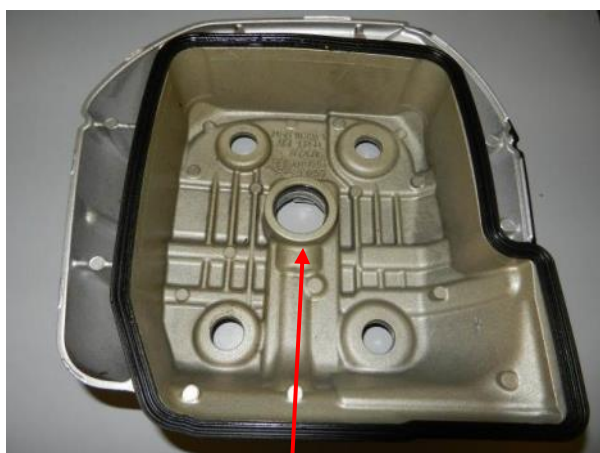
OK

To determine if the vehicle may be modified with **kit B or C**, remove the timing cover and check that it is a **NON-floating** type cover, which is identifiable by the absence of a circlip in the spark plug hole area:

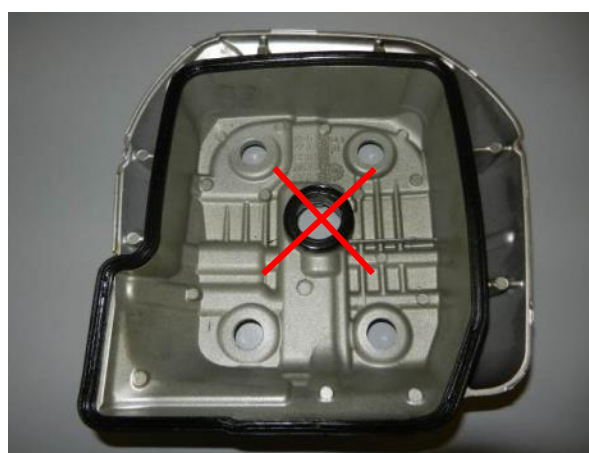
NO

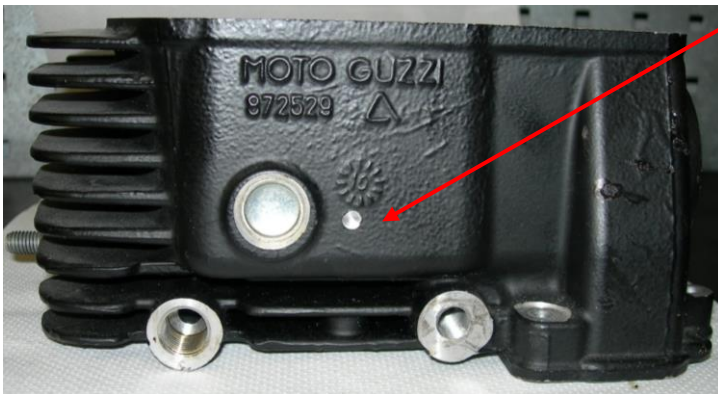
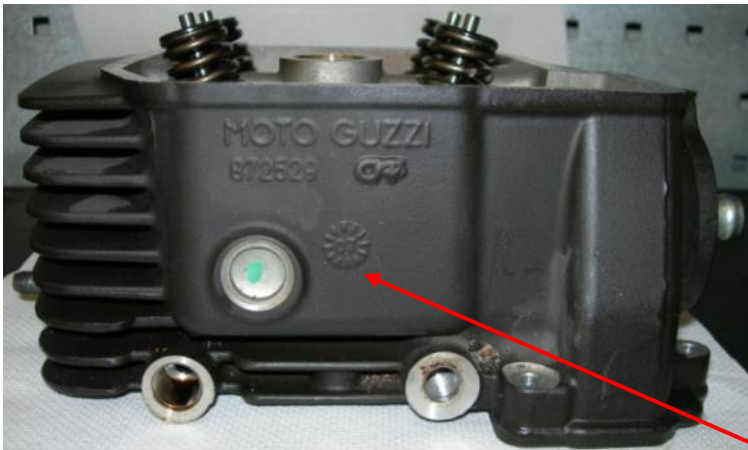
If the marking is present, use **KIT B**

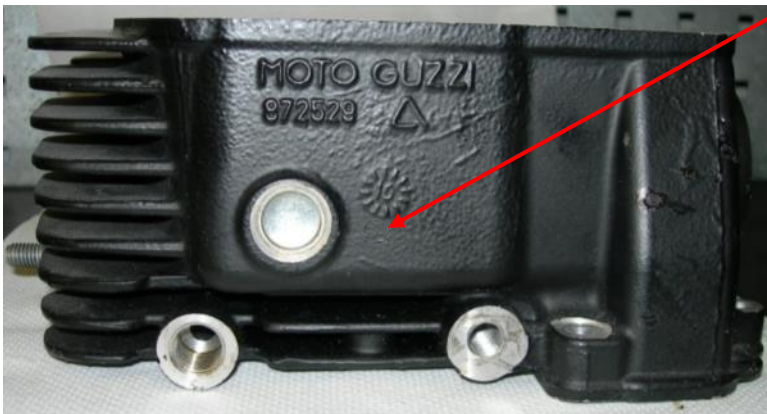
If there is no marking, use **KIT C**

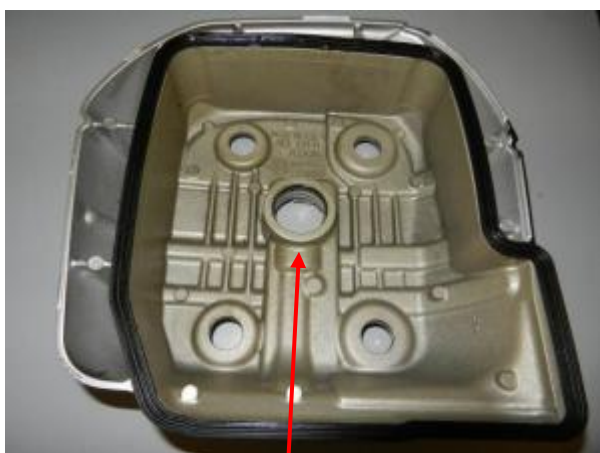
Non floating → **KIT C**

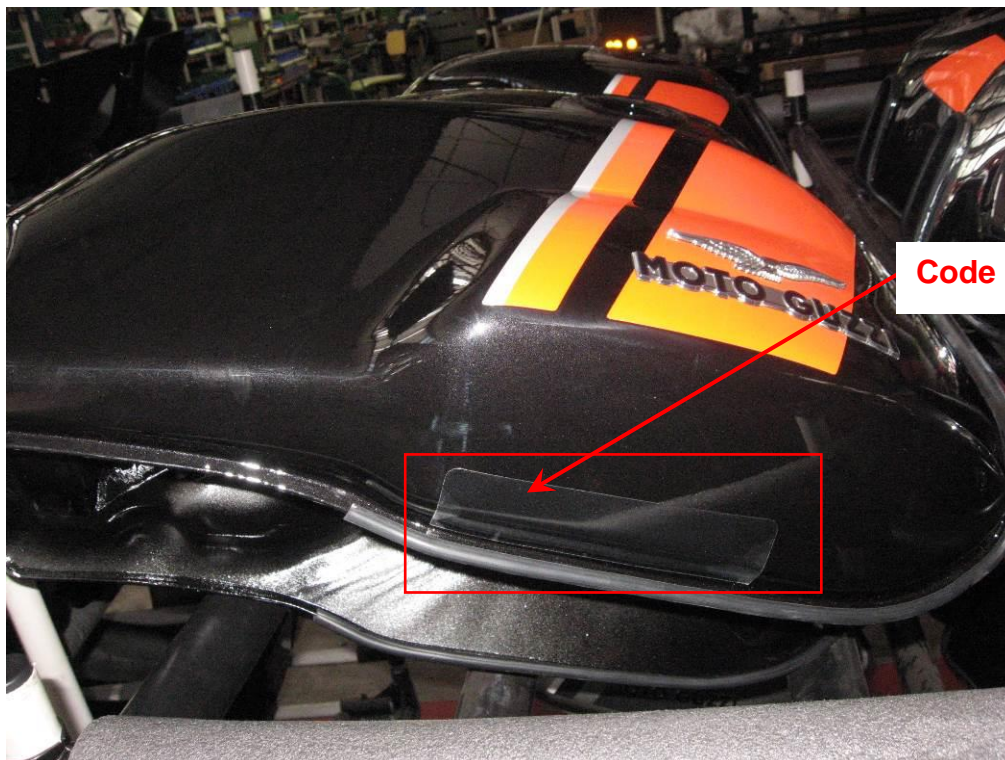
please note that the specific adhesive clear protective film must be applied to the tank at the first available opportunity as described as follows to prevent damage caused by the spark plug cable fretting against the fuel tank.

- Ensure that the relative surfaces of the tank are clean and degreased.
- Apply the adhesive film **P/N GU32944310** in the indicated area on the right and left hand sides of the tank, taking care not to leave air bubbles trapped under the film itself.

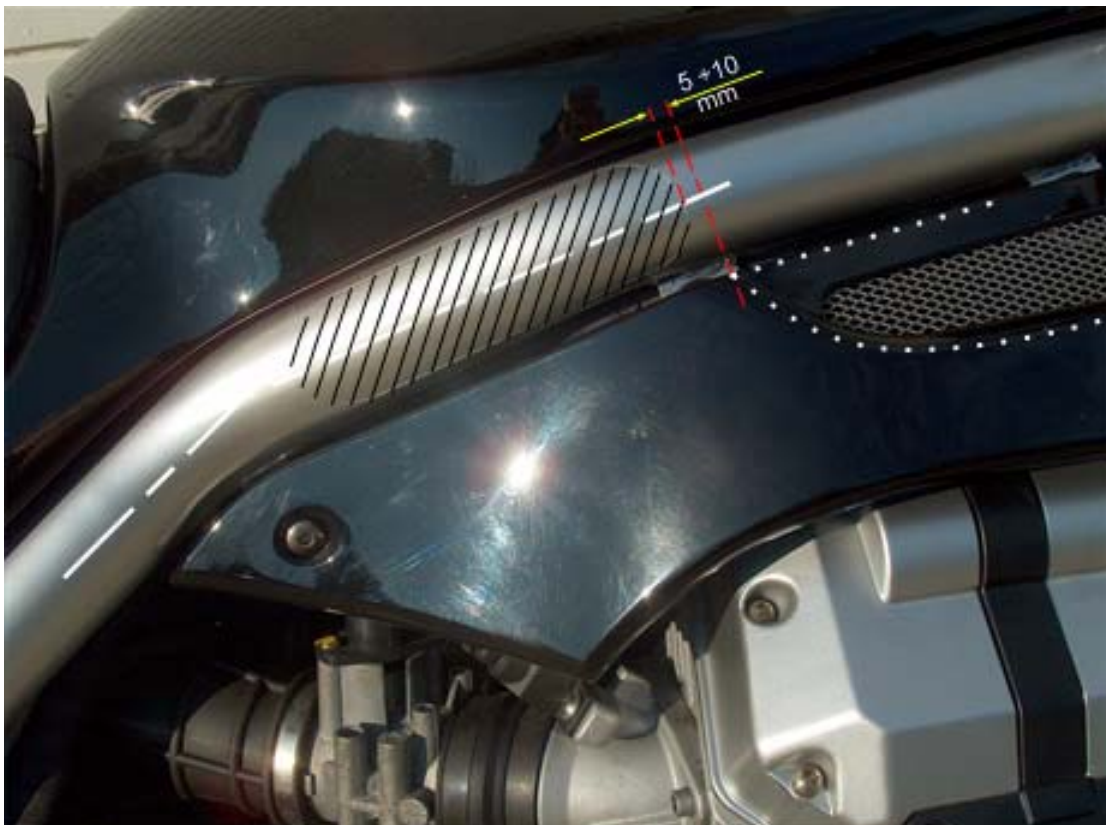
Following analysis, we have determined that these colour fadings could eventually be caused by the rubbing of the frame surface with the pilot clothing.

Pasting: apply uniformly the tape with a dry and soft cloth, making sure that no air-balls are formed.

The corresponding photo shown here, refers to the side DX of the vehicle; the same procedure applies to the side SX of the machine.

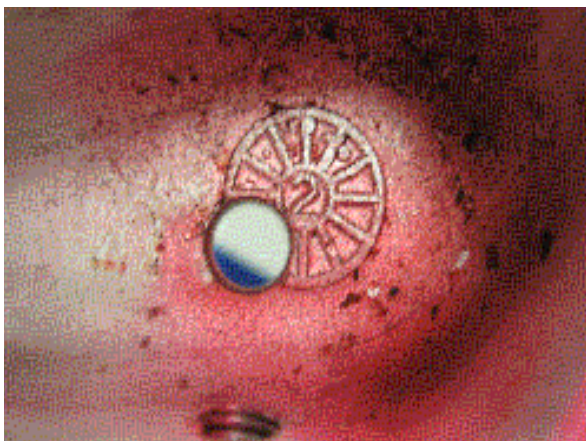
in some models of the above-indicated vehicles we had some cases of bottom yoke failure (part no. **03494000** for California 1100 EV and part no. **03494045** for California 1100 Stone).

The inspection you will be performing consists in checking the production date punch, located in fork yoke bottom end (see attached picture).

NOTE: the hole on the production date punch, as shown, still allows you to read the production date

Plates needing replacement are only the ones with number 2 at the centre and having four or five dot marks on the “sections” :

We will warn the customers and tell them that they should come to you for a simple check aiming at finding out whether the bottom yoke needs replacement.

If the plate is not marked as above indicated, replacement is NOT necessary and in this instance you are obliged to notify us by sending an e-mail specifying the frame number to: **warranty@motoguzzi.it**.

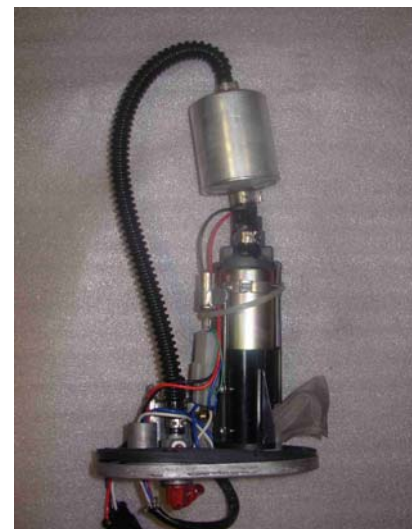
Within the frame of our effort to enhance our products all the time, we inform you that Griso 850 and Griso 1100 vehicles will receive an update for the fuel pump, mainly consisting in the replacement of the rubber connection hose.

The figure on the side shows pump configuration, after fuel tank was removed.

- 1. REMOVE THE FUEL TANK AS SPECIFIED IN THE WORKSHOP MANUAL**
- 2. REMOVE THE FUEL PUMP FROM TANK**

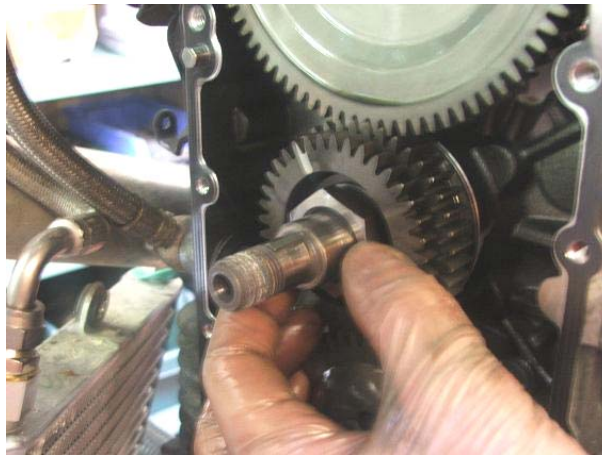
Fig. 16

We found that on the above referenced vehicles the nut retaining the crankshaft timing gear works itself loose leading to a displacement of timing gear and sprocket. This may cause the engine lubrication system to malfunction.

The nut works itself loose due to the washer placed between nut and gear. The problem is solved by replacing the current washer with a taper washer.

- Remove the retaining nut of the crankshaft timing gear and replace the flat washer with the taper washer.

TIGHTEN TO 200 Nm, DO NOT USE LOCTITE. To this end, lock out rotation of the clutch gearwheel as for removal of the alternator pulley nut (see above)

PLEASE NOTE: THERE IS NO NEED TO REPLACE THE RETAINING NUT (fig. 16)

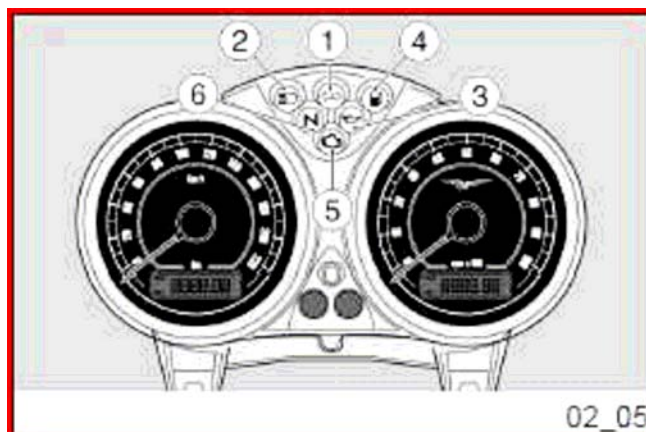
This new map solves the faulty illumination problem of the amber coloured warning light on the instrument panel (number 5 in the figure).

In addition to the technical bulletin no. 12 of the year 2008 dated 21/11/2008, please be informed that from the Axone 7.0.4 release, available and downloadable starting from 15/09/2009 (or from the Navigator 6.0.0 release), it is possible to reprogramme the vehicle's control unit by selecting the **REPROGRAMMING** function and choosing **V7NEVAD** mapping.

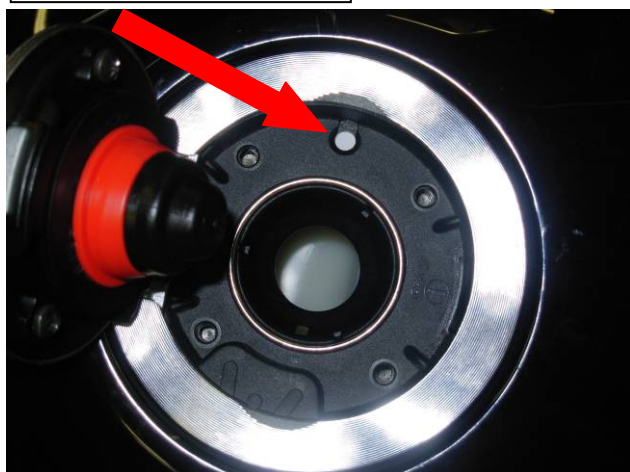
Photo A

The obstruction of the breather hole could cause the vehicle to stop.

Blocked passage

The breather hole cannot be seen, where as the overflow drainage hole (shown by the arrow) could be blocked as shown in Photo A. In the case of doubt, insert a small screwdriver which must go down at least 2 cm if the hole is free, Photo B

If this hole is blocked, the tank must be replaced.

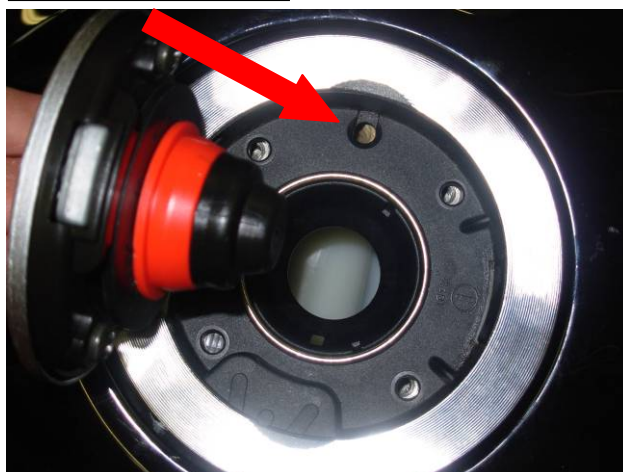
Photo B

Free passage

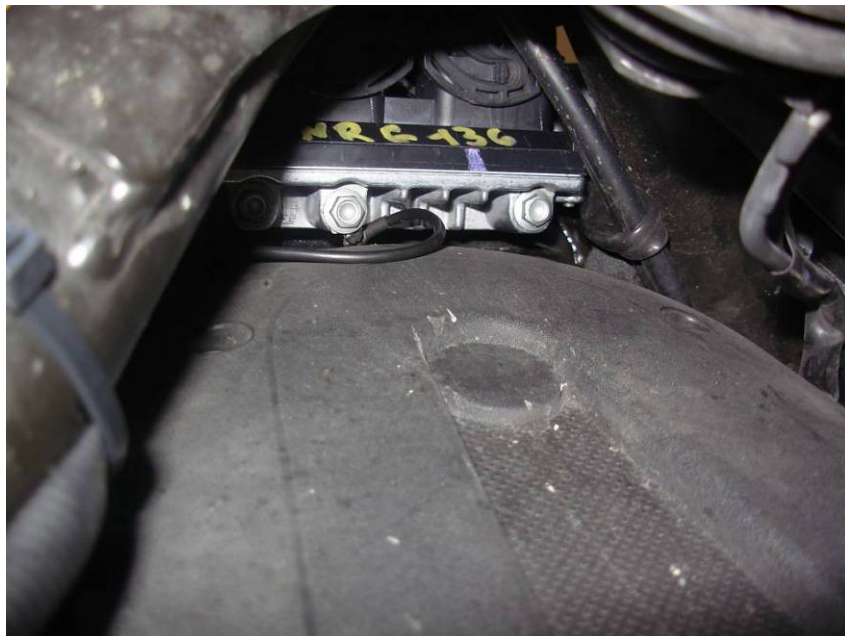
INCORRECTLY POSITIONED CABLE: the lug terminal may be damaged due to interference with the alternator cover

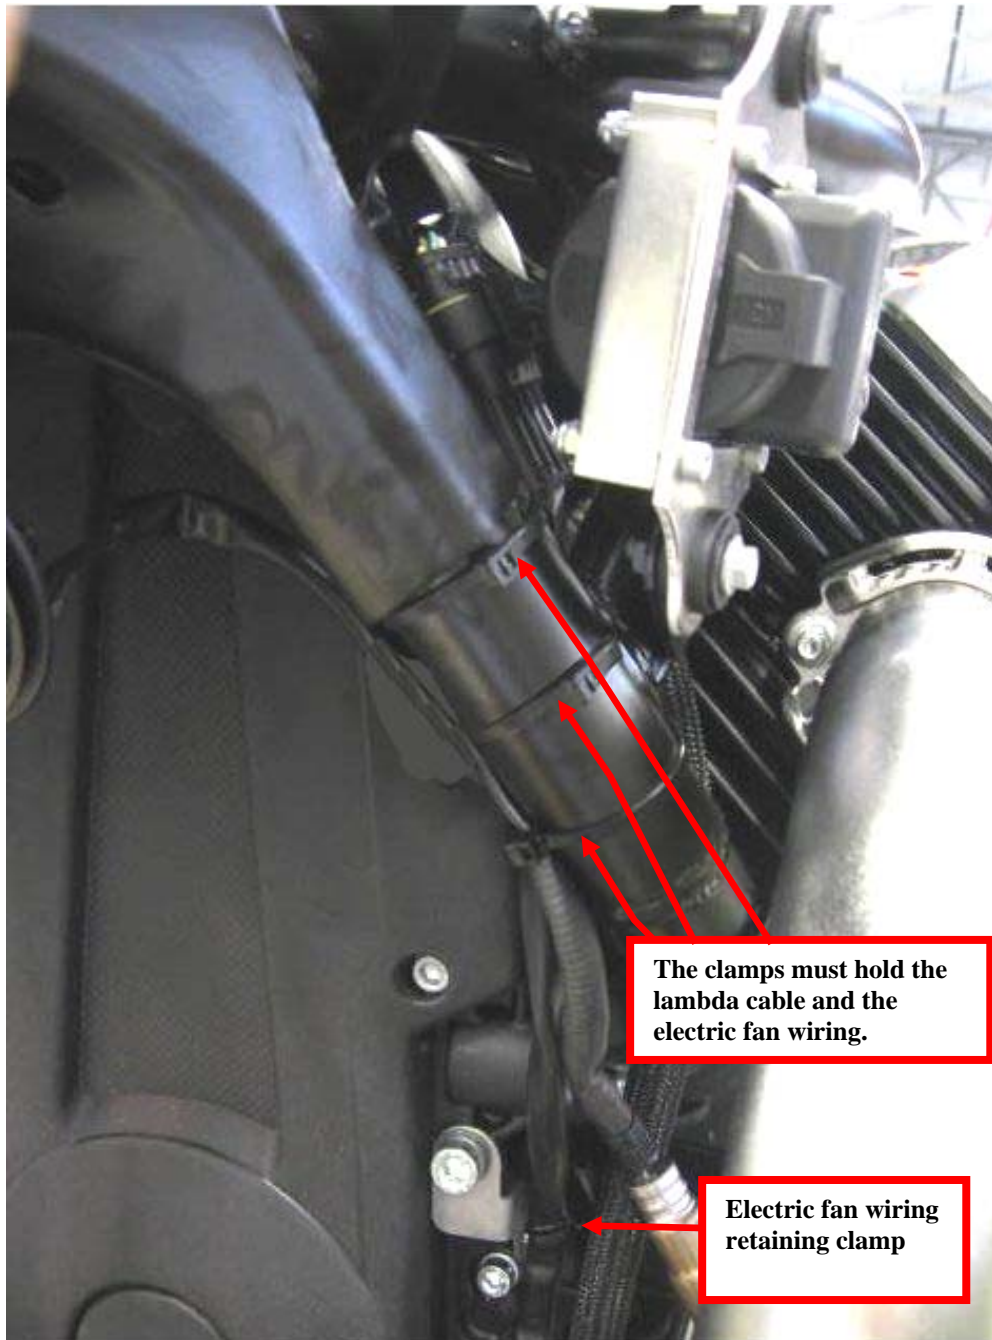
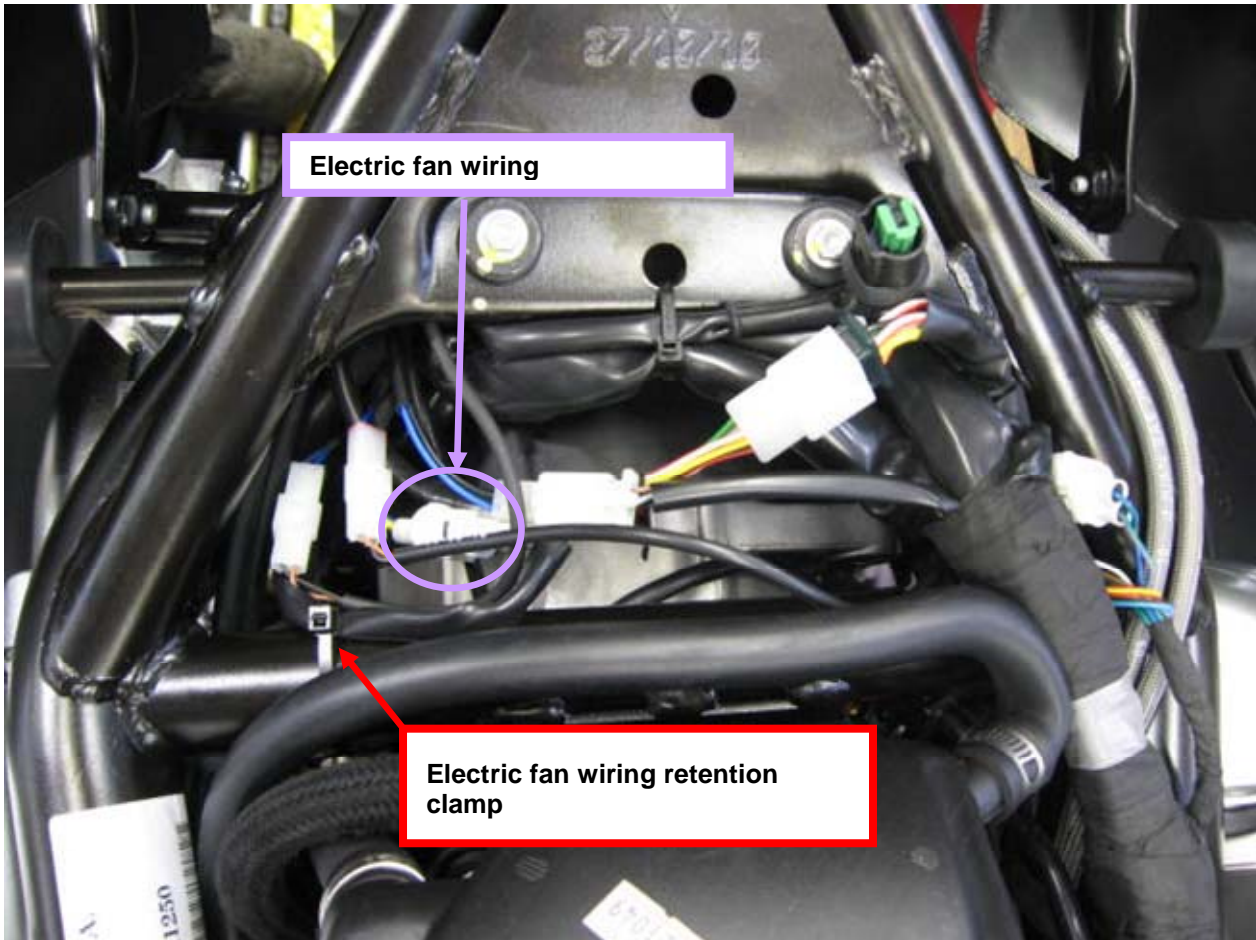
- 1) Check that the electric fan layout is the same as that indicated in the photo and that it is fastened as shown in the photo below

- disconnect the electric fan connector
- Remove any retaining clamps
- Remove the wiring from the incorrect position
- Start the repositioning and the corresponding fastening as indicated in the photo above

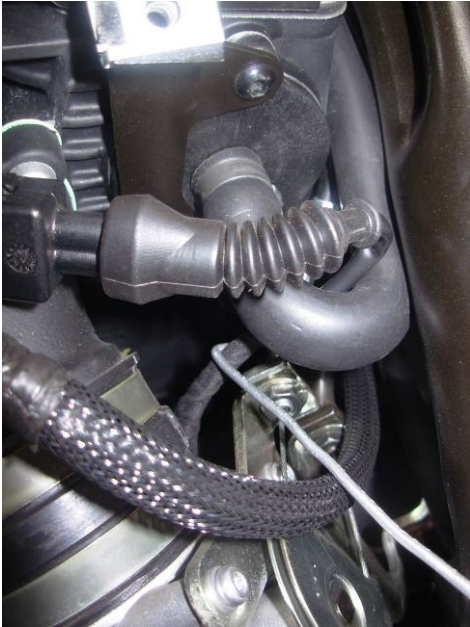
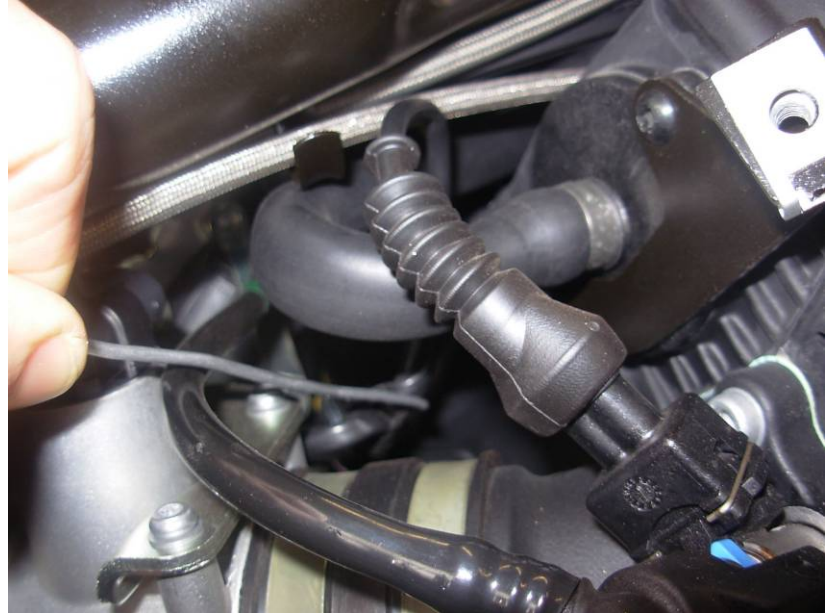
Check that the connection lines of both injectors are positioned as shown in the attached figure:

If both wirings are not positioned as shown in the figure, proceed as follows:

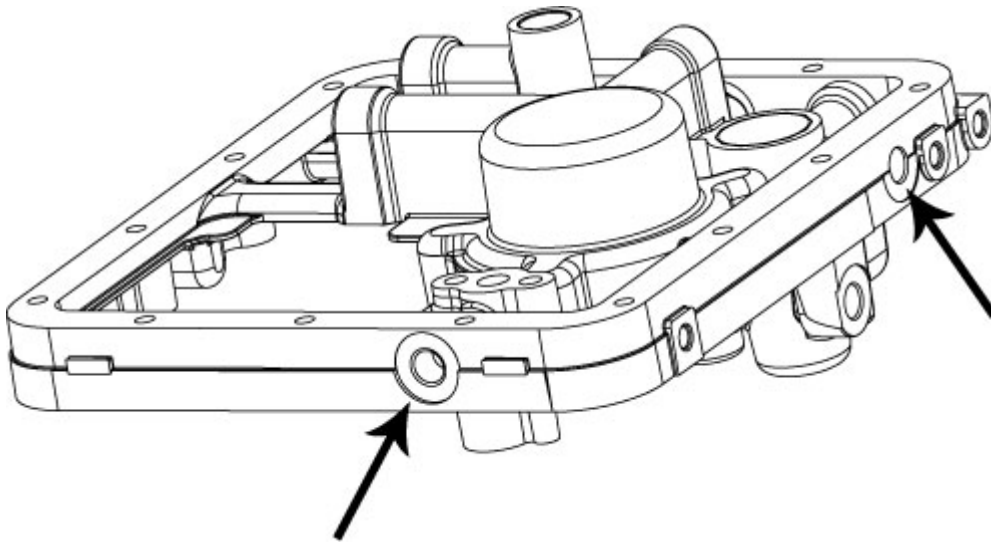
further to our technical inspections on the product, we found out that in one production batch of the indicated models the engine flange plugs might have been improperly installed.

Disassemble all parts necessary to punch the two plugs you find on the right of the flange and at the back of the same, as shown in the figure

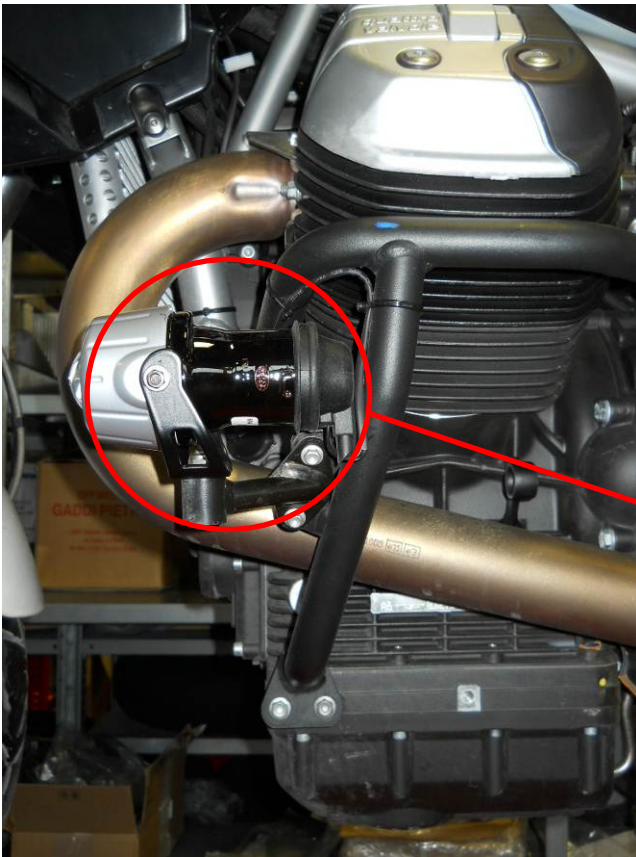
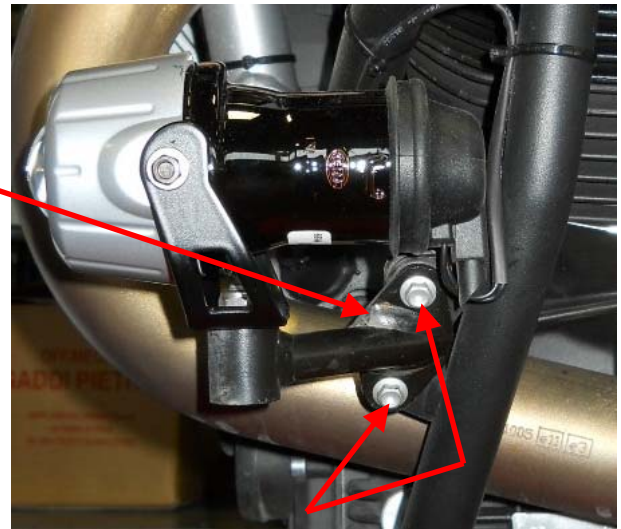
- Verify that the type of attachment mounting the spotlight to the engine bars is like the one shown in the photo, that is, a metal fin welded to the engine bars on which the spotlight is fixed by 2 screws.

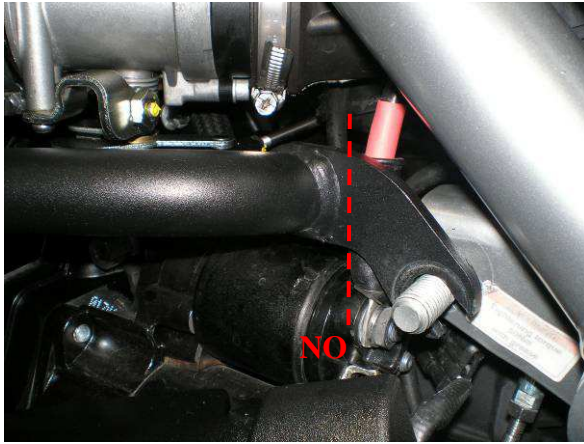
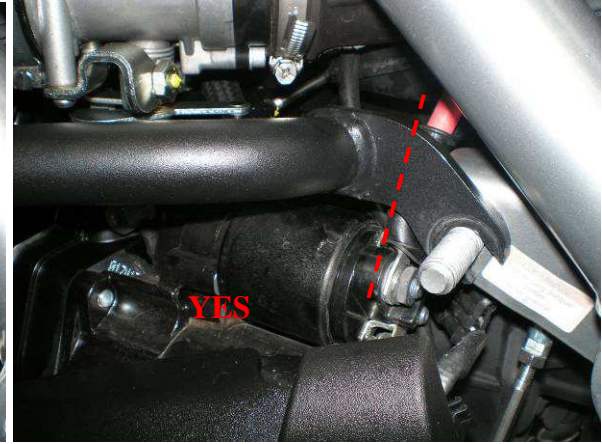
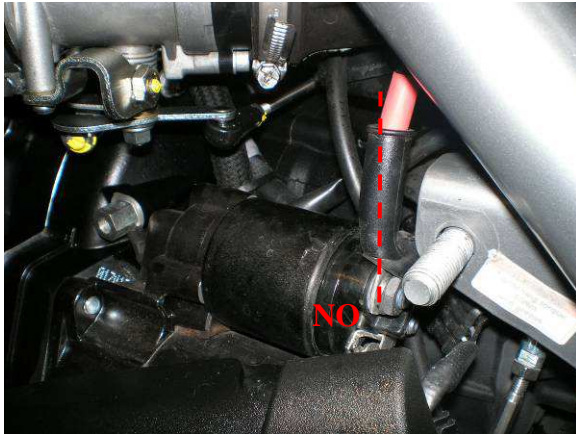
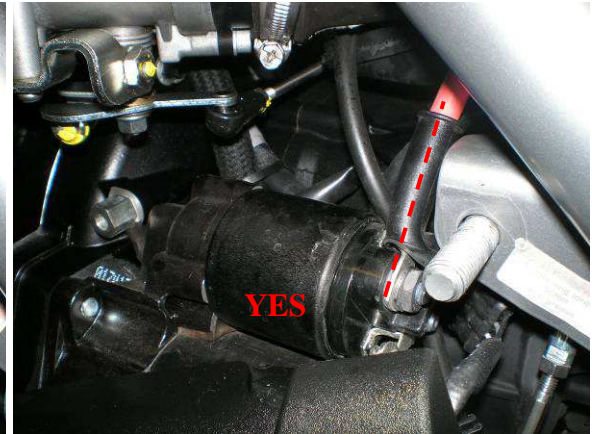
- Check to see if the positive cable harness of the starter motor is dangerously compressed by the dresser bars
- **If it is in a dangerous position** (labelled **NO** in the photos) then remove the nut securing the dresser bars, loosen the nut on the positive cable harness clamp of the motor and then lock it in the correct position

- Tighten the cable harness clamp nut, being careful to reposition the protection of the clamp, tighten the nut fixing the dresser bars, reposition the starter motor protection, and lastly restore the connection of the starter battery.

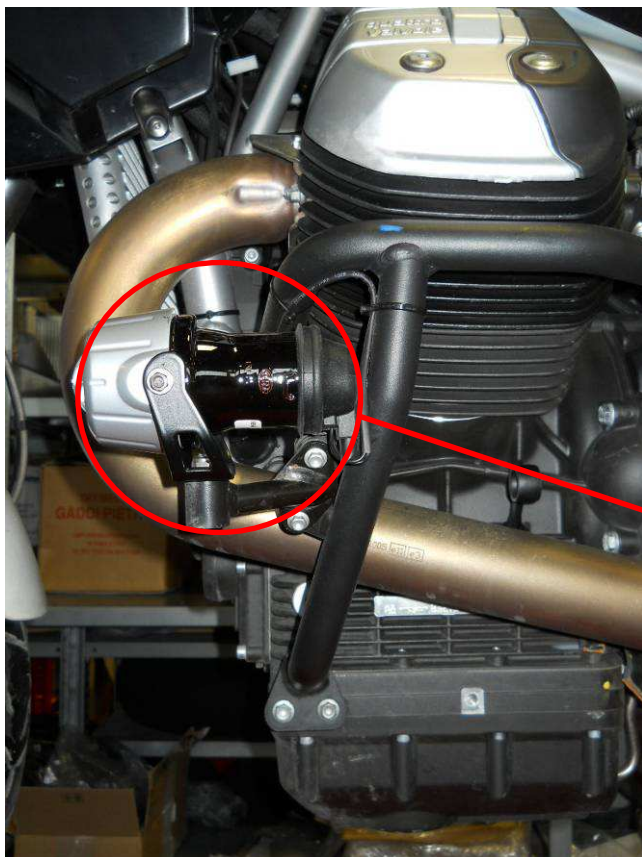
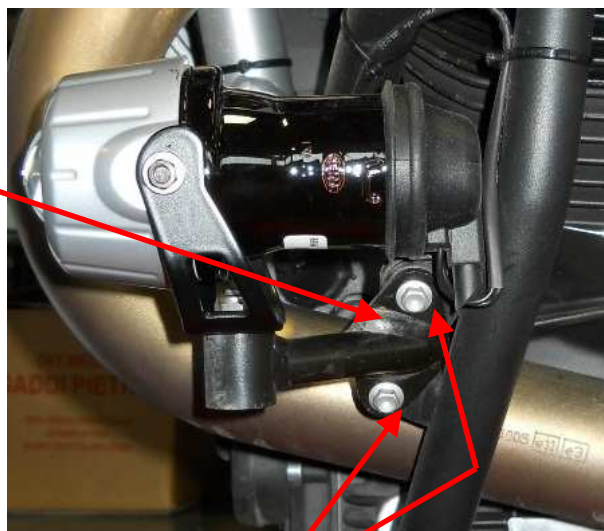
- Verify that the type of attachment mounting the spotlight to the dresser bars is like the one shown in the photo, that is, a metal fin welded to the dresser bars on which the spotlight is fixed by 2 screws.

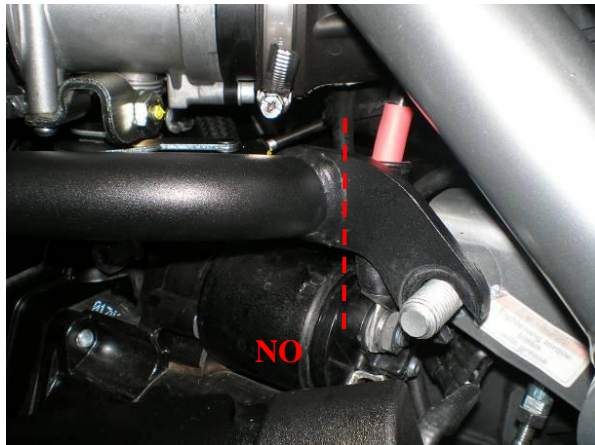
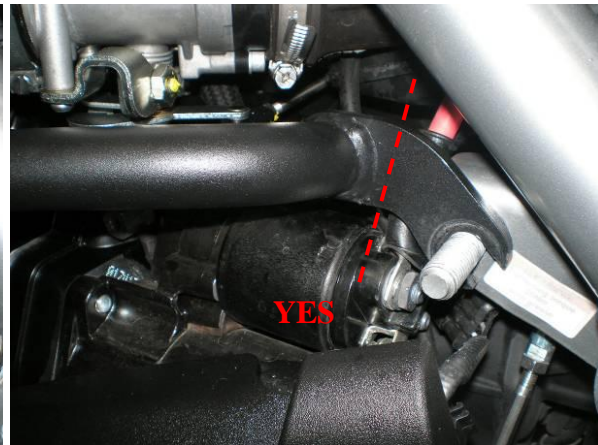
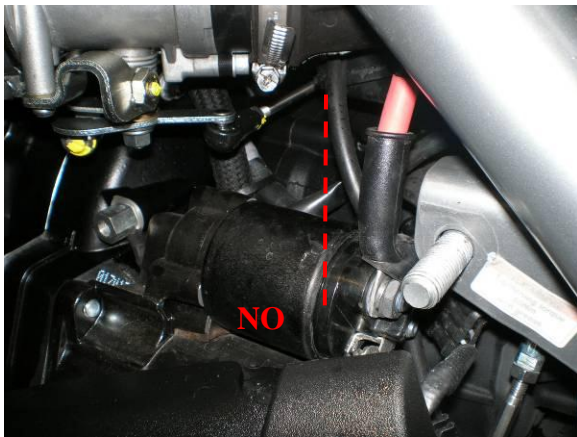
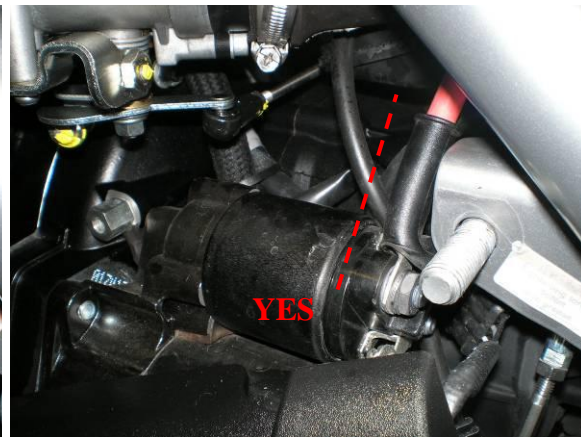
- Check to see if the positive cable harness of the starter motor is dangerously compressed by the dresser bars
- **If it is in a dangerous position** (labeled **NO** in the photos) then remove the nut securing the dresser bars, loosen the nut on the positive cable harness clamp of the motor and then lock it in the correct position

- Tighten the cable harness clamp nut, being careful to reposition the protection of the clamp, tighten the nut fixing the dresser bars, reposition the starter motor protection, and lastly restore the connection of the starter battery.
