Moto Guzzi technical training

February – March 2010

- Sheet No. 1: Differences between Stelvio MY'08 and MY'09
- Sheet No. 2: Engine oil leakage on gearbox side
- Sheet No. 3: Stiff, noisy clutch
- Sheet No. 4: LH calliper mounting bracket failure

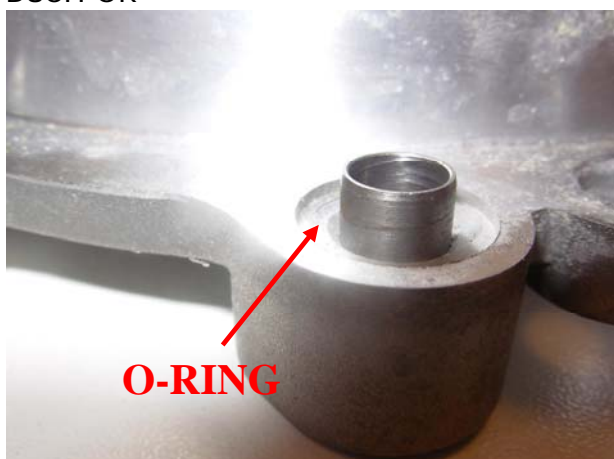
BUSH OK

SUBJECT: Engine oil leakage on gearbox side

- 1) Possible defect of oil seal p/n GU90405367, gasket p/n 874257 or O-ring p/n 874980.
- 2) Faulty oil passage bush on crankshaft mounting flange
- 3) Nonconformity of holes for crankcase/flange mating screws
- 4) Possible incorrect flange assembly

- 1) Remove the flange p/n 874213, following the procedure given in the workshop manual, and replace the damaged component.
- 2) Remove the flange p/n 874213, following the procedure given in the workshop manual and check that the oil passage bush is installed correctly as shown in the figure:

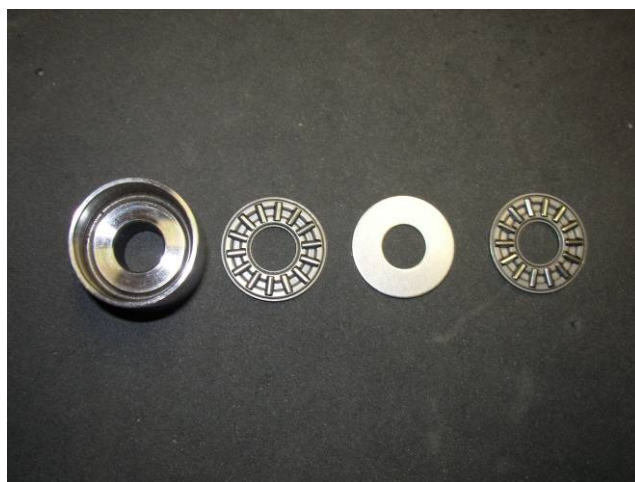
CAUSES: Incipient bearing seizure, with resulting deterioration

- 1) Replace the thrust bearing kit (detail 14 in the image, indicated by the blue arrow). Order p/n 976696 complete with spring cup, the two complete roller bearings and the intermediate metal washer. Before assembling the components described above, lubricate with Agip GREASE SM2. NB: before delivering the vehicle to the client, also grease the clutch lever pin on the left hand side of the handlebar

- 2) Grease the clutch control rod, indicated by the red arrow in the figure.

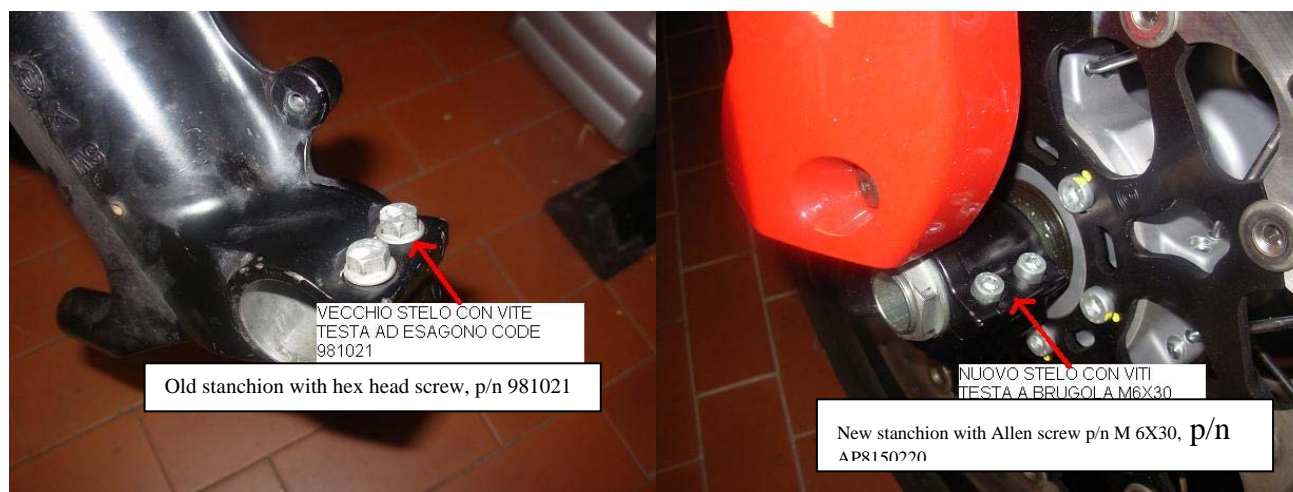
SUBJECT: LH calliper mounting bracket failure

CAUSES: excessive tightening torque applied to screw p/n 981021

SOLUTIONS: replace LH stanchion with fractured calliper mounting bracket with a new stanchion with the same p/n (981029), using the relative Allen screws with p/n AP8150220 (which must also be applied to the LH calliper mounting bracket).

The correct tightening torque of 10 Nm for the 4 screws must be respected.

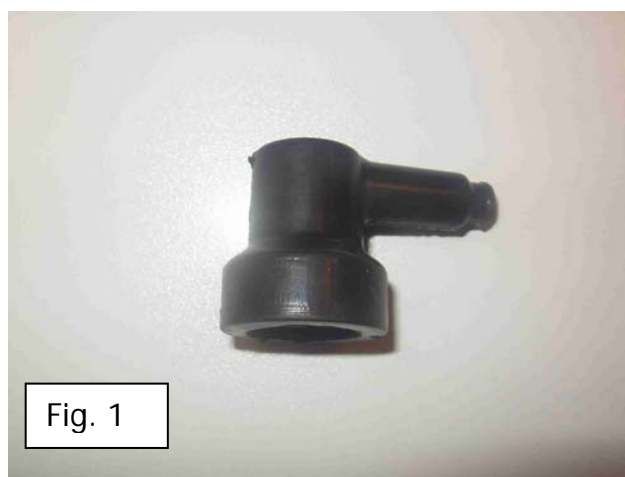
SUBJECT: Water infiltrating into oil pressure sensor

Moto Guzzi has decided to introduce a protective rubber cap, shown in fig. 1, as a spare part

This cap is supplied along with p/n 976688 and offers greater protection for the sensor. The procedure for installing the cap is as follows:

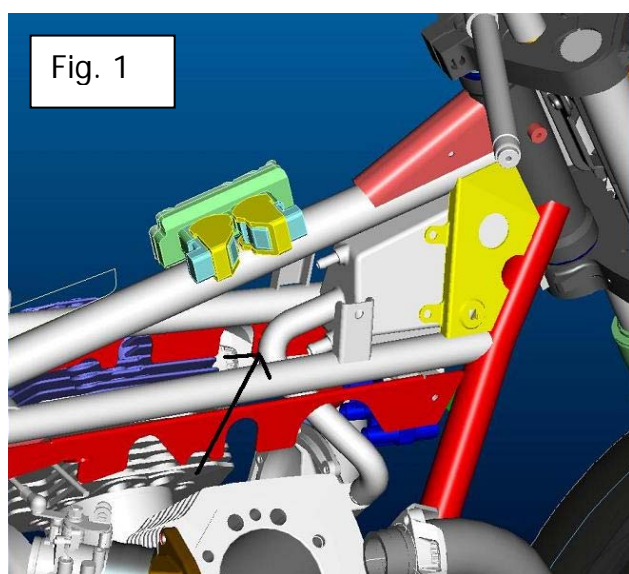
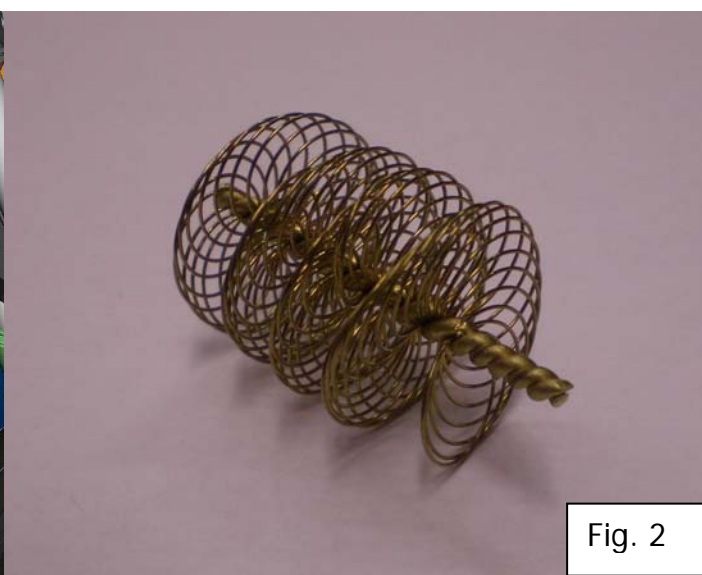
SYMPTOMS: Oil leakage in filter box area

CAUSE: Excessive flow of oil from engine to filter box

The new pipe is distinguishable from the old pipe by its shape.

The old pipe is straight. The new pipe, p/n 978461, has a preformed S shape. If the old pipe is installed, replace with the new pipe.

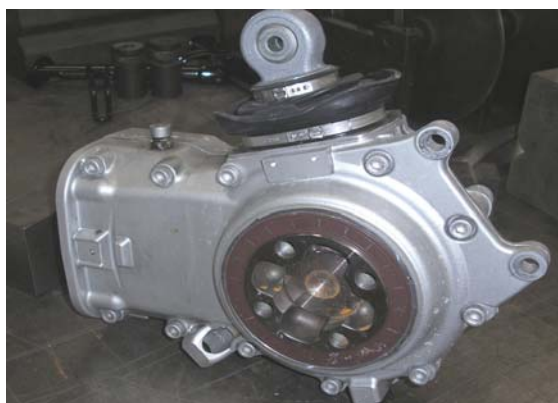
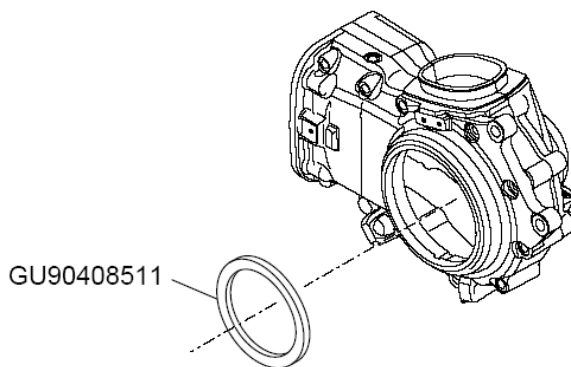
SUBJECT: Oil leakage from CARC cardan shaft

- 1) Faulty oil seal p/n GU90408511, if the leak occurs in the lateral part of the CARC on the wheel side
- 2) Faulty oil seal p/n GU90404558 and/or no sealant paste if the leak occurs in the link area between the CARC and the swingarm.
- 3) Poor seal tightness of sealant at the mating surface between the two halves of the transmission case

- 1) Remove the complete transmission case from the vehicle following the procedure described in the workshop manual and replace the damaged component.

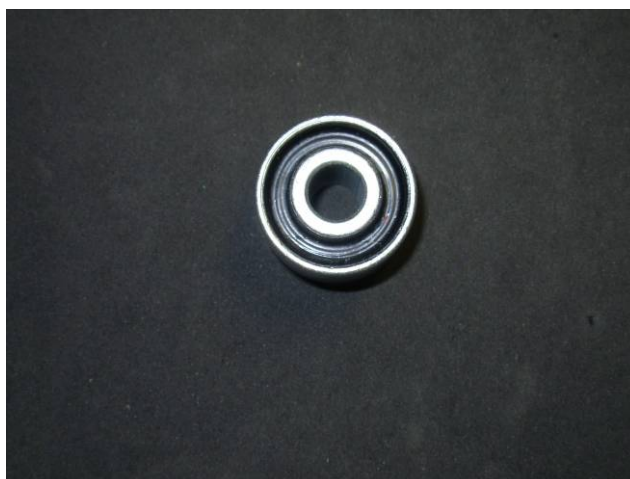
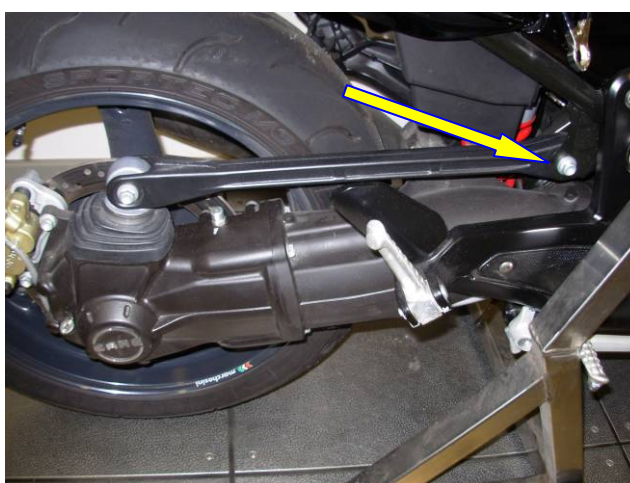
CAUSE: Excessive clearance in frame side bearing on reaction rod. on certain vehicles, a noise may be heard from the gearbox area under acceleration and lift-off. This noise may be caused by the excessive rigidity of the ball joint on the gearbox side end of the reaction rod. The rigid joint cannot absorb the longitudinal flexing to which the reaction rod is subjected, generated by the inversion in the direction of acceleration (such as when lifting off immediately after accelerating or accelerating hard immediately after decelerating).

SOLUTIONS: Remove the reaction rod following the procedure described in the workshop manual, then extract the frame side bearing and replace with the silent block p/n 883045.

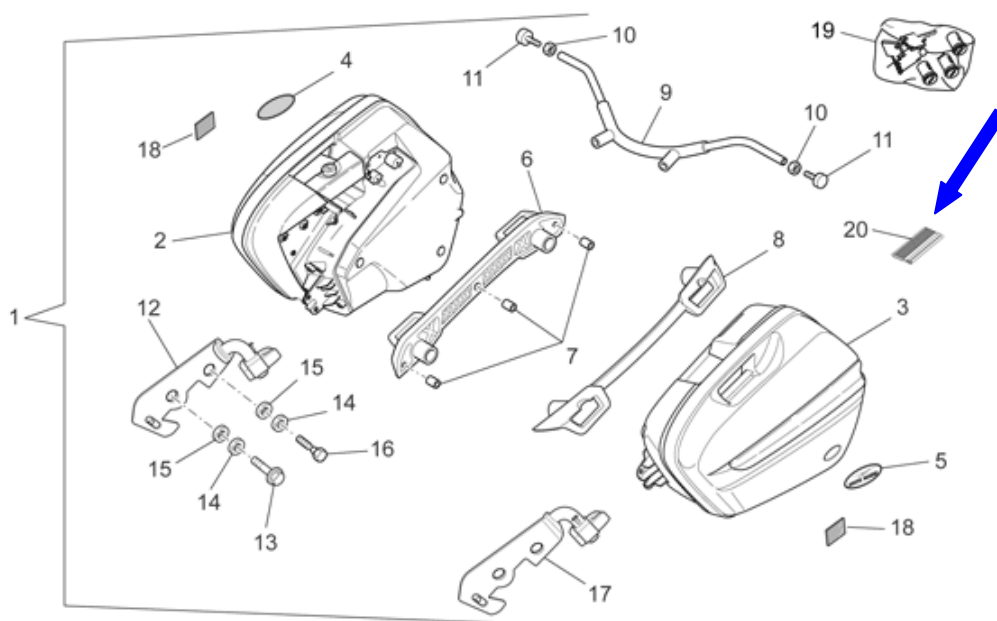
Figure 1

SYMPTOMS: on certain vehicles, the panniers (left or right) may fail to close properly after a very few kilometres of use.

Specifically, the hinged shell fails to close correctly against the fixed part of the pannier: in some cases, there is a visible gap in the upper area where the two shells should seal against one another. This gap may reach significant dimensions (to assess the size of the gap, remove the seals and close the two shells together): and it is through this gap that water infiltrates in rainy conditions or when washing the bike.

CAUSES: Warping of one of the two pannier shells resulting in poor closure, as shown in figure 1.

- 1) Replace the seal, using the new component with p/n 883246 (detail 20 in the image, indicated by the blue arrow). The new seal differs in thickness and stiffness (all contact surfaces must be lubricated with petroleum jelly). Immediately after replacement, the hinged shell may not seal easily against the fixed part of the pannier and the pannier itself may be difficult to close. Open and close the pannier repeatedly until the new seal settles correctly between the two shells.
- 2) As mentioned earlier, if a significant gap between the shells is revealed when test closing the shells without seals, it may be possible that even replacing the seal may not be sufficient to solve the problem (see figure 2). In this case, the replacement of the entire pannier is necessary, after sending photographic documentation to the respective department for evaluation of the case.

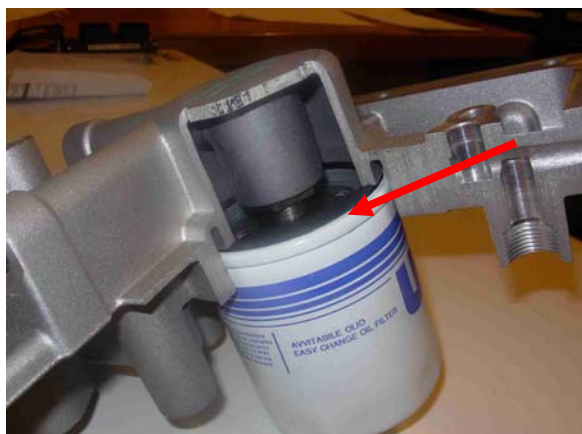
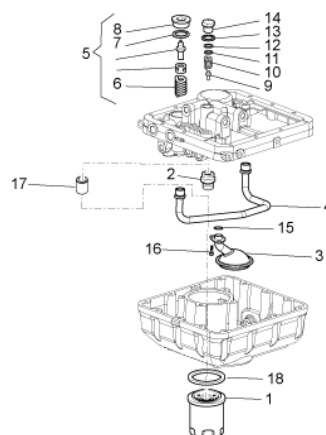
File from spare parts catalogue

SUBJECT: Leakage from oil filter gasket

Filter cartridge p/n GU30153000 with non conformant gasket

Replace the original filter assembly gasket with a new gasket with p/n 981115, which is identical in size but has different rubber characteristics.

NOTE: Check the production date indicated on the exterior of the filter (see figure). If the year of production is earlier than 2009, the gasket must be replaced with a conformant component.

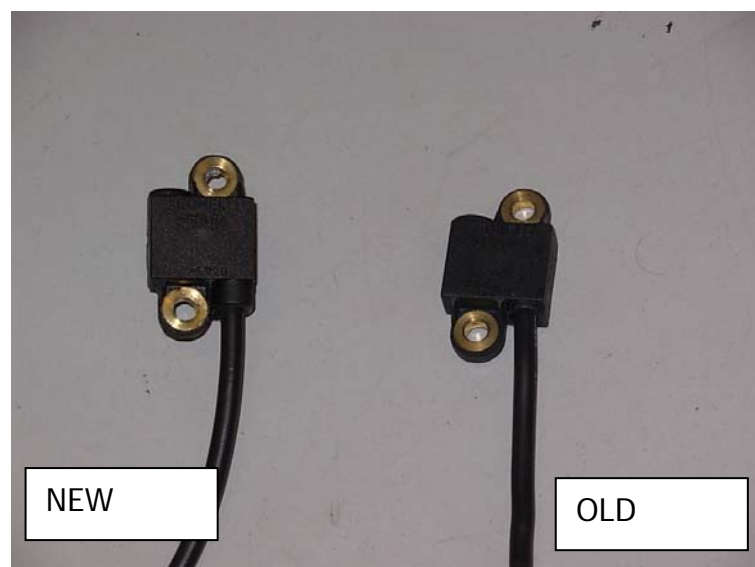
Water infiltration into vehicle speed sensor p/n GU06765400

Replace speed sensor with a more recent equivalent sensor with the same p/n.

Refer to the following figure to identify sensors:

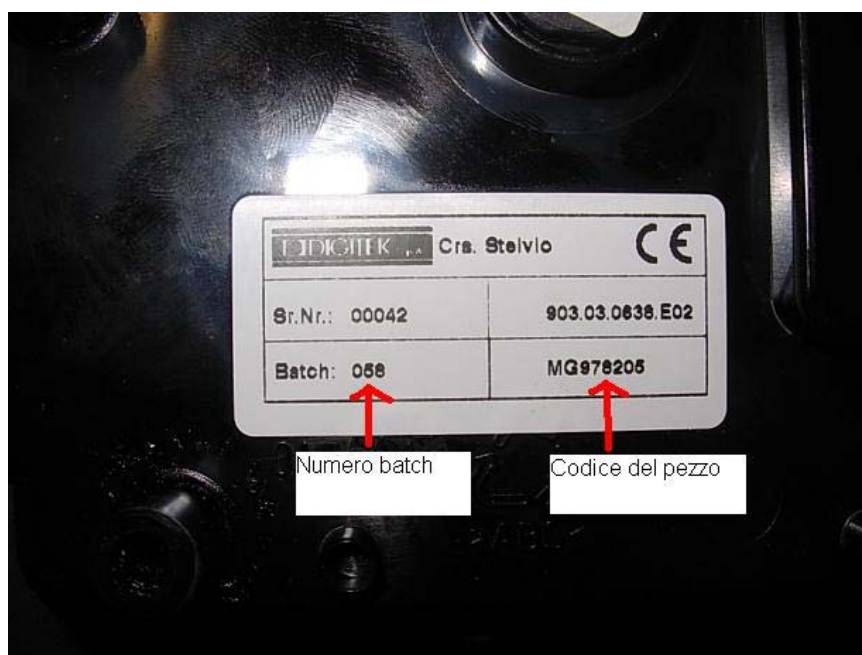
SUBJECT: Water infiltration in instrument panel

CAUSES: Non conformant seals.

In this case, the most important aspect is to determine whether or not instrument panel replacement is necessary. It is necessary to differentiate between cases in which water is effectively infiltrating into the instrument panel and cases where there is merely light condensation inside the instrument panel (see image below)

In the latter case, condensation generally forms near the instrument panel perimeter surround and usually disappears within a few minutes of riding the vehicle. It is important that the instrument panel is always legible (both the analogue and digital areas) and that the condensation disappears within the first 5 – 7 minutes of riding the motorcycle. In this case, the instrument panel does not need to be replaced as it is still conformant with project specifications and, therefore, with the quality standards required.

SOLUTIONS: Replace the component under warranty

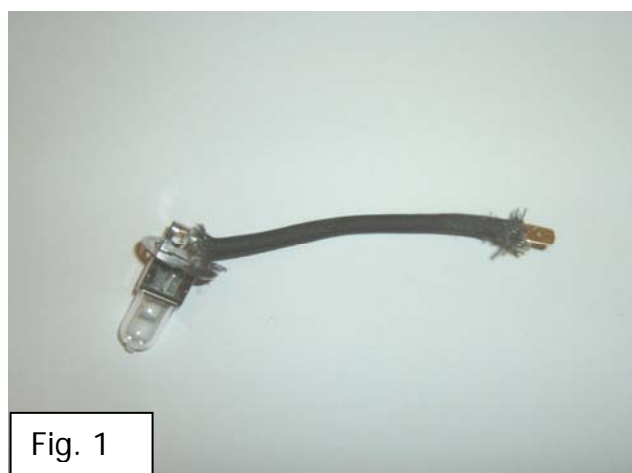
Fig. 1

SYMPTOMS: Vehicle cuts out while in motion when the high beam lights are switched on due to failure of 30A fuse

A modification has been developed for the high beam lamp cables, introducing a sheath (fig. 1) to offer greater protection for the cables themselves.

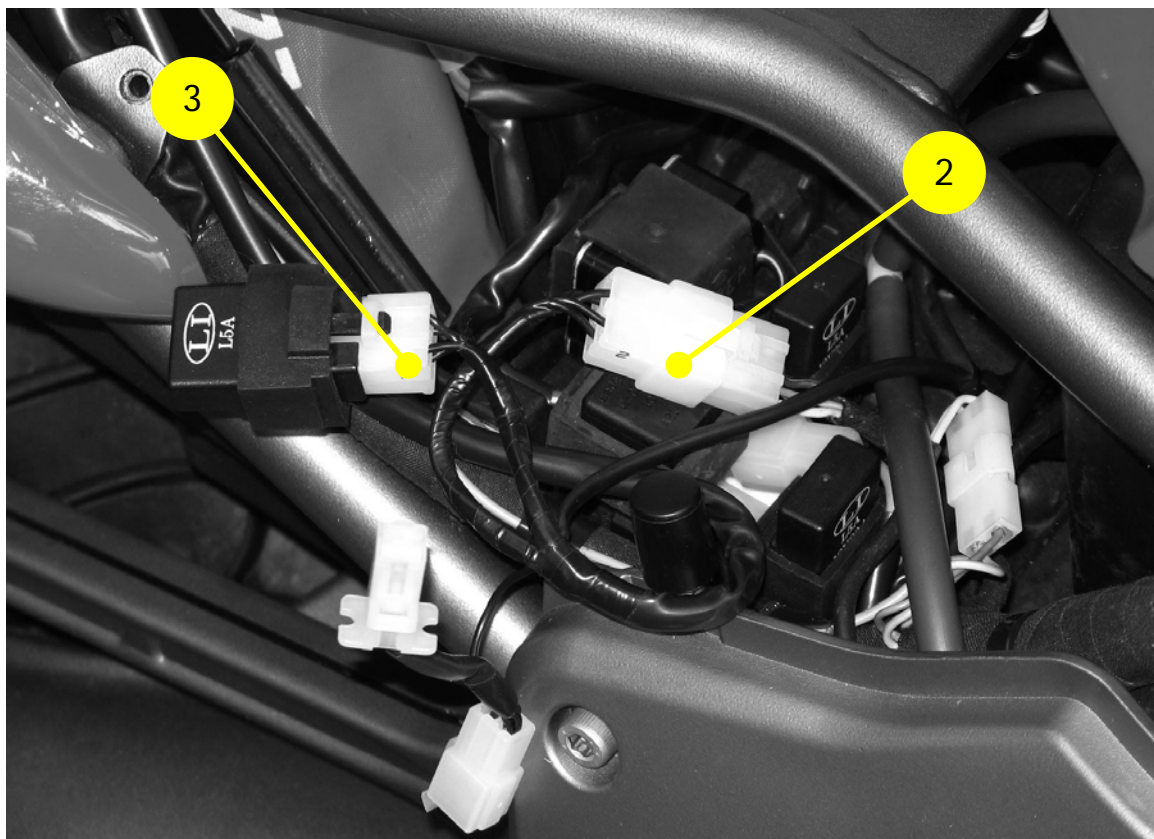
CAUSE: Probable electromagnetic disturbance in antitheft system/vehicle wiring harness

The two connectors at the bottom which are loose in the photo are the positive connections for the antitheft system and must be connected normally.

To disable the engine immobiliser function of the antitheft system, restore the starter relay to its original position on the main wiring harness. Using the photo as reference, remove the relay from connector 3 (Z1 in the wiring harness layout) and disconnect connector 2 (Z4 in the wiring harness layout), then reconnect the relay where connector 2 was connected. This disables the engine immobiliser function while leaving the fuel pump inhibitor function enabled (the fuel pump connectors are not visible in the photo). Seal the loose connectors 2 and 3 with insulating tape.

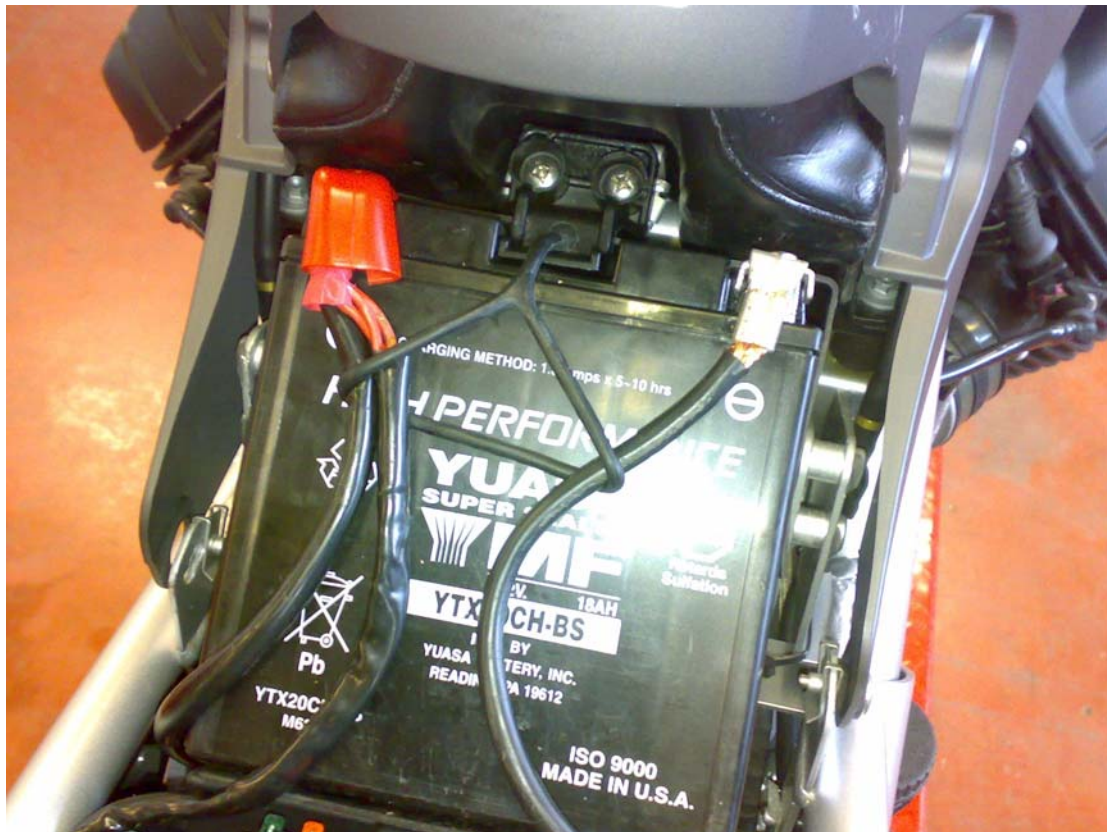
SYMPTOMS: positive and negative cable which could become damaged when the saddle is inserted

CAUSES: It is possible that as there are no constraints for the electrical system/battery connection, when the saddle is being repositioned its two metal hooks might irreparably damage the cables during vehicle maintenance, whether performed by your dealers or by yourself.

The end result must be like the following image.
